Urgent Report of the Landslide Disasters by the Mid Niigata Prefecture Earthquake in 2004, Japan

Investigation Commission of
the Japan Landslide Society and the Japanese Society of Engineering Geology

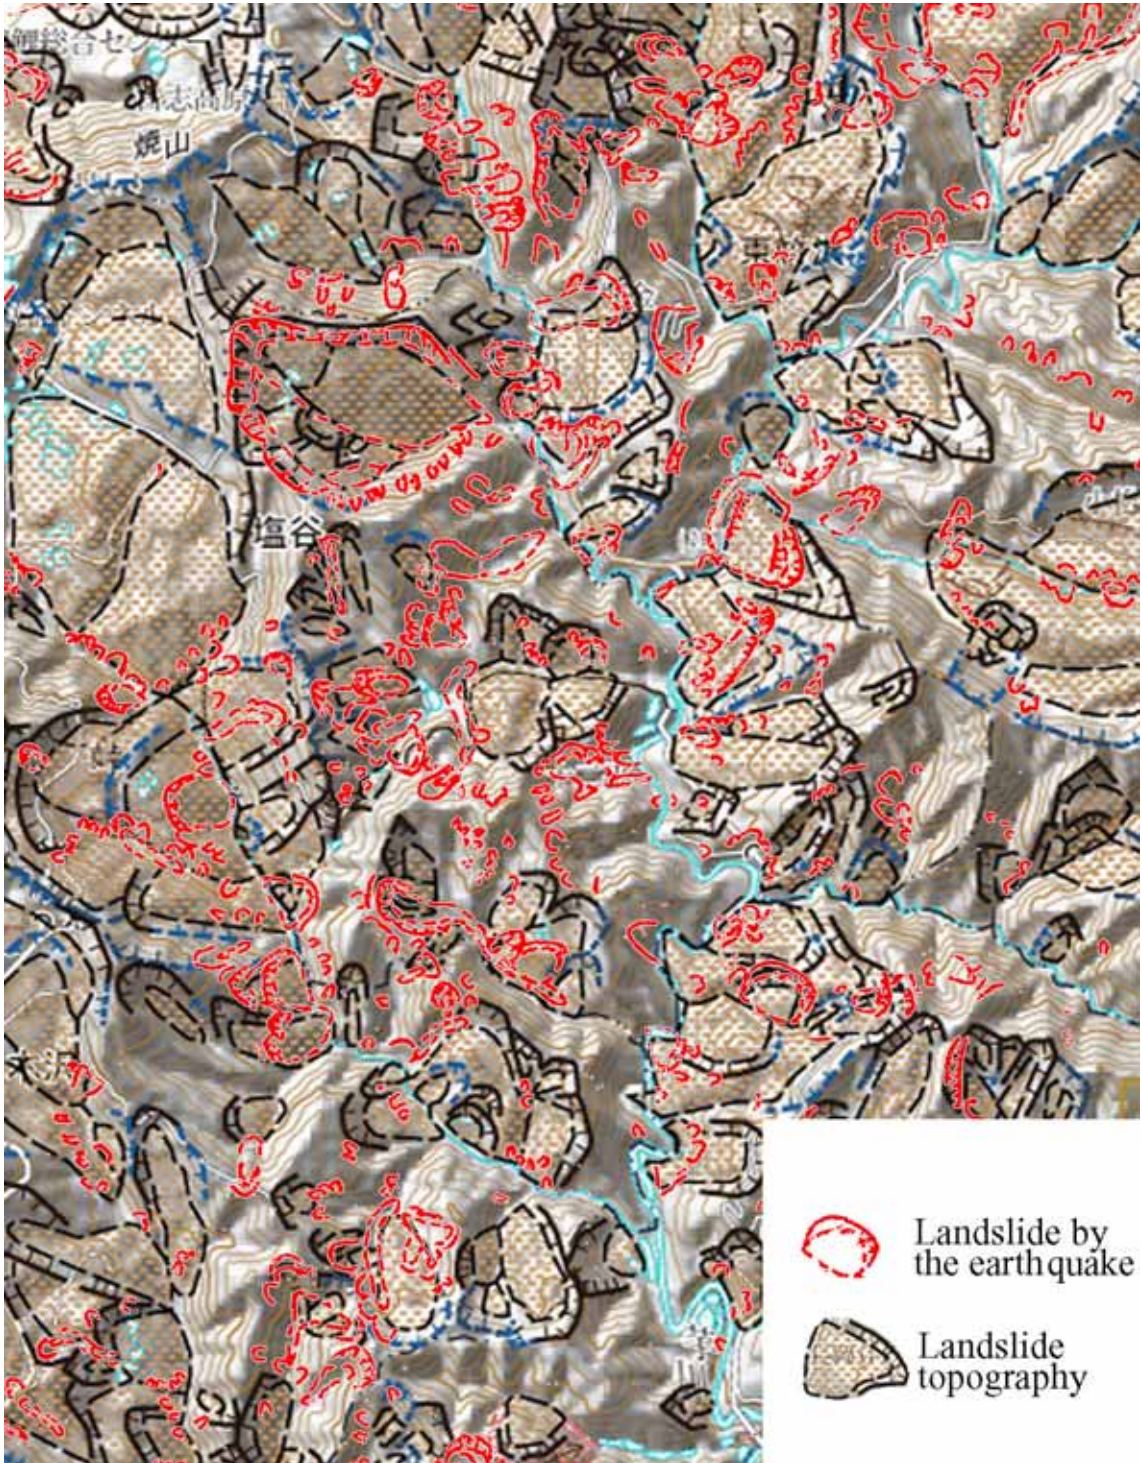
Fig.2 Relationships between the landslide topography and the landslides by the earthquake.

- 1) Many of the landslides occurred within the landslide topographic area (Fig.2).
- 2) Most of the large-scale landslides occurred on dip-slopes within the areas of sandstone overlying siltstone or the areas of alternated beds of sandstone and siltstone. Mudstone area suffered from less number of landslides, although it is widely covered by previous landslide topography.

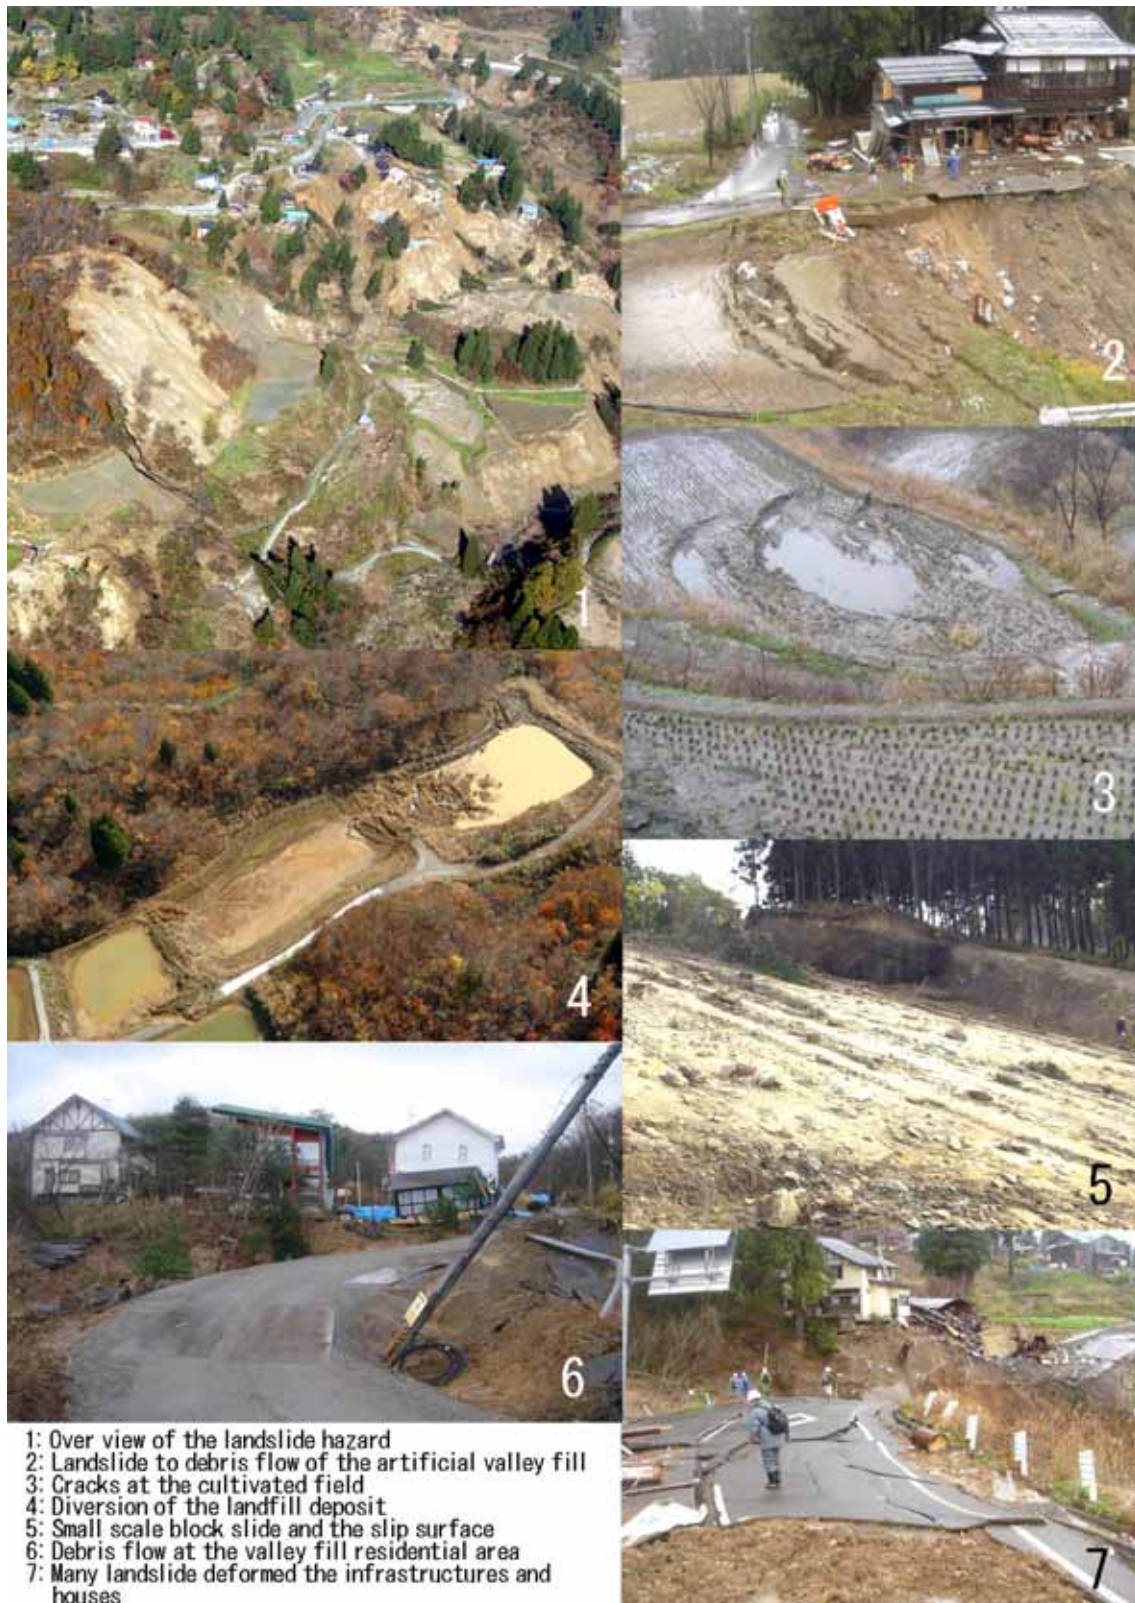
Fig.4 Samples of various types of landslides by the earthquake.

- 3) Most of shallow landslides are concentrated into such geomorphic situation ridges, side slope and attack slope of the rivers and valleys, the toe part of the area of the topographic landslide body.
- 4) The landslides are categorized into several types i.e. large scale block glide, small scale rock slide, small slump, debris flow, shallow landslide (slope failure), rock avalanches, and the complexes (Fig.4, 5). Landslide dams are also remarkable phenomenon by the earthquake disaster.(Fig.6)
- 5) A huge number of cracks appeared at the step cultivation area and the hill slopes.

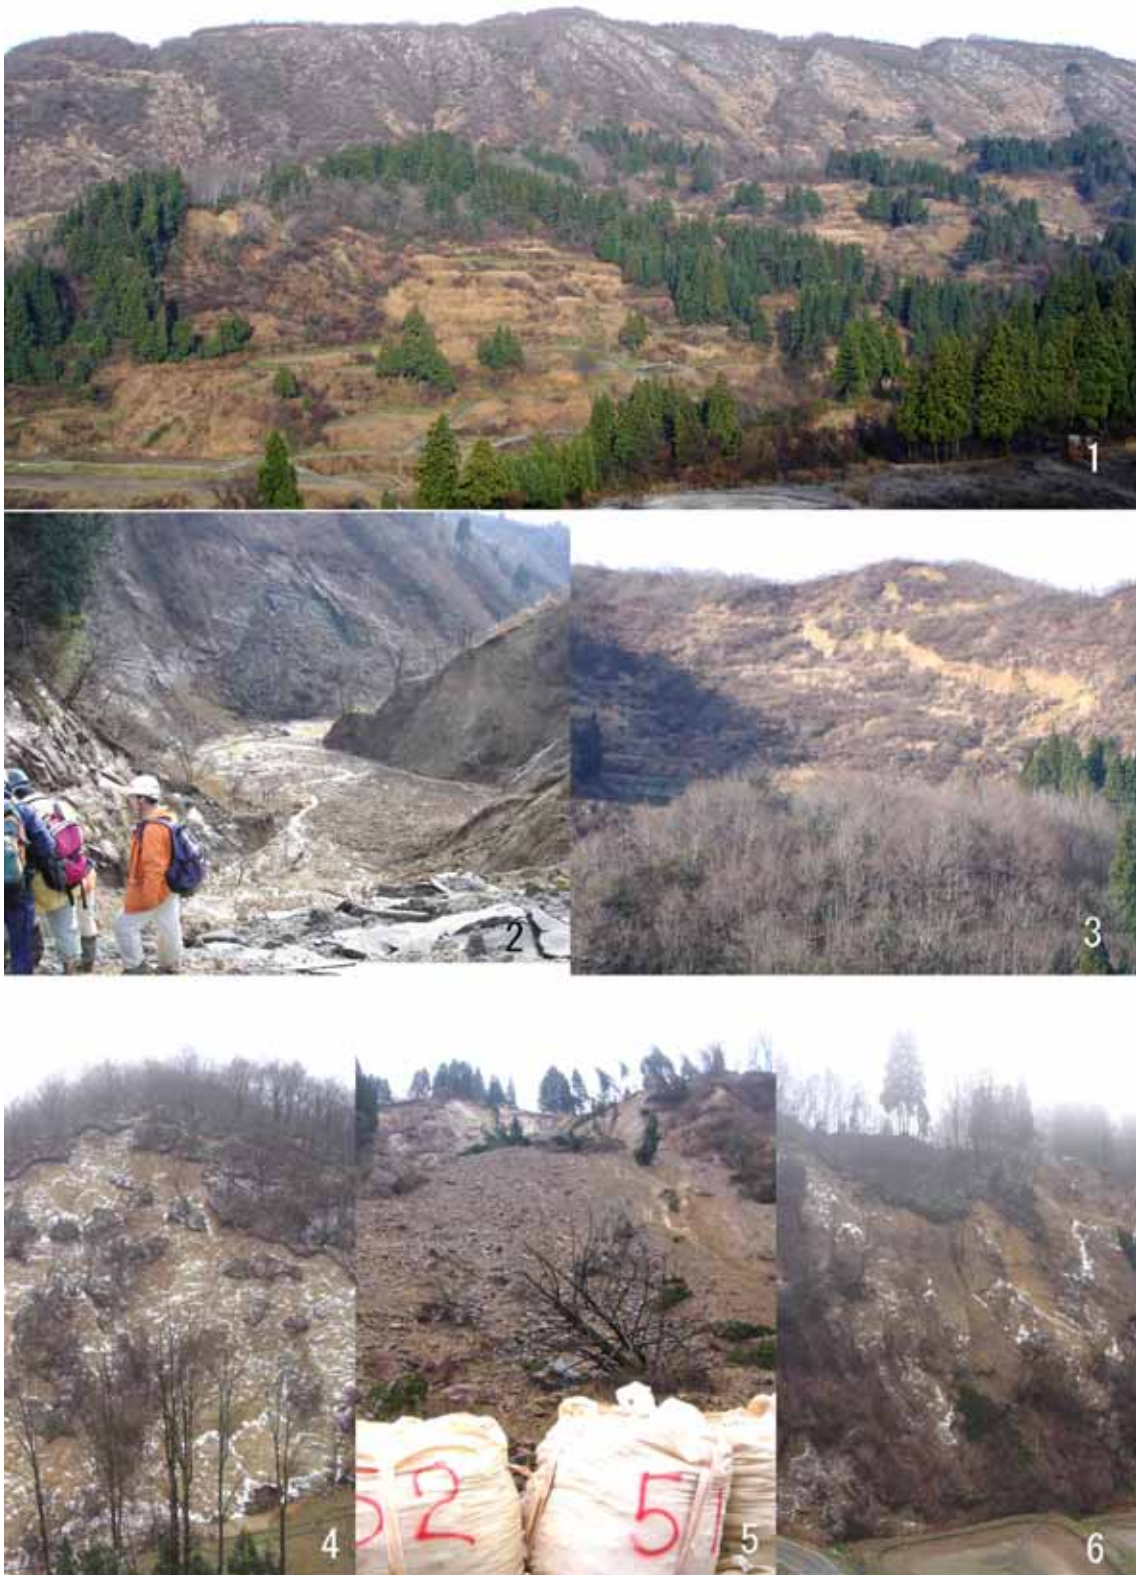
Fig.5 Samples of various types of landslides by the earthquake (2)

1: Landscape of the Yamakoshi village (Almost slopes are consist of landslide topography)
 2: Debris flow into the river 3: Block glide landslide (Slip surface is located at the bedding plain)
 4: Shallow landslides 5: Rock avalanche 6: Slightly large shallow landslides

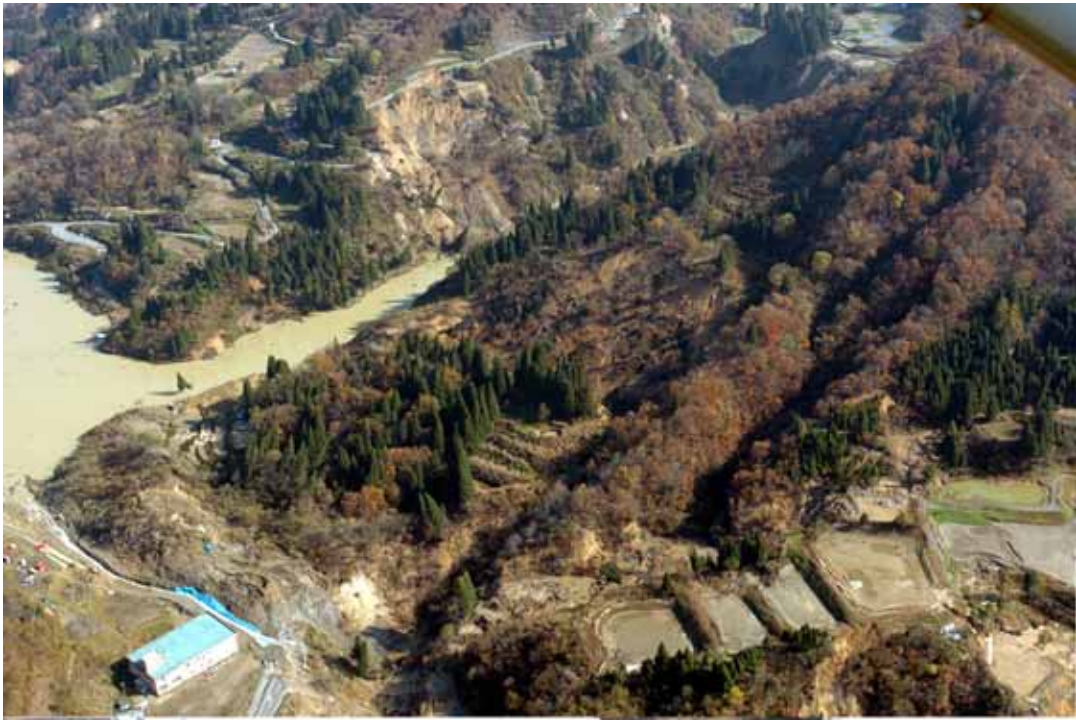
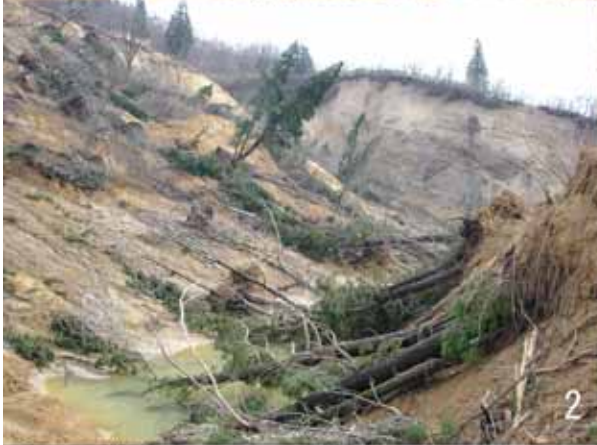
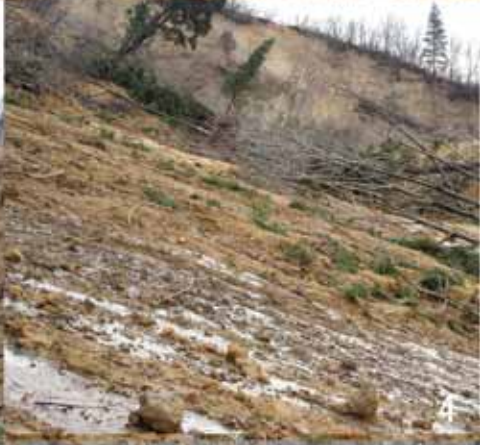
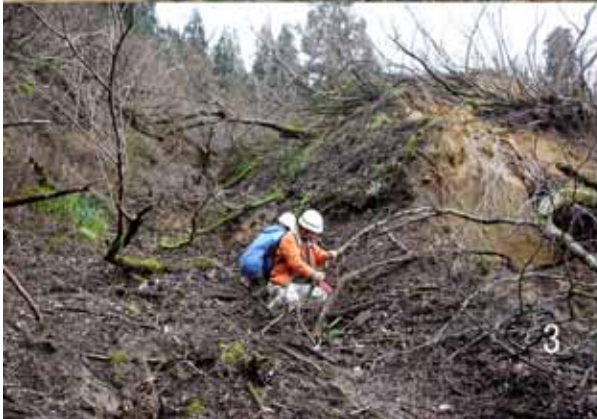
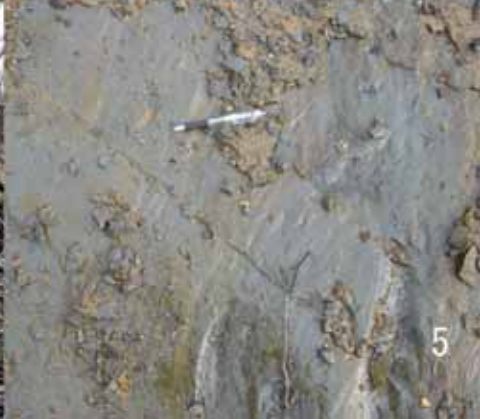
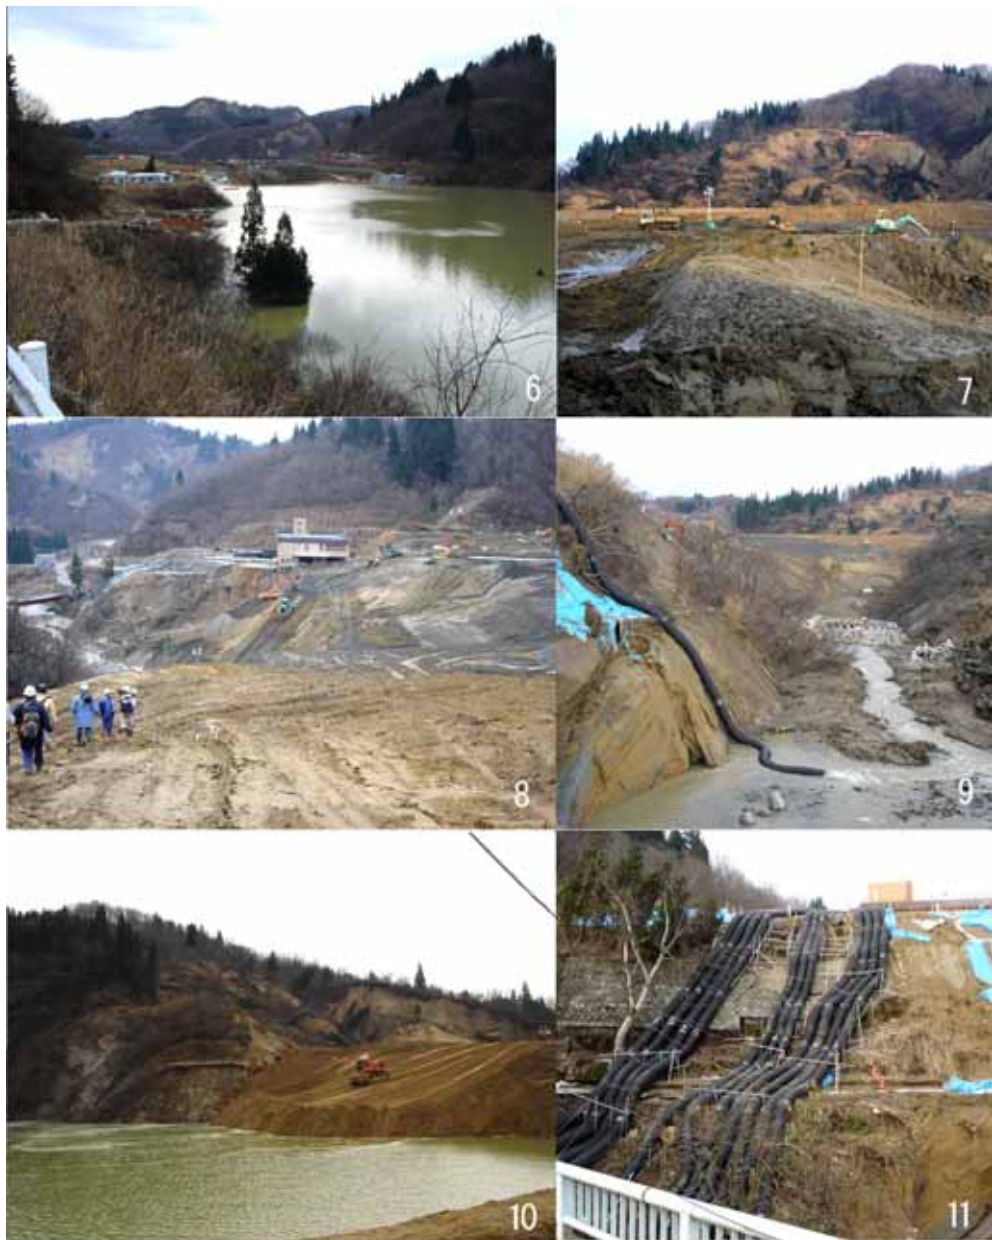
Fig.6 Landslide dam by large-scale block slide at the Higashi-Takezawa

Higashi-Ttakezawa site (Fig.6): Typical block slide established the biggest landslide dam. This was also reactivation of a part of previous landslide.

1: Over view of the Higashi Takesawa landslide establishes the large landslide dam at Imogawa river
 2: Graben like landform in the landslide body 3: The boundary of the former landslide body and the main scarp 4: Large outcrop of the slip surface 5: Close up the slip surface 6: Landslide dam
 7: Repair operation at the surrounding landslides 8: Repairment operation (Cut and fill for the secondary disaster prevention) 9, 10, 11: Cut the canal for water temporal level control

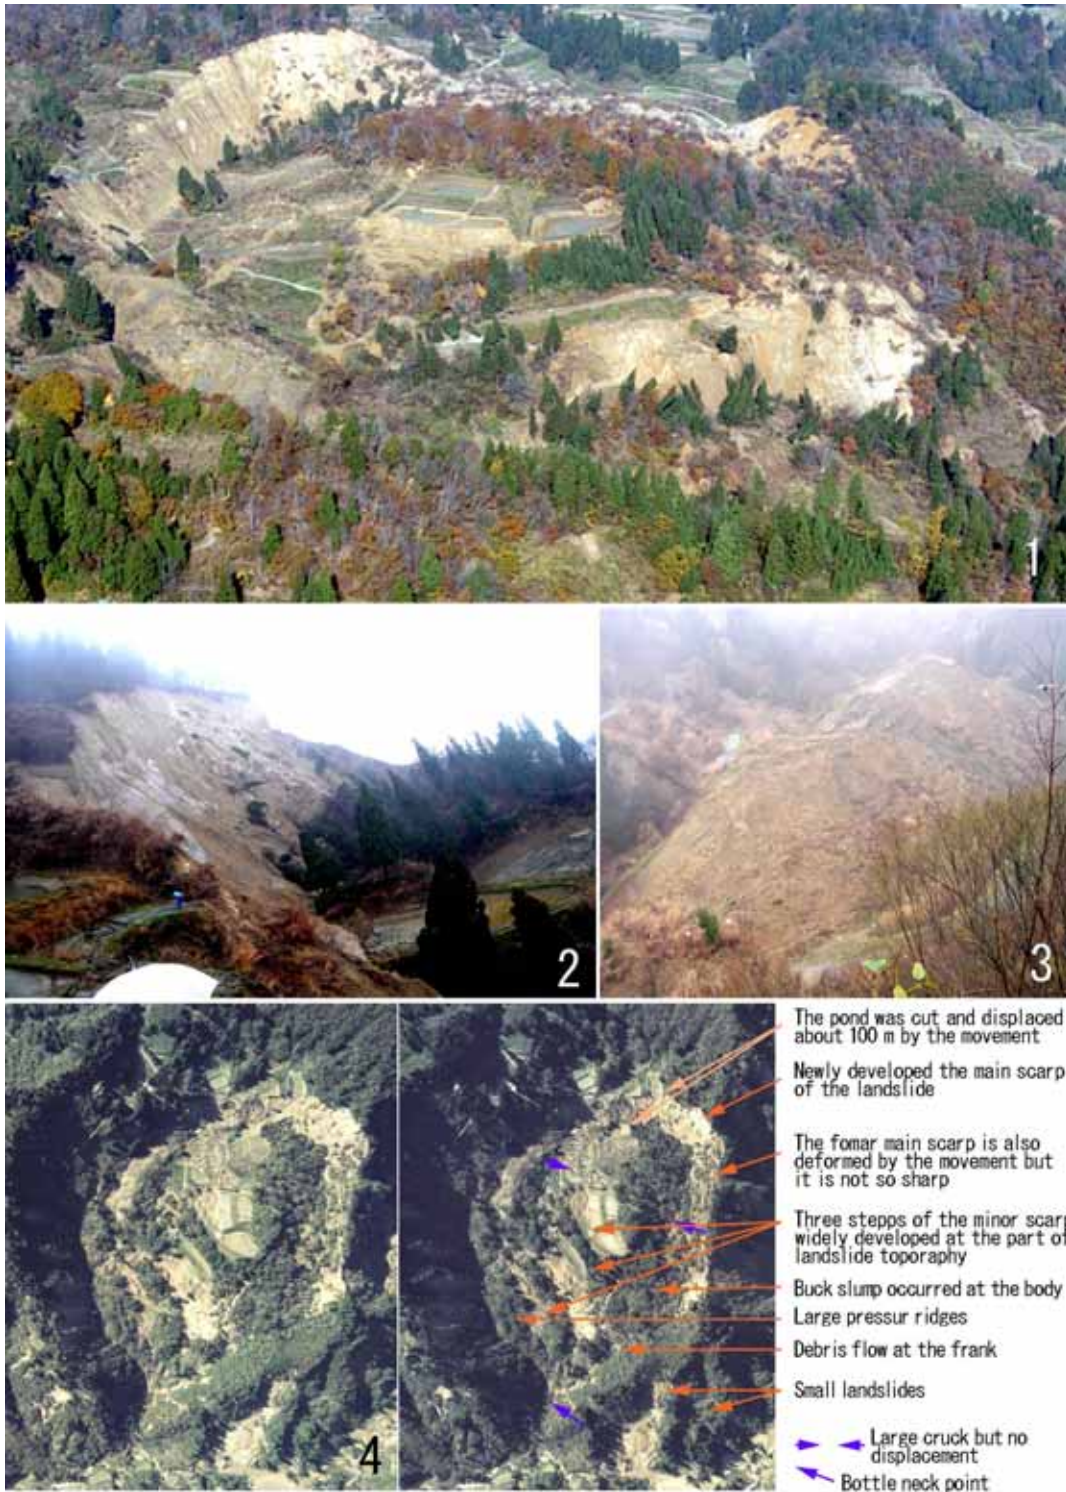
Kajikane site (Fig.7): The largest block slide occurred 5 km north from the epicenter. The slide occurred within the previous slide body. The action appeared at the area of landslide topography. But the area was extent about 100 to 200 m wide more. The effected area was 600 m by 600 m. The thickness of the slide body is assumed to about 70 meters.

Fig.7 Geomorphic features of the biggest landslide at Kajikane site, Yamakoshi village. 1. Overview of the landslide, 2. Main scarp of the landslide, 3. Marginal toe of the landslide, 4. Stereo-paired photographs of the landslide.

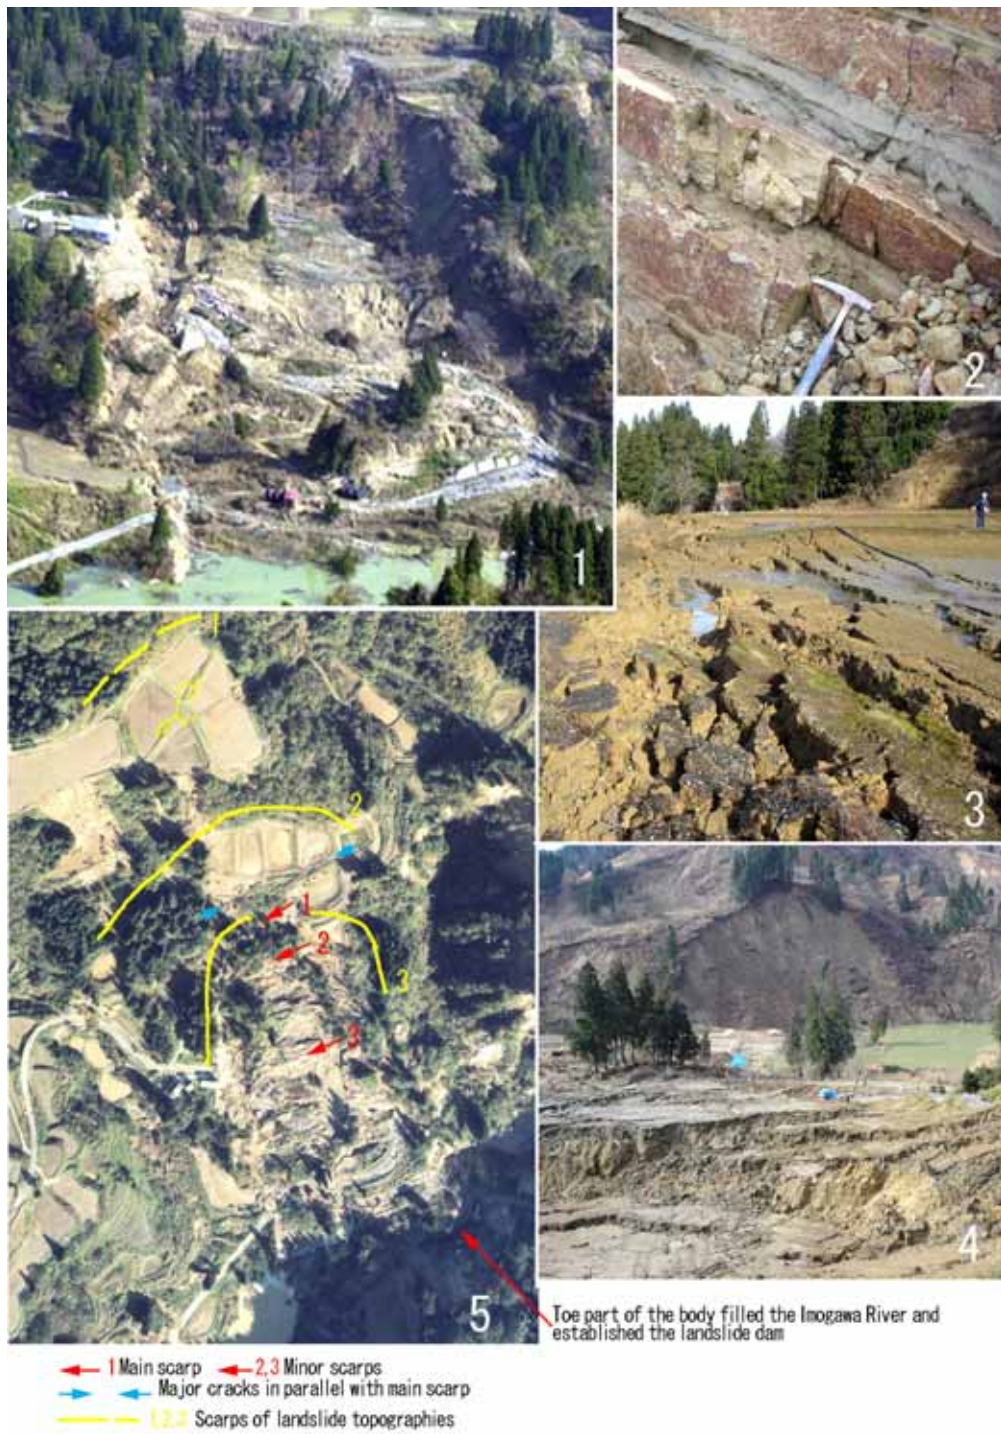
Terano site (Fig.8): This was a typical reactivation of existing previous landslide, forming a landslide dam. The type of movement seems to be basically translational with local backward rotation near its head scarp and a subsidiary scarp. Several large cracks are distributed on the upper slope of the crown.

Fig.8 Geomorphic features of landslide at Terano site. 1. Overview of the landslide, 2. Close-up view of the bedrock, 3,4. Cracks cutting the ponds, 5. Interpretation of the aerial photograph of the landslide.

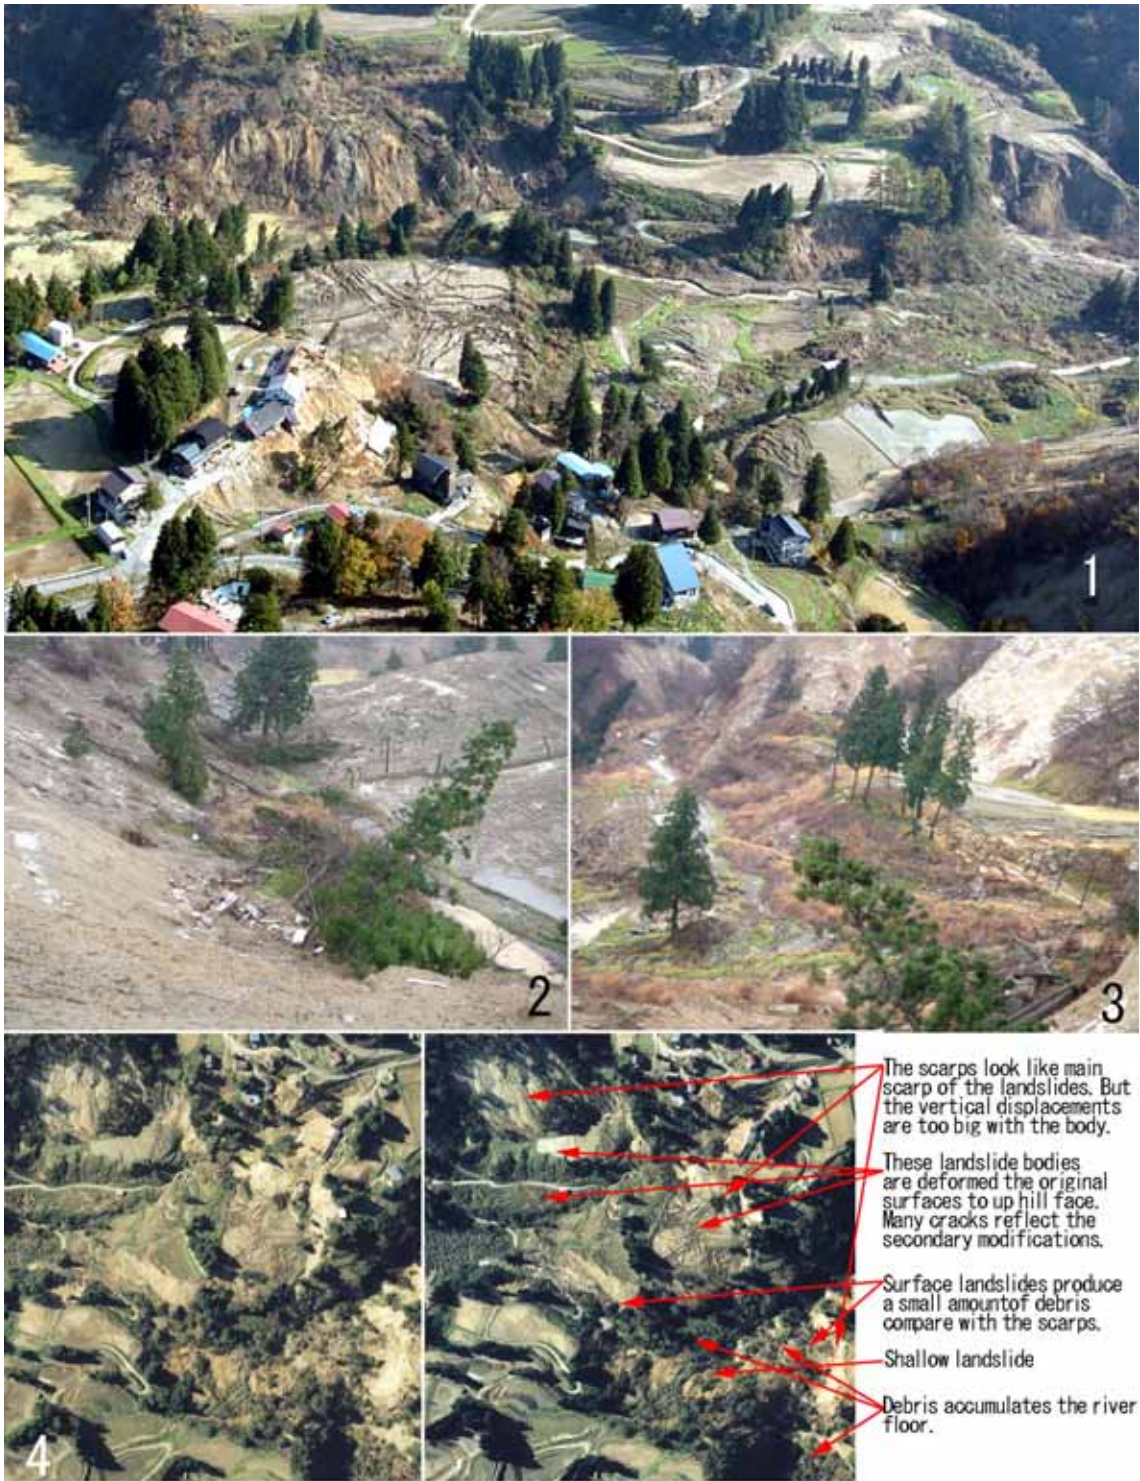
Fig.9 Geomorphic features of several landslides at Ikedani site

Ikedani site (Fig.9): A number of small landslide and surface landslides occurred at the toe part of the area of landslide topography. The type of the landslides seems to be not slumping. Block slide might be dominant. Each size of the slides is relatively small.

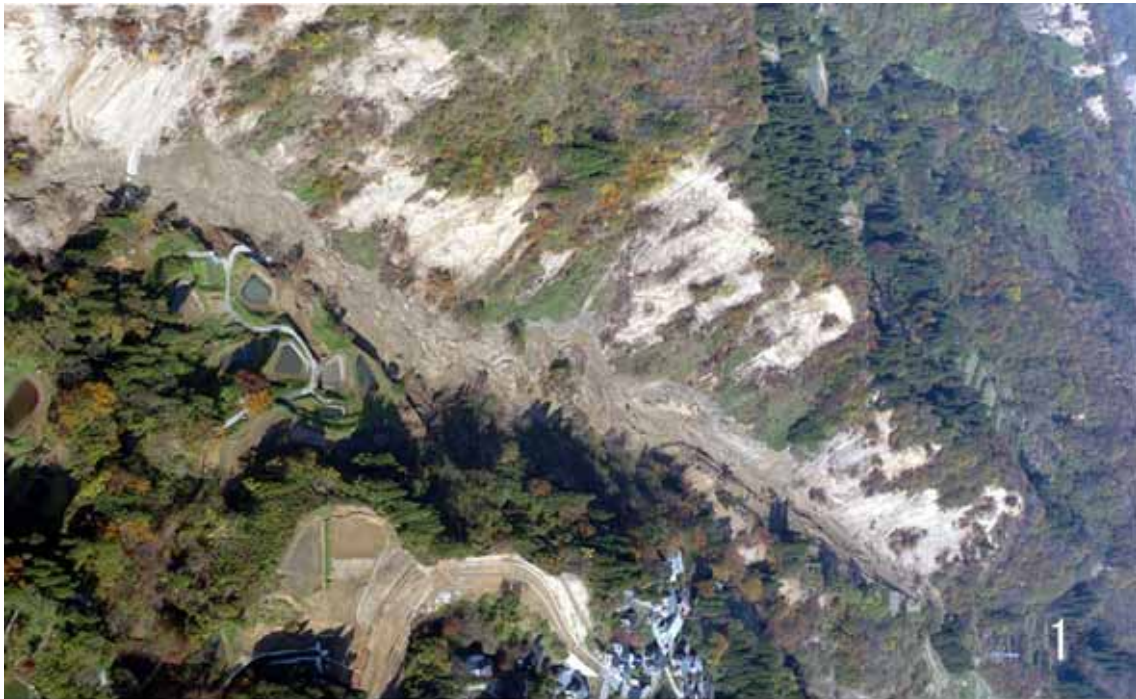
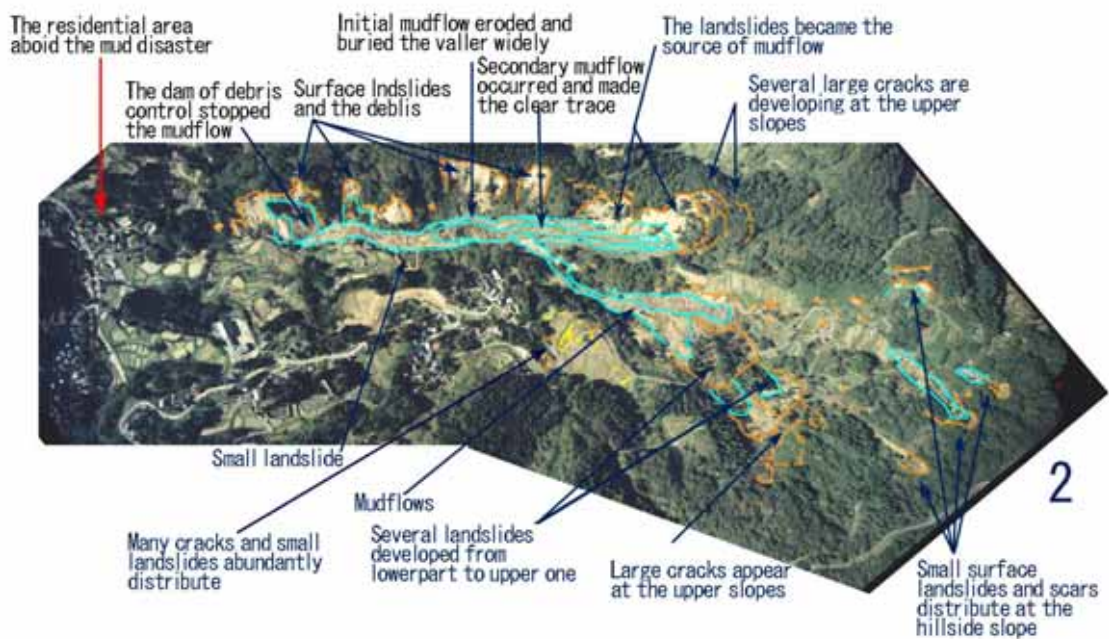
Fig.10 Geomorphic features of the mud flow at Kokuriyama site

Kokuriyama site (Fig.10): A large mudflow occurred caused by relatively large landslides in the uppermost part of the valley. The initial mudflow flowed about 1 km, the debris buries the valley very thickly and the secondary mudflow developed clear debris flow traces about 500m long. A landslide control dam had prevented further downstream flow.
