# Recent landslides in Niigata Region, Japan

H. Yamagishi (e-mail: hiroy@env.sc.niigata-u.ac.jp), L. Ayalew  
*Niigata University, Japan*

**ABSTRACT:** The Niigata region is known in Japan for landsliding at high frequency. Recently, slope failures were taking place at different places in the region as a result of heavy rainfall, rapid snow melting and other factors. This paper introduces some of these landslides and gives a brief discussion on what has been done subsequently.

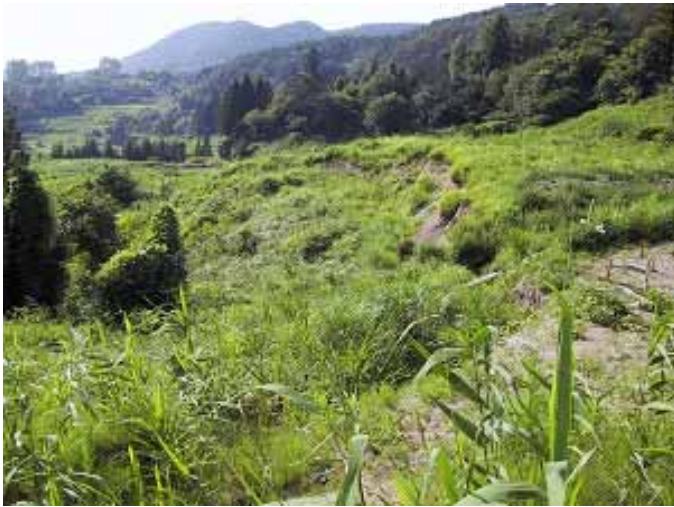
On August 4, 1998, the northern Sado area was damaged by intensive flooding immediately after heavy rainstorms. There is a belief with little evidences that it might be on this day that Shiidomari landslide has started to occur. However, it was in May, 1999 that the slide was first recognized by the people living in the area. In September 1999, an amphitheater like scarp (Fig. 2) associated with cracks has appeared, and was followed by the deformation of river structures of the nearby Masara River. The marginal slip plane was presumed to be under the river. Finally a squeezed-up mound (Fig. 3) appeared at the opposite side of the marginal front (Kanno et al., 2002), most probably due to the fact that the margin of the slide pushed the opposite side of the stable wall of the river.

Figure 2. A crack appeared at the crown of the Shiidomari landslide.

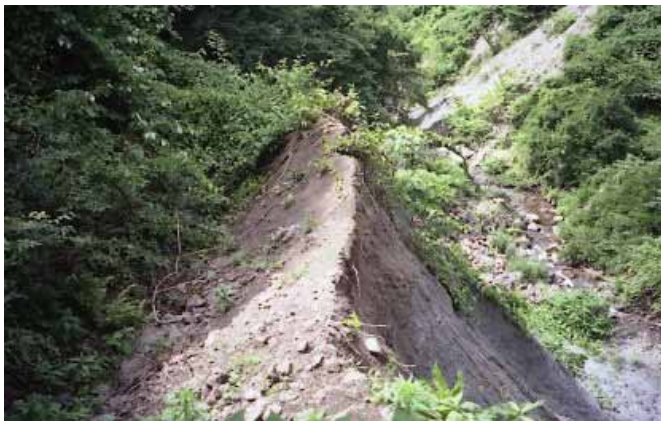
Figure 3. A squeezed-up mound at the opposite side of the lower margin of Shiidomari landslide.

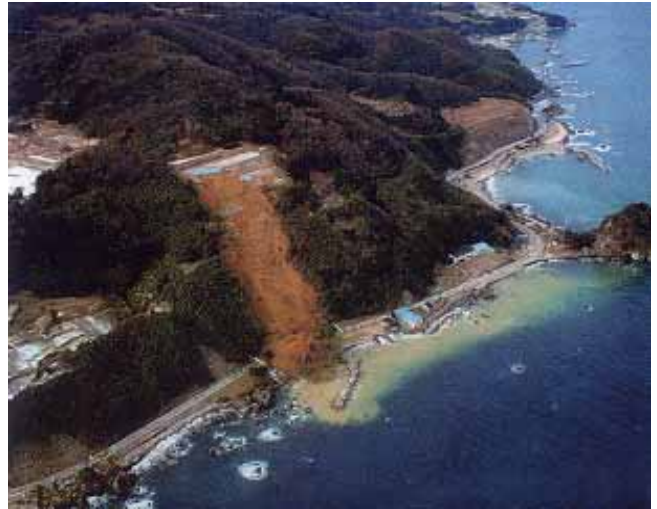
The other recent landslide in Sado Island was Katanoo, occurred on January 28, 2003 (Fig. 4). It is located at the north eastern part of Kosado where the geology is dominated by gravel, clay and the underlying Neogene tuffs. This landslide is 75 m wide,

250 m long and 11-18 m deep. The sliding block was divided into two, a lower one and an upper part. At the time of sliding, it was the upper block which was mobilized first. The stress on the lower one has increased instantly and the block failed entirely under gravitational pull. The immediate effect of the slide was that the main road which connects the Oh-sado and Kosado parts was completely blocked.

Figure 4. Aerial view of the Katanoo landslide (Courtesy of Kowa Co. Ltd.).

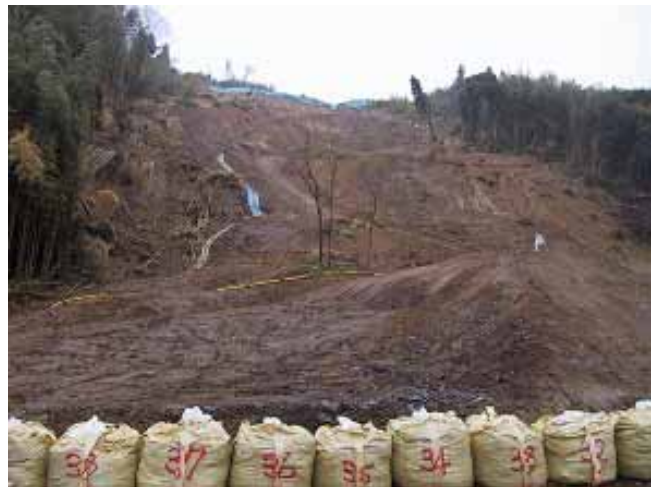
Figure 5. A closer look into Katanoo landslide as the effort to prevent further sliding was underway.

The contribution of geology in the formation of Katanoo landslide was directly related to the type of materials lying underneath the sliding area. The bedrocks exposed on the main scarp were Neogene tuffs. These rocks are highly weathered and changed into brownish clay soil (Fig. 5). At some places, the extent of weathering deep into the mountain has reached 30 m. This encouraged the upper block mentioned above of the slide to make a crest and the lower block a hollow even before landsliding, which could be an indication for the presence of a repeated slope failures in earlier times, just because the material is weak.

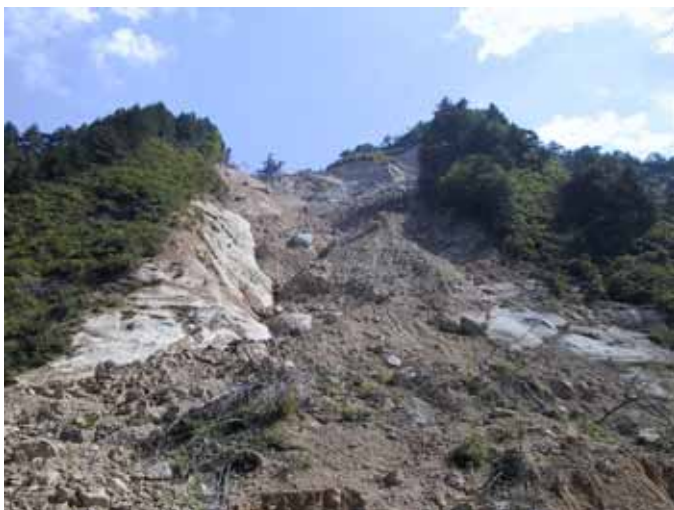
On January 5, 2000, a landslide occurred on the right-hand side of the Tozawa River, which is an upper tributary of Agano River in Niigata Prefecture. The area of landsliding was located approximately 56 km northeast of Niigata City (Fig. 1, point 2). The landslide affected mainly the less consolidated sediment at the top and the movement was concentrated along that part of the hill where an eroding gully was present. The type of materials involved were a mixture of soil debris and blocks of rocks that can reach 1-2 m in diameter (Fig. 6). At the time of landsliding and for sometime after, relatively hard and fresh varieties of these blocks rolled downstream for a distance of about 2 km along the river course. While there was no direct damage on humans or their properties, the main mass that was moving together downhill was able to dam the river and form a lake of up to 10 m deep.

Figure 6. Front view of the Tozawagawa landslide.

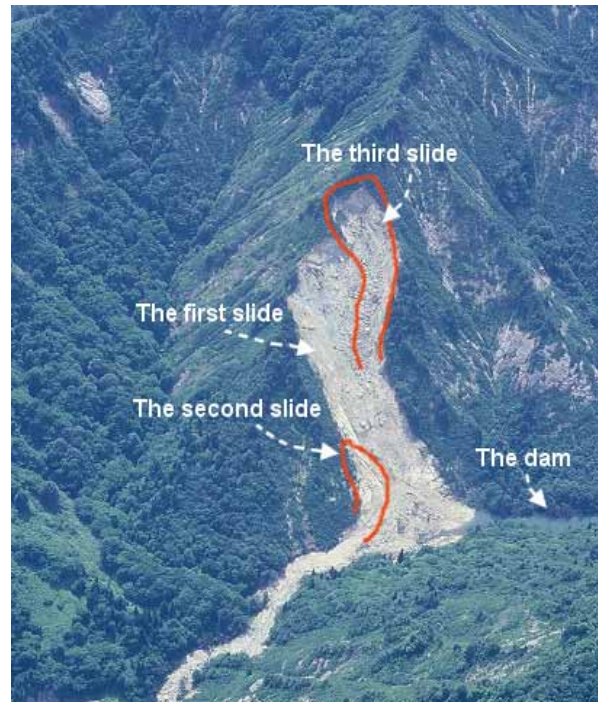
Figure 7. Oblique aerial view of the Tozawagawa landslide (Photo taken in September, 2001 by Shin Engineering Consultant Co. Ltd.).

Figure 7 shows the aerial photograph taken on October 27, 2001 by Shin Engineering Consultant Co. Ltd. Post failure field investigations aided by the interpretation of this photograph allowed us to deduce that the landslide complex as a whole might have developed as a result of a series of relatively brief episodes of ground movement with intervening phases of general inactivity. Hence, as it is shown in Figure 7, we identified three progressive phases of ground displacements. Movement most probably started a little below the crown of the current slide, possibly influenced by the location of soil pipes and zones of higher permeability. The material further down was becoming completely unstable soon after the driving force from above was increasing. A transient rise in groundwater table in the hill following heavy rainfalls would have a greater contribution to transform the small scale slope movements into a landslide observed on January 5, 2000. What has been termed as a third phase of sliding in Figure 7 could simply be taken as a sign of a retrogressive action of the current landslide to encroach shoulders of slopes uphill before equilibrium is established.

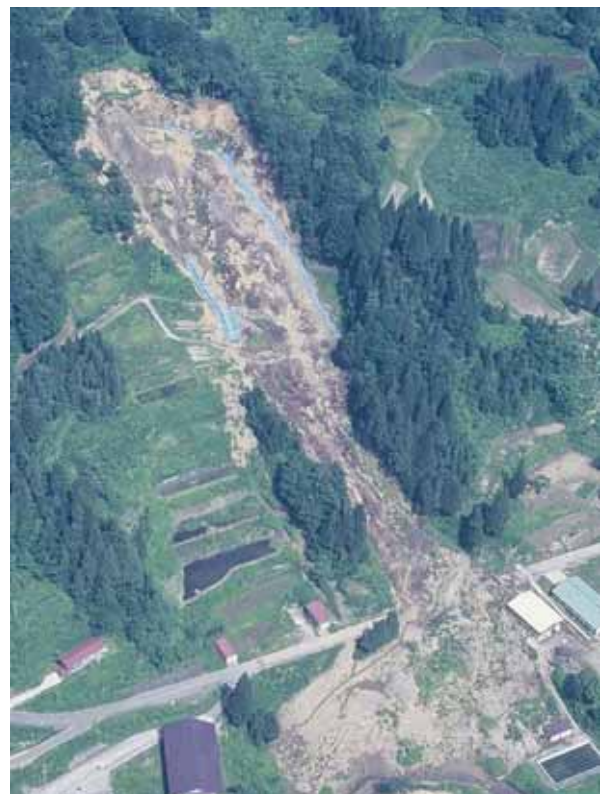
Figure 9. Aerial view of Higashikawa slide (April 28, 2001).

The Higashikawa landslide occurred in the early morning of April 28, 2001. The first person to witness the activity was a lady who was delivering newspapers. As it is shown in Figure 9, the landslide rode over the mountain for a considerable distance before it crossed a road and completely blocked it. The slide continued further moving downward and reached the floor of Higashikawa River. The entire debris accumulated along the hill was about 380 m long, 80 m wide and 5 m thick. From the crown down to the 200 m mark, the slope failed in the form of quasi-translational sliding. Toward the bottom, the slide was transformed into earth-flow because it was coming in contact with enough moisture (Fig. 10). At the top of the slide, the slope gradient is around  $22^\circ$ . The latter decreases to  $12^\circ$  in the middle section and then to  $10^\circ$  further downward, allowing the hill to accumulate a relatively high amount of groundwater with a near-surface static level at the bottom. There is a high probability that the moisture content of the materials displaced from top has increased dramatically because of a supply of excessive water from the ground and the immediate surroundings of the slide.

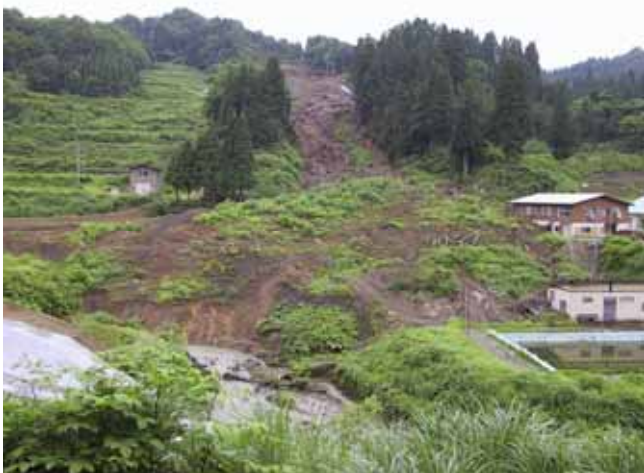
Figure 10. Marginal toe of the Higashikawa Slide.

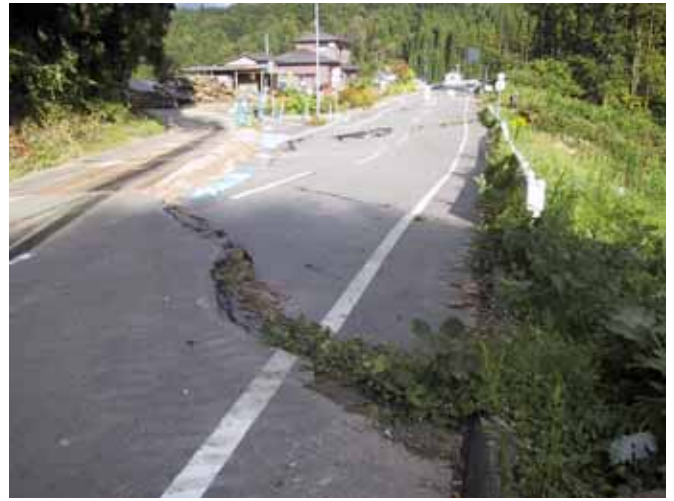
Figure 11. New cracks appeared on the road in May 2003.

One of these areas is Tsugawa, located 37.5 km east of Niigata City (Fig. 1, point 4), where rhyolitic lava domes associated with mudstones that are interbedded with clayey tuffs are prone to landsliding (Yamagishi et al., 2003). In Tsugawa itself the Iwatsu area located along Agano River, is currently designated to be active. In this area, old landslide zones that were once thought to be relatively stable are changed to be active with an increase in rain fall. In October 2001, new cracks appeared on the nearby road (Fig. 11), marking the beginning of the formation of a scarp of probably a large landslide that can engulf a big area. The crack is still growing in size moving toward the right (river side). The road has already stopped services, and at the moment, there is a coordinated activity of ground monitoring in the area with an aim of acquiring a detailed knowledge on why the ground is unstable.
