(公社) 日本地すべり学会関西支部シンポジウム

「地すべり技術の海外展開」

(6) マレーシア国の土石流対策及びエルサルバドル国の地すべり対
策に係る業務例

インドネシアにおける土石流ソフト対策の技術移転 ～東ジャワ州ジュンブル県を例にして～

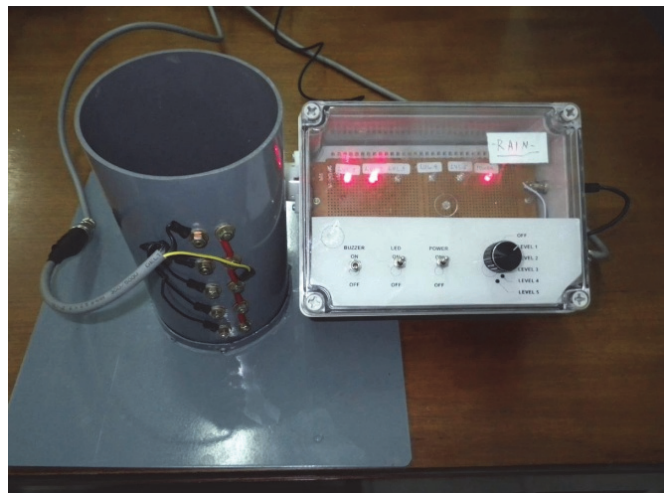
写真-4 警報機能付き雨量計

雨量計や水位計の製作に当たっては JICA 大井地球環境部アドバイザーのアイデアを元に、構造を簡素にし、手に入りやすく安価な材料を用い、雨量や水位が各レベルに達した場合、コントロールボックスのブザーが鳴りランプが点灯することで危険を周知することができる仕組みとなっている(写真-4)。また、機器の設置に当たっても地元で手に入る材料と、地元住民の協力も得て設置作業を行うようにした。このような取り組みの中、2011 年 4 月に水位が Level4 (避難) に達する出水があり、SOP に基づき避難の呼びかけが住民に対して行われた。

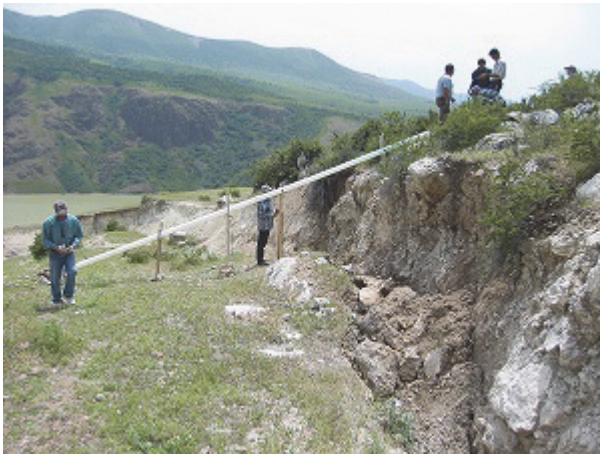
図-17 滑落崖に伸縮計設置状況

また、京都大学防災研究所の福岡准教授（当時）に指導いただき、最大の地すべりサイトには超スパン伸縮計を設置した。

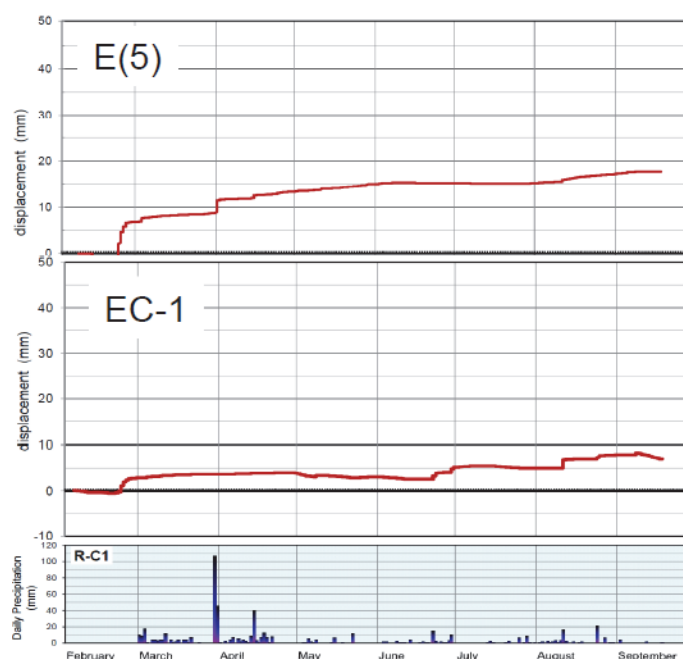
図-20 降雨量と伸縮計変位 (チトラクト)

モニタリング設置は完了したが、計測はまだ現在進行中である。従って有意なデータの蓄積が十分あるわけでは無い。今までの各種測定結果より、1) すべり面は地表面下 5~6m と浅い、2) 地表面の変形は降雨後比較的短い間に発生することが判明した。今後はさらに計測を続けることにより、予警報基準への応用が期待される。図-20 にチトラクトにおける伸縮計データと降雨の関係を示す。雨量と伸縮計の変位は良い相関を示している。

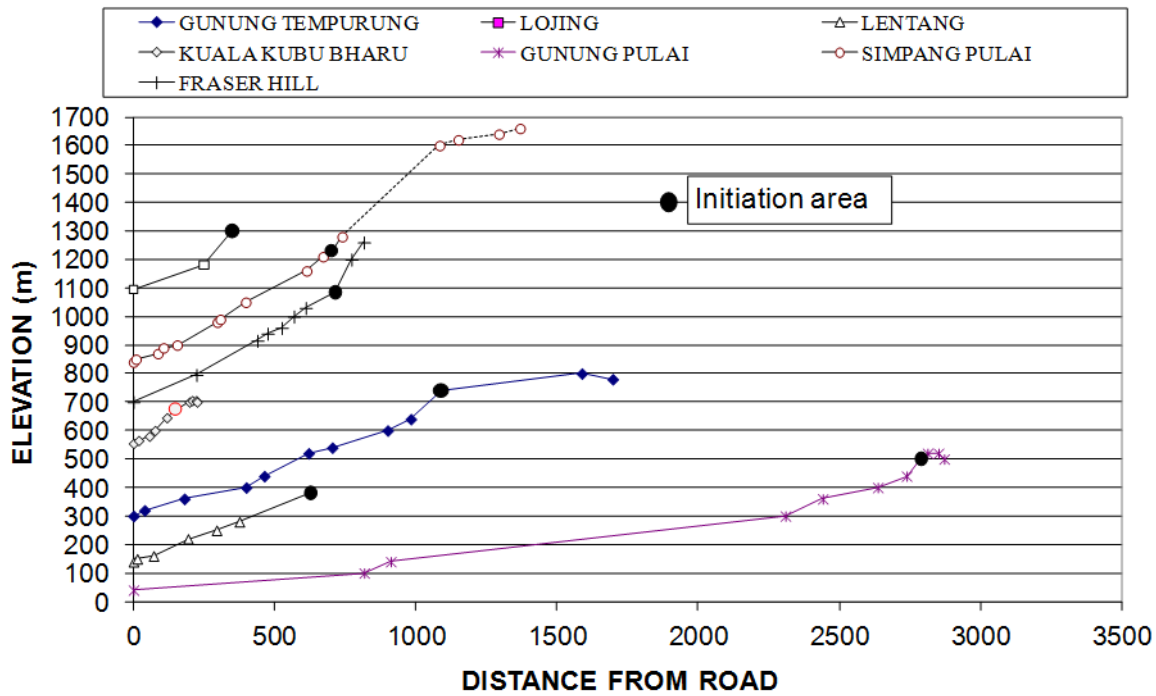
As shown in Fig. 7, sources of debris flow are typically found to be generated on steep slopes of 20 degrees or more in 0-order channels and the mobilized sediment appeared to have deposited on the milder slopes where the gradient is 10 degrees or less. Many debris flows occurred in basin areas of 1km² or less.

Fig. 7 Cross section taken along the channels of the seven sites. Resolution of the contour map was in general course and contour of the Genting Sempah was not available.

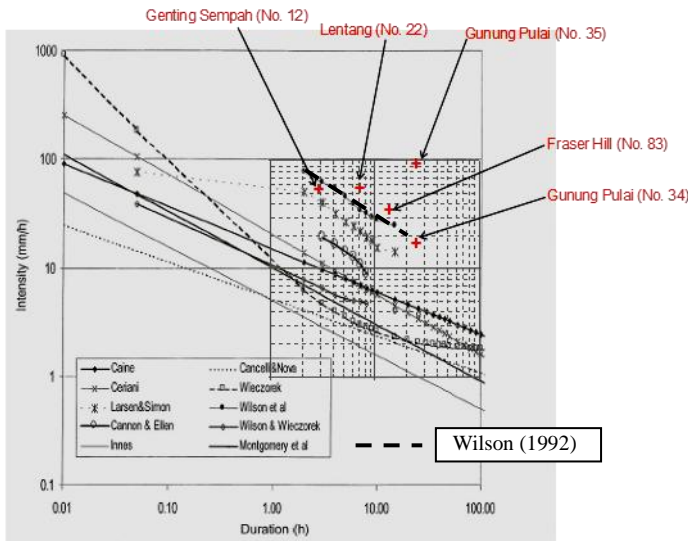
Trial and error were made, using the rainfall data of the of the cases where the correlation between landslide event and the rainfall can be established, to examine whether I-D type of equation can be used as a preliminary method to estimate the threshold. It was found that if the maximum hourly rainfall is used, as proposed by Wilson (1992), which is cited by Matthias et al. (2005), four points plot close to the I-D line of Wilson as shown in Fig. 8:

Fig. 8 I_p (Maximum hourly rainfall) and duration (D) of the four sites superposed on World wide intensity-duration threshold curves (Matthias et al. 2005).

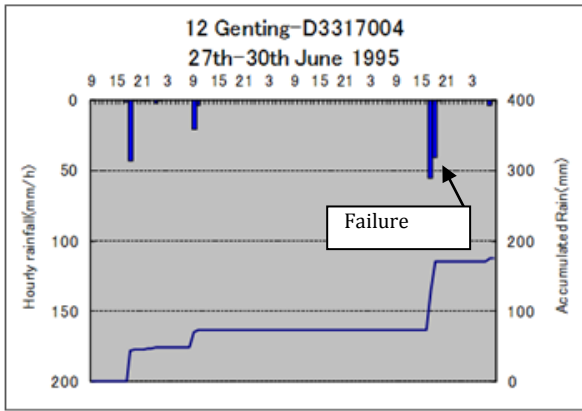
Fig. 10 Hourly rainfall depths prior to the debris flow at Genting Sempah on 30th June 1995.

Snake curves were calculated for the data of Genting Sempah and some the points corresponding to the major rainfall events and the point of failure are plotted as shown in Fig. 11. The hourly rainfall and the daily rainfall prior to the failure are shown in Fig. 9 and 10.

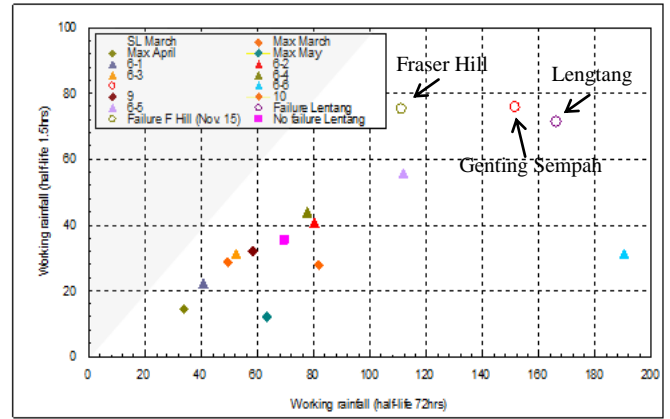
The failure points of Lentang and Fraser Hill were added in Fig. 11, noting that thresholds of these events can be approximated by the same intensity-duration relationship. The failure point of Gunung Plai is not added, since the distance from Genting Sempah is far greater than those of Lentang and Fraser Hill and also because the topographic features, such as catchment area and gradient of the channels, of Gunung Plai are very

different from Genting Sempah. The three failure points, shown in, appear to form a group of failure points. The Critical line may be drawn if more data can be obtained in the future.

Fig. 11 Failure points of three sites calculated with WR of 72 hours half-life and 1.5 hours half-life.

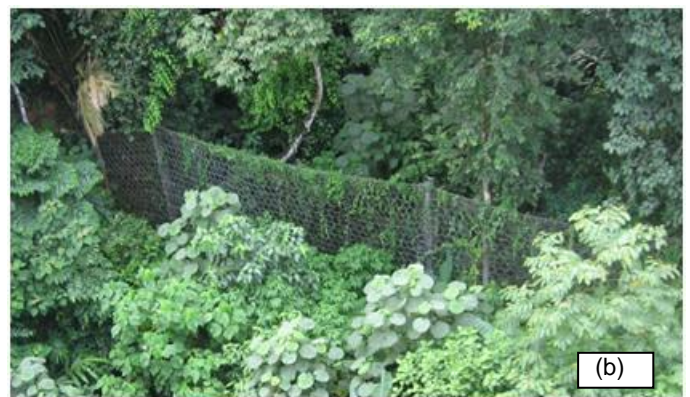
Flexible type barrier was found in the channel adjacent to the channel where debris flow occurred at Gunung Tempurung (Fig. 13). The barrier is installed close to the highway bridge.

Fig. 13 Flexible type barrier at Gunung Tempurung for capturing debris flow. Photo (a) is taken after the occurrence of debris flow on Ocotober 11, 2004; Photo (b) shows the flexible type barrier in the channel adjacent to the one shown in Fig. 12 (2012, June 28)

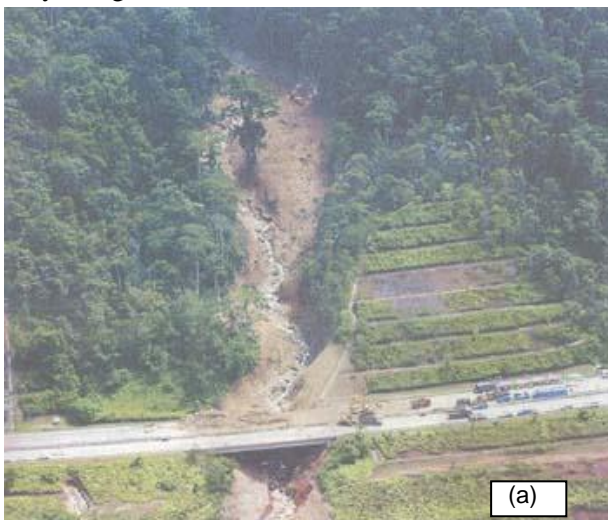
Another flexible barrier was found near the end of the channel of Gap Fraser Hill (Fig. 14). At this site, various forms of landslides, such as surficial failure, debris flows, massive landslides, may have intermittently occurred between November 16, 2007 and July 8, 2009, according to the chronological records of the failures and restoration works. Most distinct feature of the site is the series of retrogressive landslide which was the source of the debris flow.

The barrier is installed as a part of restoration work, including the shotcrete and sol nailing of the scarp area (Fig. 14 (b)). Close view of the barrier (Fig. 15) indicates that the barrier is similar to the one installed in the channel near the State Highway-1 of California (Fig. 16).

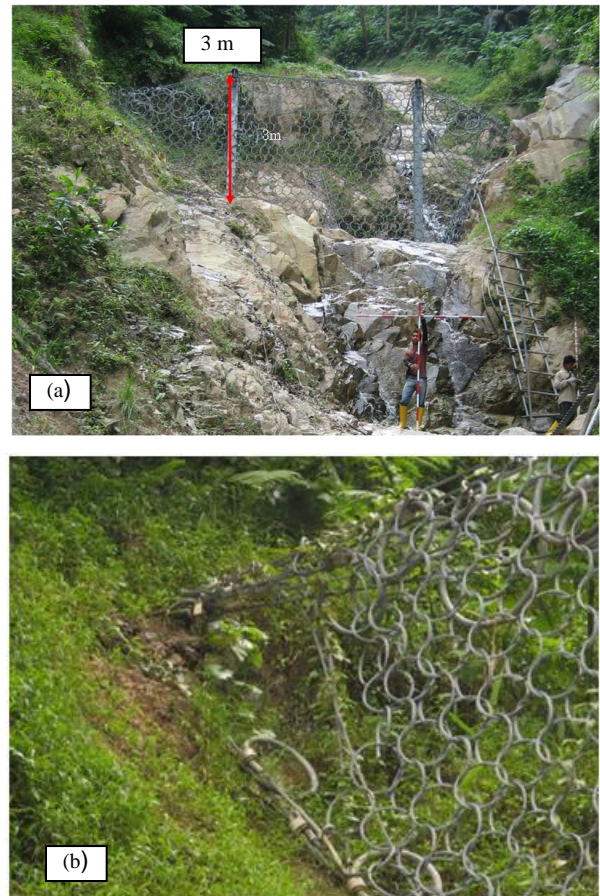
Fig. 15 Three meter high flexible type barrier at Gap Fraser Hill. (a): View from the road; (c) close view of the barrier showing the brakes and the ring net (Ocotober, 2010)

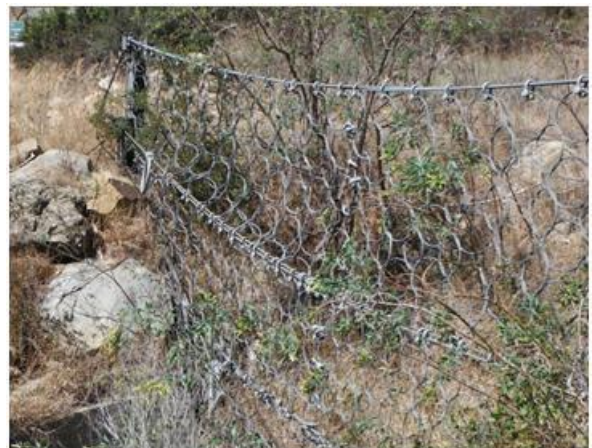
Fig. 16 Flexible type barrier in the channel near the State Highway-1 in California (August, 2013)

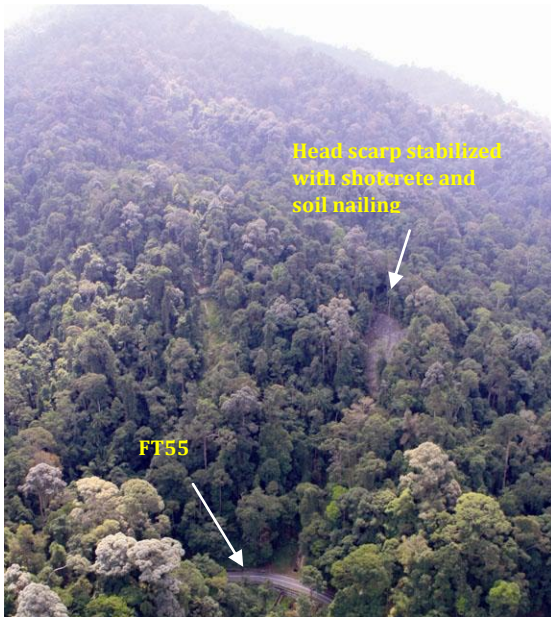
The debris flow at the Kuala Kubu Bharu carried tons of debris comprising of boulders in various size, mud and tree trunks that deposited on the road FT55 (Fig. 17), and caused the road closure for 15 days. It is suggested that the debris flow occurred due to the surficial failure in the colluviums layer which was identified through geophysical investigation for designing the stabilization measures that are described below.

Fig. 17 Aerial photo of the stabilized scarp and the road (FT55) at Kuala Kubu.

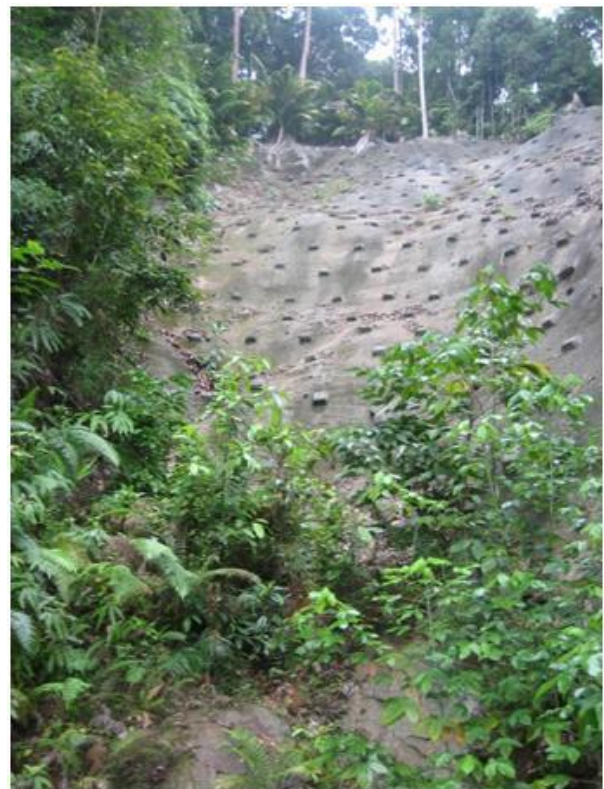
The 20 - 30m high initiation zone needed to be strengthened to prevent any future landslide. After the debris flow, most of the colluviums on the slope surface had been washed away, exposing the weathered granite layer. Based on the results of the site investigation, 9 m long soil nails with 100 mm thick shotcrete were designed to stabilize the initiation zone.

Fig. 19 Photo of the shotcrete and soil nailings at the scarp area of the site at Kuala Kubu.

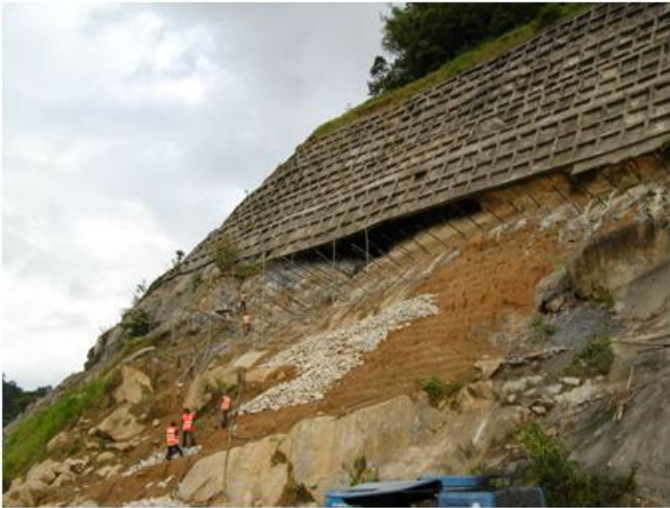
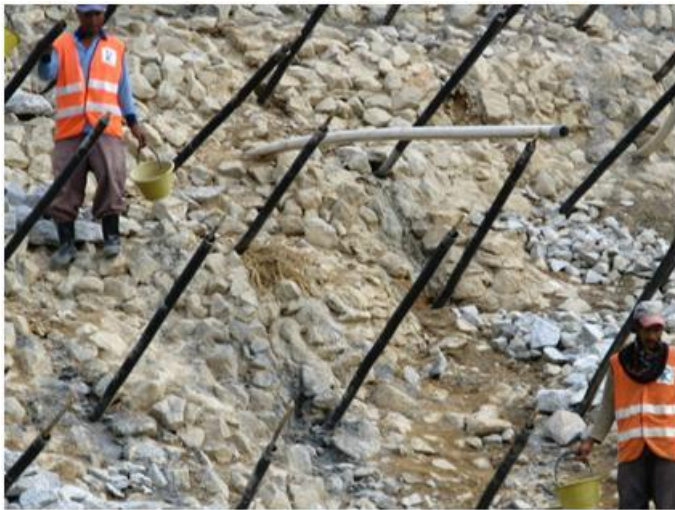
Prior to beginning of this project, soil nailing work was observed on the East-West coast highway from Simpang Pulai to Kuala Berang as shown in Fig. 20. It is also noted that shotcrete and soil nails were used for stabilizing the head scarp of the site at the Gap Fraser Hill (Fig. 14 (b)).

Fig. 20 Photo of the soil nail works along the East-West coast highway from Simpang Pulai to Kuala Berang (May, 2007) .

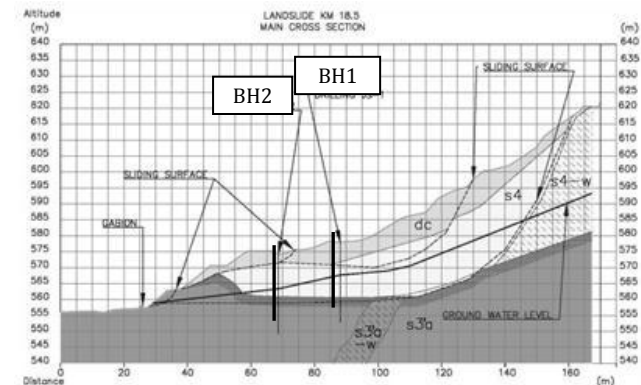
derived from the pyroclastic flow deposits. In some cases, these soft rocks are present as an intrusive tuff dyke with steep dip. The fundamental factors contributing to the landslide activity is considered as follows. Firstly, the paleosol clay, which is the top portion of the Tobas color café, has very low shear strength under saturated conditions. Secondly, the boundary of Tierra blanca and Tobas color café exhibit “dip slope” towards the scarp of the landslide (Fig. 28). Thirdly, this boundary acts as an impervious clay layer with spoon-like concave formation such that groundwater tends to cumulate inside the landslide. Hence, the boundary, consisting of paleosol clay, is thought to be the sliding surface which is confirmed by the vertical strain profile of the PVC pipes.

Fig. 28 Main cross section of the landslide with the main geological stratigraphy that is given in Table 5.

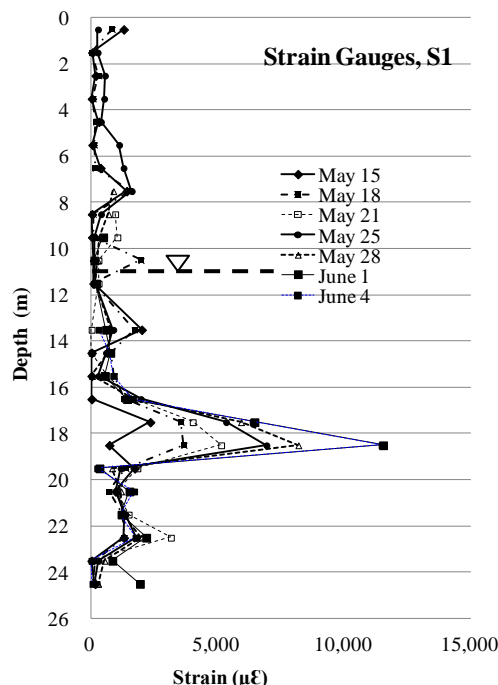
Results of the two strain-pipe meters, installed in borehole-1 (BH1) are shown in Fig. 29 . As shown in Fig. 29 , the strain at 18.5 m depth of BH1 started to markedly increase from May 11th to July. This trend suggests that pipe is subjected to shear deformation across the sliding surface which is likely located at the depth of 18.5 m. After July 6 sudden increase was observed with the strain at the depth of 7.5 m, indicating possibility of another shallow sliding surface.

A similar trend is found with the strains measured with the pipe in BH: the strain at the depth of 15.5 m started to show large increase from May 11th to July.

Fig. 29 Vertical strain profile of the pipe-strain meter in Borehole 1 (BH1)

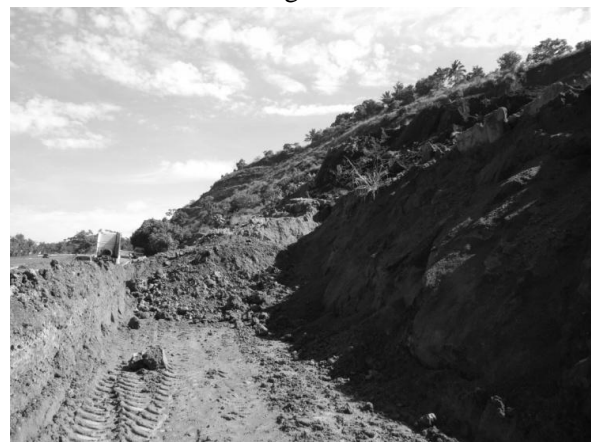
The high velocity in the range of 50 to 70 mm/day had induced localized failures near the toe region (Fig. 37) and has become a concern for the safety of the traffic and the prevention works were performed as described in the following section.

Fig. 37 Toe region of the landslide showing localized surficial failures (Photo taken on September 11, 2012)

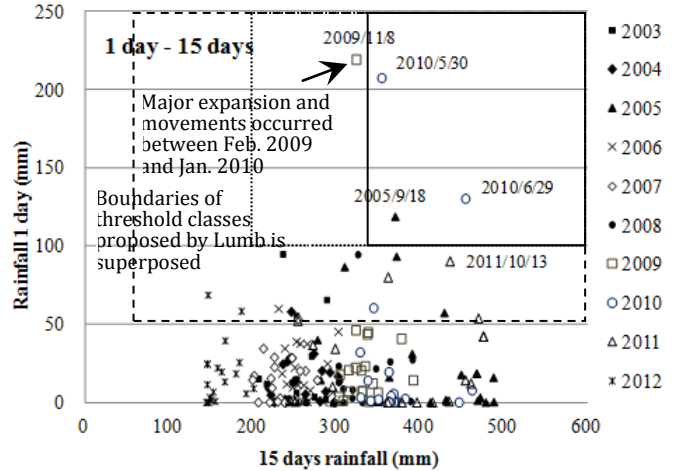
Fig. 39 Plot of 1-day and 15-days rainfall depths of the station at Illopango, using the data from 2003 to 2012. Solid and dashed envelopes correspond to the threshold classes proposed by Lumb (1975). The dates in the plot correspond to the major tropical depression or storms: Tropical storm Stan on 2005/9/18; Low pressure system on 2009/11/7 to 8 following Tropical storm Ida; Tropical storm Agatha on 2010/5/30; tropical depression 12E on 2011/10/13.

As shown in Fig. 39 , except for the tropical depression 12E, three major events are inside the “Severe” class. It is noted that a major expansion and movements of the landslide can be seen by comparing the two aerial photos of the Google Earth dated February 2, 2009 and January 27, 2010. Hence, even though the Illopango station is 6 km away from the landslide, this type of analysis and data collection can be helpful in improving the warning method.

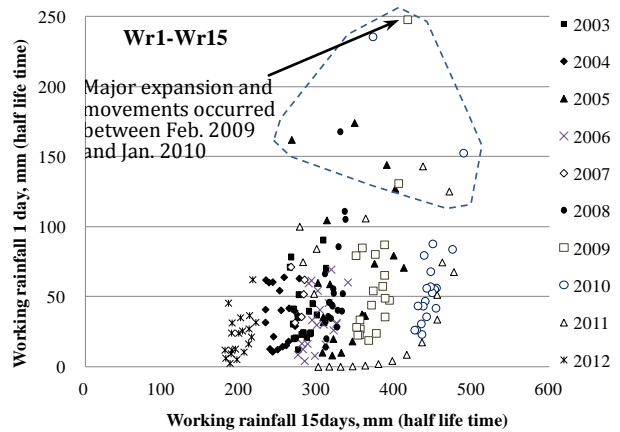
Fig. 41 Plot of 1 day WR(working rainfall) versus 15-days WR. Dates for the points corresponding to the major tropical storm and notably high values are shown

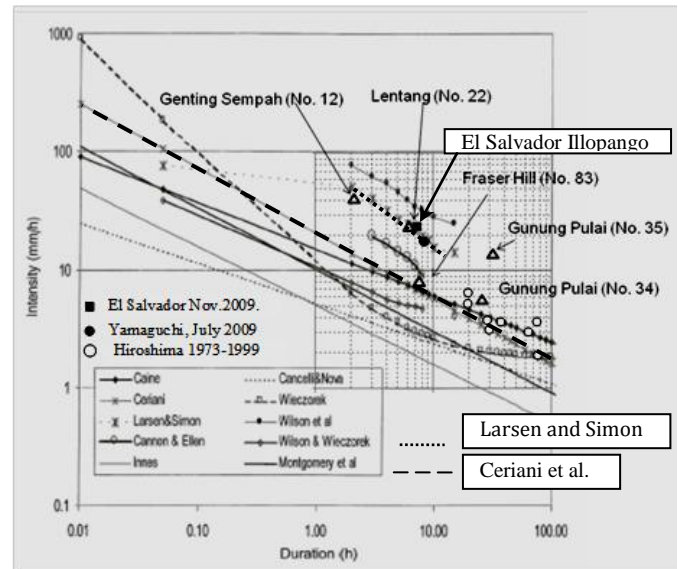
Fig. 43 Intensity-Duration data of failed slopes in Hiroshima-prefec (1999). and Ymaguchi-prefec (2009). Japan, 4 sites in Malaysia, and one data of Illoponago station are superposed on I-D curves. Intensity of Illoponago is the mean taken from the beginning of the continuous rainfall to the peak hourly data.
