# **LANDSLIDES IN JAPAN**

**The Japan Society of Landslide  
National Conference of Landslide Control**

**1972**

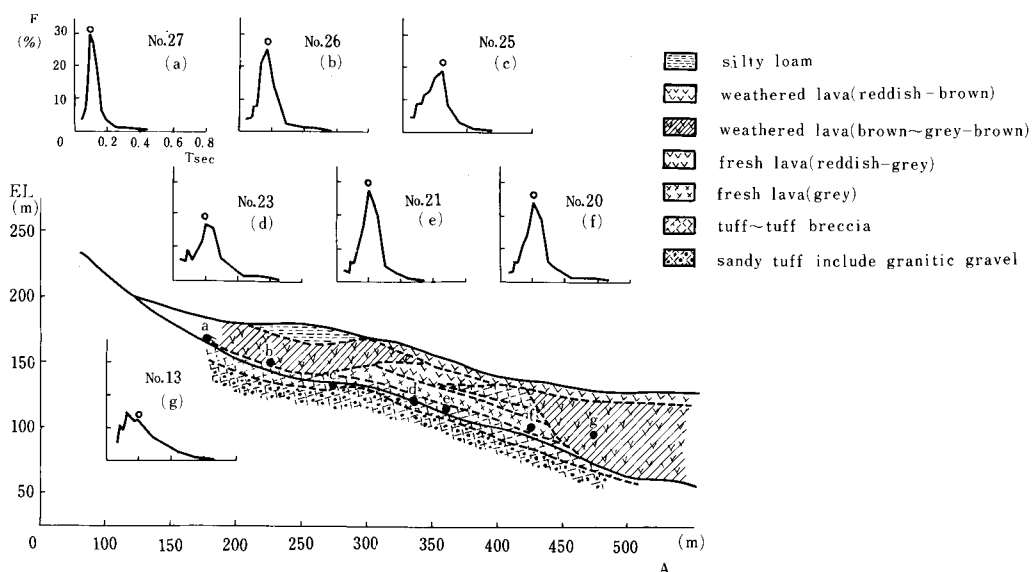
Fig.1 Relation between sliding surface and excellent recurrence

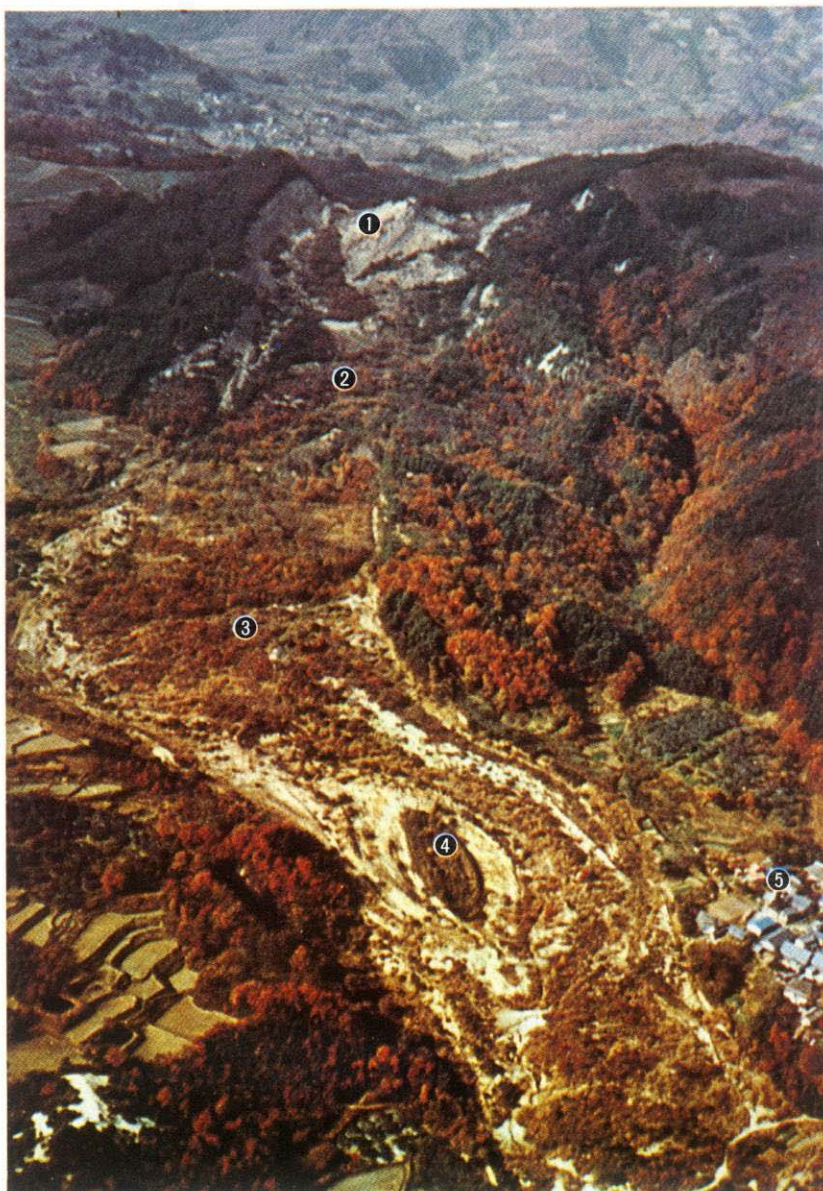
General view of the upper part of Chausuyama landslide

- 1 Main scarp, 2 Slump zone 3 Flowing zone 4 Immovable land  
5 Village

The direct motive of this landslide is regarded as the Zenkoji earthquake which occurred in 1847. Foretokens of landslide appeared in 1884, the whole outline of the activity being nearly clarified in 1898 and the activity lasting up to now. At present this landslide is 2,000 m long, and has an area of 46 ha, and a soil mass of  $9.0 \times 10^6 \text{ m}^3$  has been pushed out. This is divided into the area of origin (800 m long) in the upper part and the secondary area (1,200 m long) in the lower part. Geology: the Miocene series, sandstone, mudstone and tuff, holding lignite seams. In the upper area many depression ponds were found and a large amount of ground water including sulphates springing out. Detailed investigations of the mechanism, movement and the ground-water has been carried out. During the first period of activity extending from 1930 to 1940, at the tip of the sliding area, the rate of moving velocity was measured as 25.4 cm/day (average between March 1935 and Nov. 1937). Between 1940 and 1945, the sliding movement was inactive. In 1945 the second period of the activity began, lasting for 15 years since. In 1960 the activity began to be inactive again, but from 1965 an active sliding movement was caused by the Matsushiro earthquake swarm. Control works: deep wells, drainage wells, water channels and steel tube piles were installed and in the movement has nearly come to be inactive.

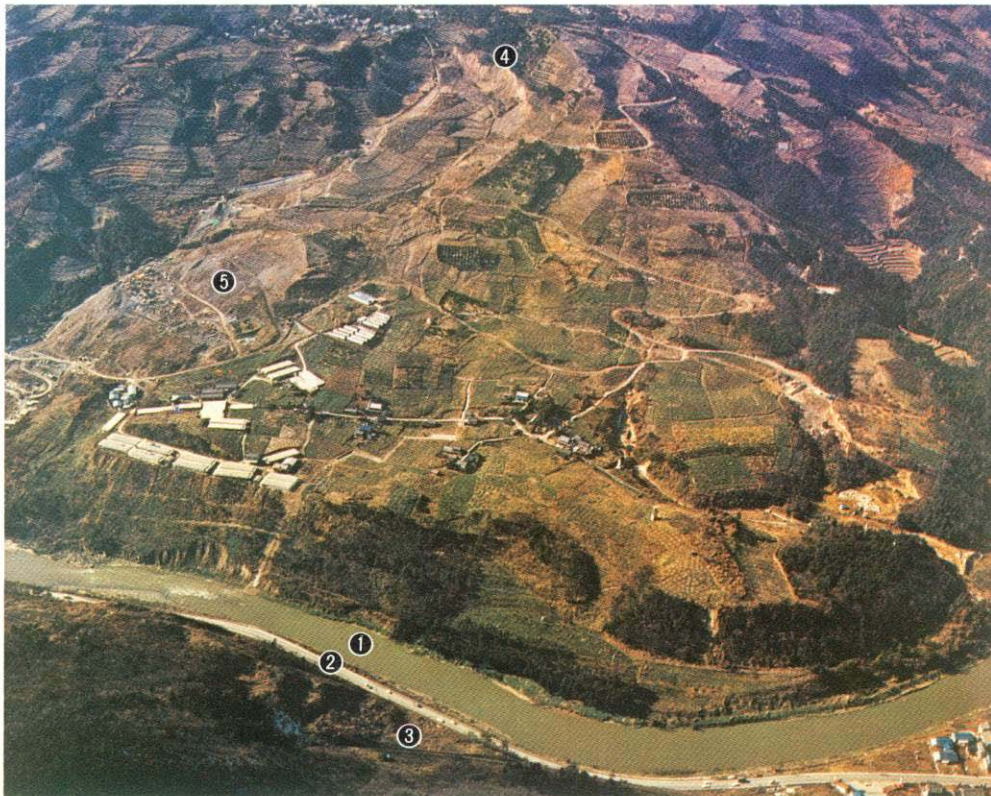
General view of Kamenose landslide

Kamenose is located at a place of traffic importance. This landslide damaged the Kansai railway line, national roads and the Yamato river. Between 1931 and 1932, and between 1951 and 1968, a mass as large as 53 ha slid. Geology: Miocene, consisting of andesite lava and tuff breccia, holding thin layers of tuff, sandstone and conglomerate. This slide was caused by the debris of weathered lava and pyroclastic rocks in the brecciated state. Control works: surface drainage, well drainage, tunnel drainage, soil removal and steel tube piling were performed.

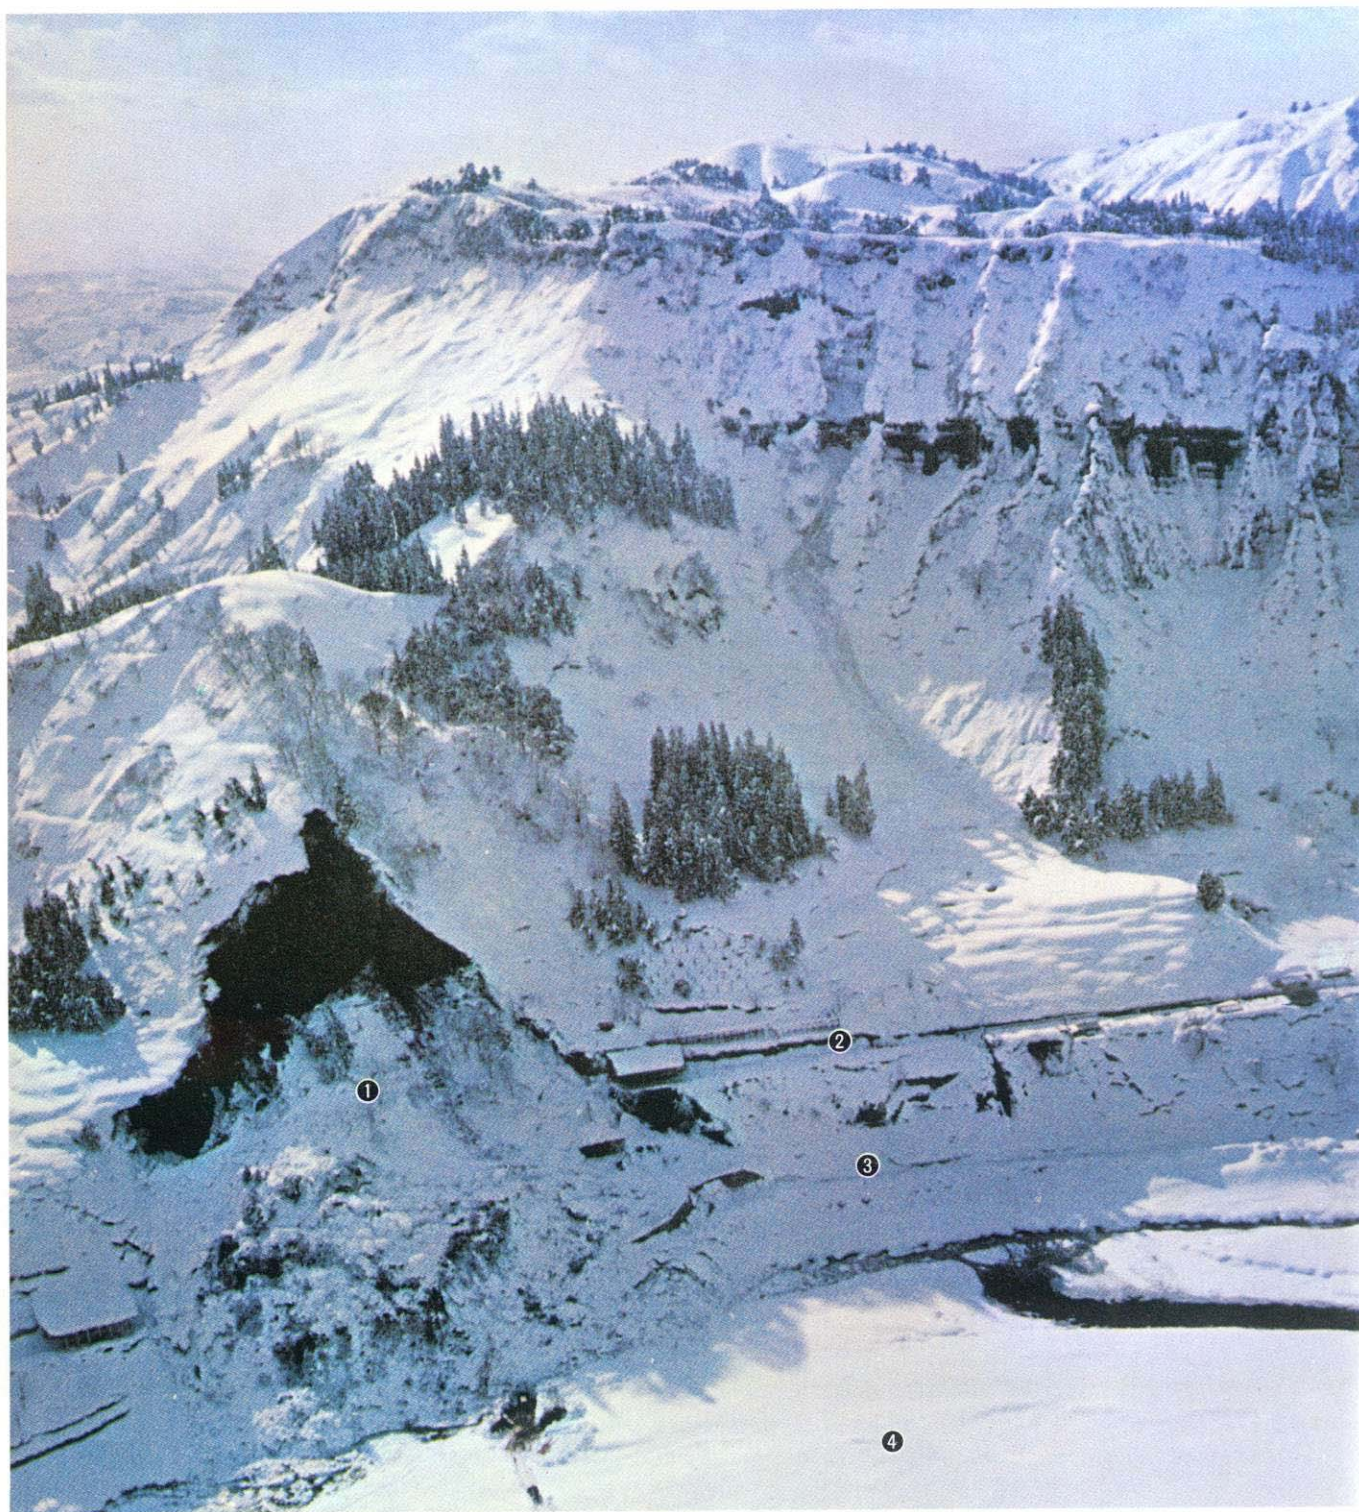
General view of slide

1 Collapse of Takabayama tunnel 2 Iiyama Railway line 3 National Road 4 Shinano river

At 1:24 a.m. on 22 January 1970, about one half of the Takabayama Railway Tunnel (187 m long) was collapsed by landslide. Geology: Neogene, consisting of an alternation of mudstone and sandstone. This tunnel, built in about 1925, runs through the foot of Takabayama hill jutting into the Shinano River. Deformation caused by landslide had been noticed from old times, and landslide investigations and control works had been carried out. It is noted that the time of collapse was exactly forecast by using data obtained with the landslide gauges and the relation between the distortion velocity and the time of creep destruction ( $t_r$ ). Before the foretokens of landslide were found on the surface of the earth, landslide displacements in the tunnel were being noticed for a long time. At the time of collapse, a soil mass which slid from the upper sliding area of the hill pushed out a lower soil mass. In Japan, many landslides are threatening the railways, and 93 areas (50 in Tertiary system, 25 in crystalline schists or serpentinites and 18 in Palaeozoic or Mesozoic or volcanic rocks) are representative.

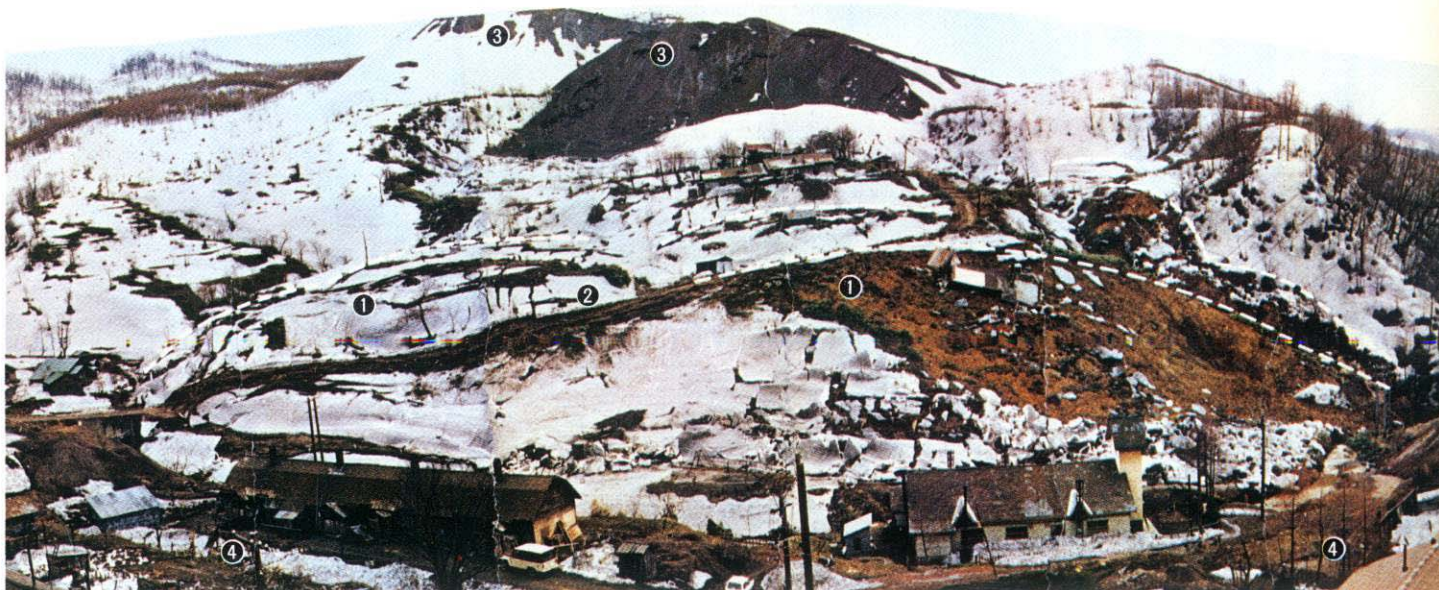
General view of landslide at North-Ichinosawa, Tokiwadai area

- 1 Main slide place 2 Road 3 Coal mine industrial waste
- 4 Same part of Tokiwadai town

The total sliding area is about 80 ha. Geology: belong to the Paleogene Tertiary, consisting of the alternation of sandstone and mudstone and holding coal seams. The upper part of the mountainside has an old scarp and from this scarp the gentle slope characteristic of the sliding area spreads to the tip of the sliding area. The sloping land is generally composed of thick weathered layers and talus which cause the repeated landslides. This sliding area can be divided into a few blocks and in April 1964 Kita-Ichinosawa block was activated. The landslide pushed out soil of  $6 \times 10^5 \text{ m}^3$ , destroying houses and concrete retaining walls along roads. For four days 14 to 17 April, foretokens and behavior of landslide were observed in full detail. Underground structures, groundwater and sliding planes were investigated thereafter. This landslide is regarded as the complex of structural landslide in the weathered rocks and the revolving landslide in the debris. Control works: tunnel drainage, steel tube piling and valley barrier were performed.

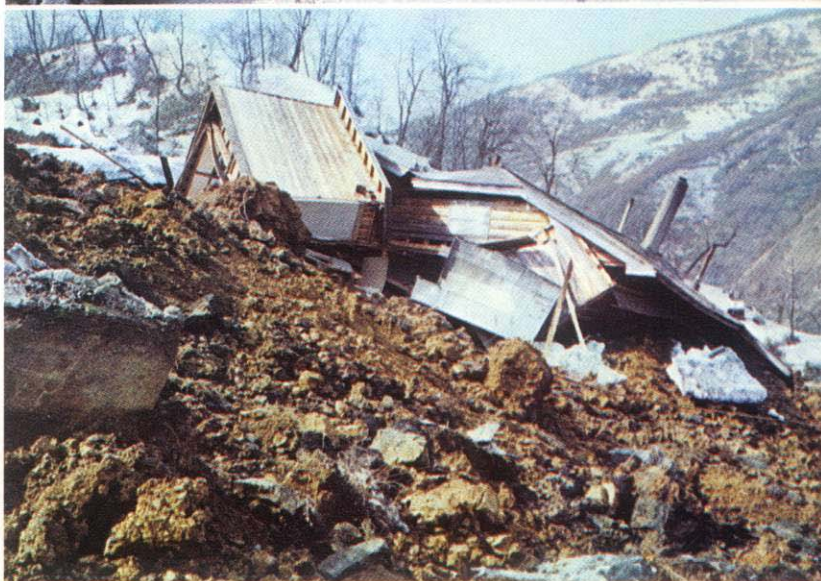
Below: Damage of houses a caused by landslide

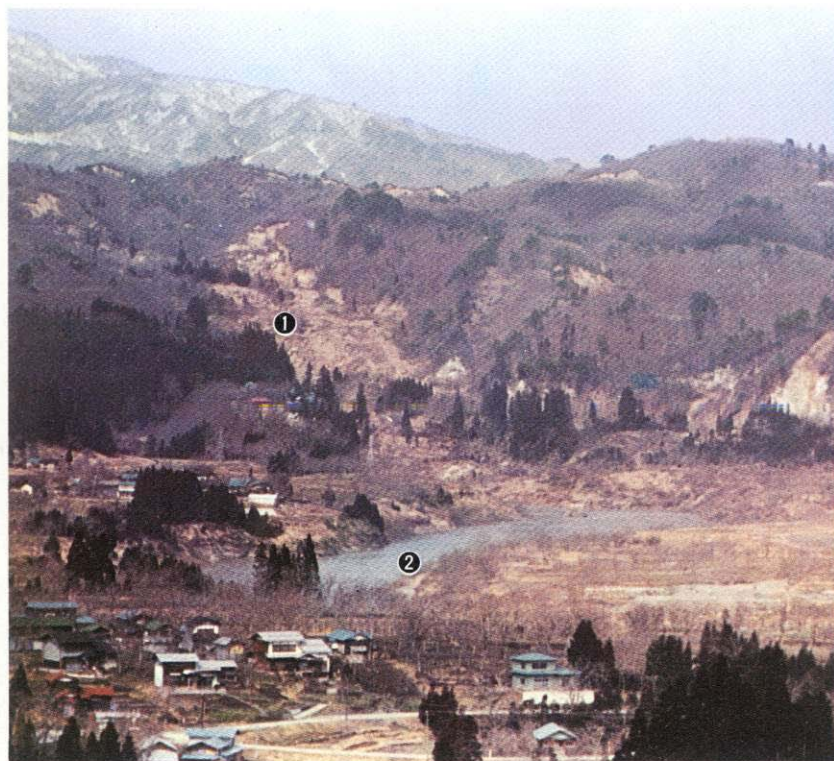
Distant view of Takisaka area

- 1 Landslide 2 River

This landslide has an area of 147 ha, being divided into a few blocks in which landslides are repeated. Geology: are composed of granodiorite and the Neogene system overlying it, the latter is mainly composed of green tuff (pumiceous tuff and tuff breccia). The geological features are very complicated, slide cliffs and depression ponds formed by landslide being developed. The landslide occurred in 1888 in the Matsusaka area damaged fields, and at the slide which occurred in 1905, Tokiwa area slid into the Agano river to destroy many houses. In 1949, a landslide occurred in the Matsusaka area, causing cracks, depressions and upheavals in the upper part and mud-flow in the lower. Various investigations were carried out. Control works: water channel, drainage well and drainage boring were performed.

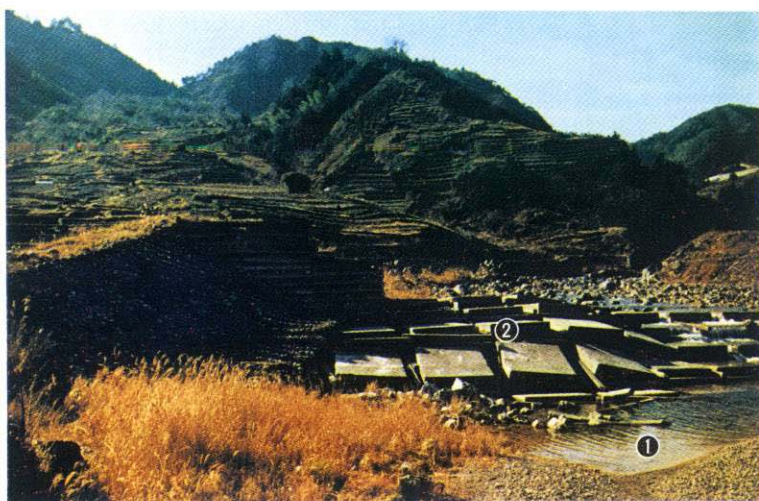
1 Choja river 2 Upheaval of the toe

The landslide has a length of about 900 m, a width of about 200 m and an area of about 68.4 ha. Geology: this is one of the landslides distributing in the Chichibu terrain and composed of the Paleozoic clayslate and the serpentine intruding it. Old records of landslides exist, and the tip of the sliding area was largely collapsed by the typhoon No. 9 on August 1963 (835 mm of rainfall). Thereafter, a slow sliding movement has been continue. The central part of this sliding area is composed of the colluvial layer made up debris of clayslates and serpentinite, having unstable sloping land with a gradient of about  $20^{\circ}$  and sliding toward the Choja river. In order to prevent the erosion, many retaining walls and training walls to protect the tips of the sliding area were built. Control works: drainage well and horizontal boring drainage were performed.

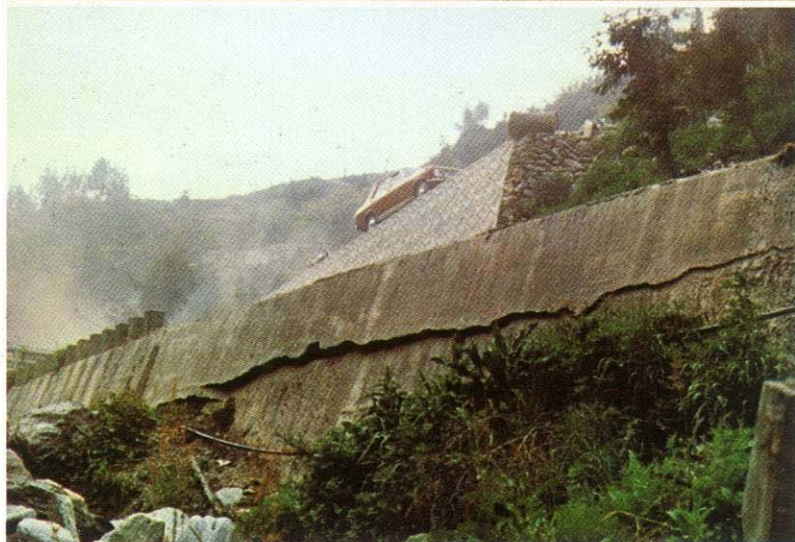
Above: Mudflow on the road by heavy rain

Below: Damages of retaining wall along the road

This is one of the schist type landslides distributing in the Iya region. The slide area distributes between 350 m and 830 m above the sea level and has an average gradient of  $26^{\circ}$ , a length of 900 m, a width of 2,000 m and an area of 108 ha. Geology: Kawaguchi formation of the Yoshinogawa group, mainly consisting of pelitic schist and holding schistose sandstone, basic schist and siliceous schist. According to the survey by drilling and seismic prospecting, the thickness of talus debris constituting the sloping land is mostly between 20 m and 30 m and about 50 m at the thickest part. In 1945, 1949 and 1954, heavy rains collapsed and interrupted only a prefectural road to the interior. A considerable sinking of the road, inclination of houses and cracks in retaining walls have come to be noted.

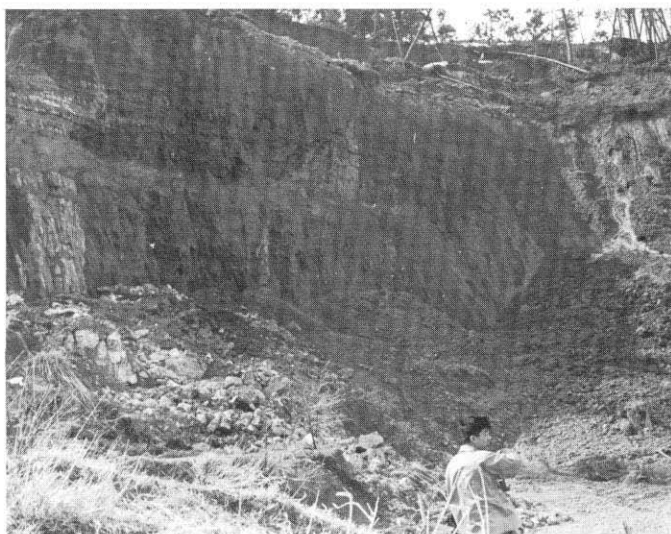
Main scarp at the top of landslide

The scarp are about 30 m high, and seepage water can be seen near the middle and lower parts of the scarp

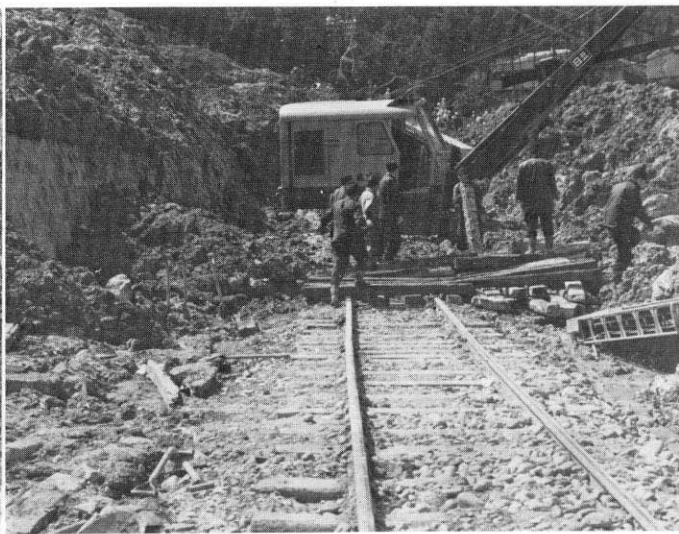
Railway buried by landslide

The slide mass mainly consists of muddy substance

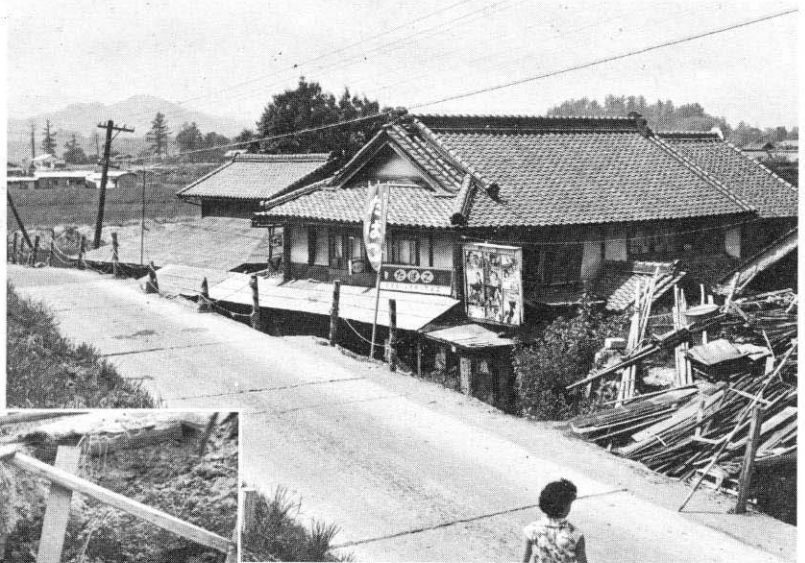
Upheaval of the toe

This area is where landslide has been repeated from old times and disasters of the Usui river and houses are recorded. Now, the area appointed to the dangerous slidable zone reaches about 85 ha. Geology: are the mixture of the Neogene system composed of the alternation of sandstone, mudstone and conglomerate with the Quaternary tuffs and tuff breccias. The strata are of a monoclinal structure with a gradient between  $18^{\circ}$  and  $20^{\circ}$  from north to east. In recent, an area of about 36 ha spreading from Terasawa to Fujizuka, from Sept. 1958 to June 1961 slid activity. Such phenomena as crack occurrence, partial sliding, depression and upheaval were noted. The upheaval of the tip of landslide in Fujizuka crossing the Usui river was specially noted, damaging the national road No. 18 and the leftside bank of about 300 m. The rate of upheaval of the national road was measured a maximum rate of about 45 cm/day and the total upheaval reached about 3.5 m in total. Control works: horizontal boring drainage, tunnel drainage and steel tube piling were performed.

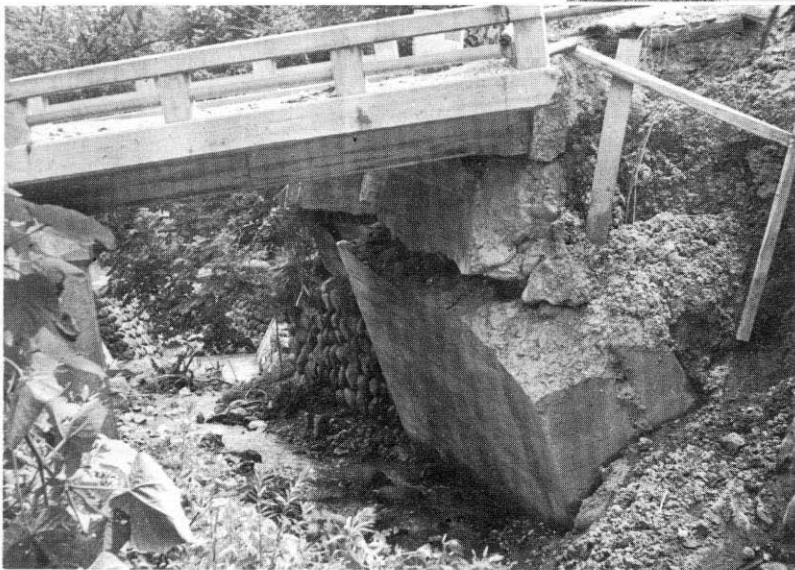
Damage of the Terasawa bridge

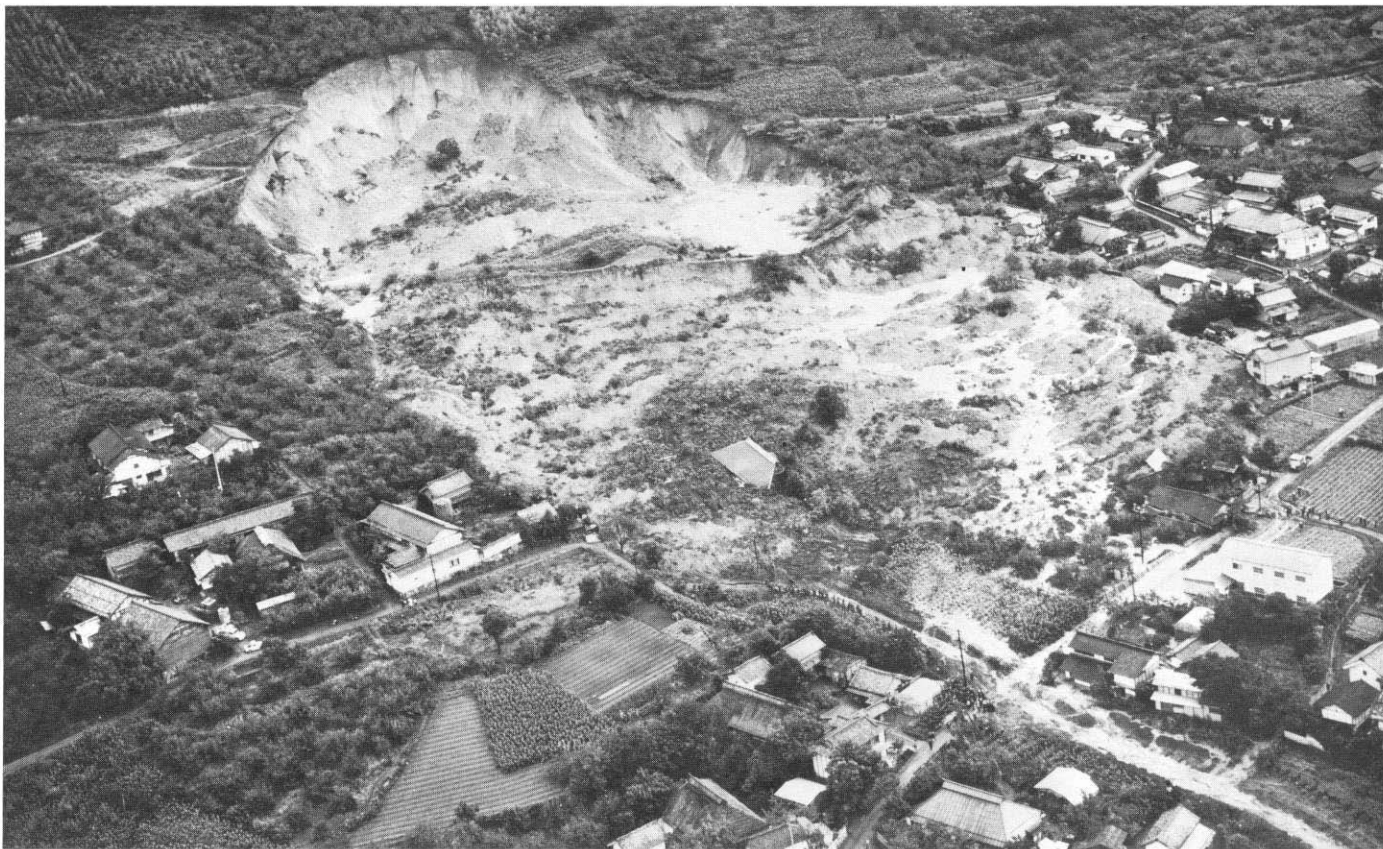
General view of Makiuchi landslide, caused by spring of much artesian water during earthquakes.

On 3 August 1965 Matsushiro earthquake swarm broke out. In September 1966, during the third period of its activity, many cracks developed around Minakami Mt. and from these cracks a large amount of pressure ground water sprang out. On 17 Sept. 1966, Makiuchi landslide broke out and on 9 Oct. 1966 Nishidairayama landslide occurred. These were caused by the large amount of ground water which sprung out from cracks made by the earthquake swarm.

Makiuchi landslide occurred in the sloping land near the mountain, being 250 m long and 160 m wide and soil mass of about  $2.0 \times 10^5 \text{ m}^3$  being pushed out. The material of landslide is composed of the Quaternary fan deposits which are a mixture of conglomerate and clay. In the upper part a rotational slump was generated, a part of debris turning into earthflow. From right under the slide cliff a large amount of spring water issued like a rivulet.

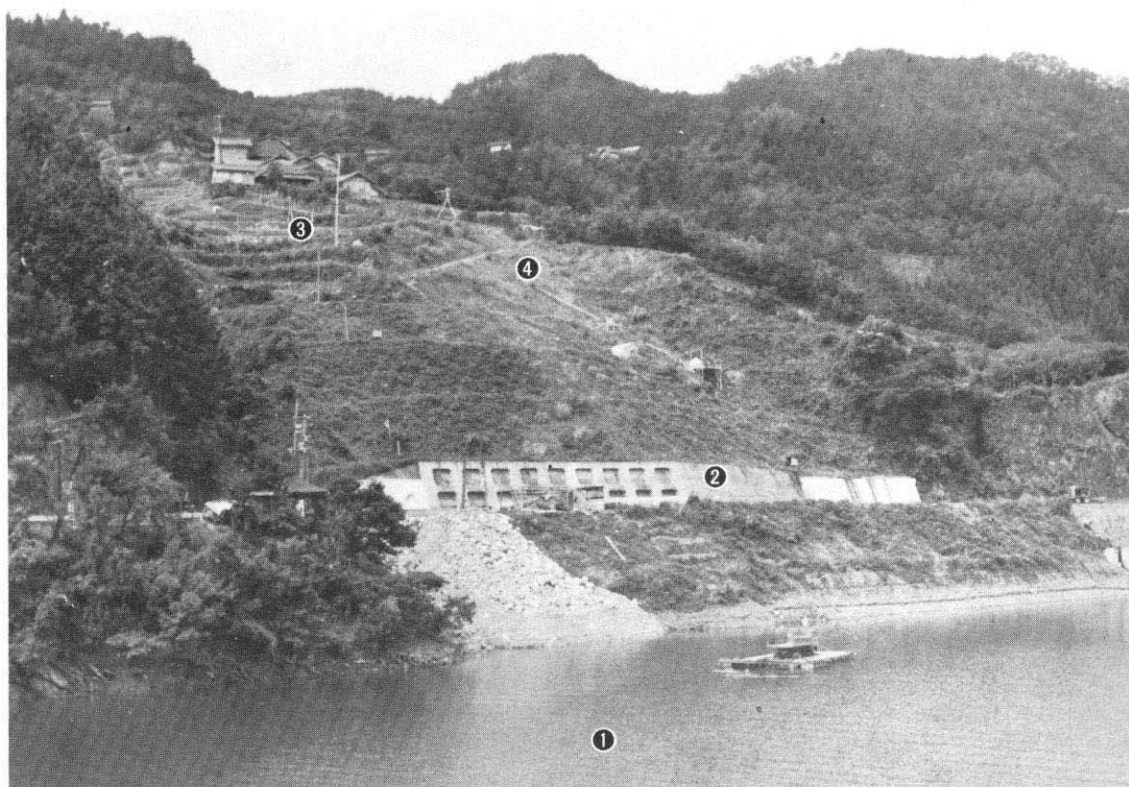
Distant view of Kurinoki landslide

1 Kanogawa artificial lake 2 Restraining structure 3 Drainage well and ditches 4 Tensometer

Kanogawa dam is a multipurpose dam for flood control and water utilization, and was built at the middle reaches of the Hiji river in 1958. The dam is of concrete gravity type with a height of about 60 m and a length of about 190 m and a pondage of about  $4,820 \times 10^7 \text{ m}^3$ . The landslide was caused by the water of the artificial lake. Geology: the site belongs to the Chichibu Paleozoic Terrain and consists of the alternation of clayslate and sandstone, and conspicuously developed fractured structures are partially found. Oji, Sakaishi and Kurinoki landslides which occurred along the shore of the lake are large-scale slides with slow movement. After the building of the dam, the water level rose about 36 m and thereafter landslides became more active. Control works: tunnel drainage, drainage well, steel tube piling, soil removal work, retaining wall work and buttresses are performed.

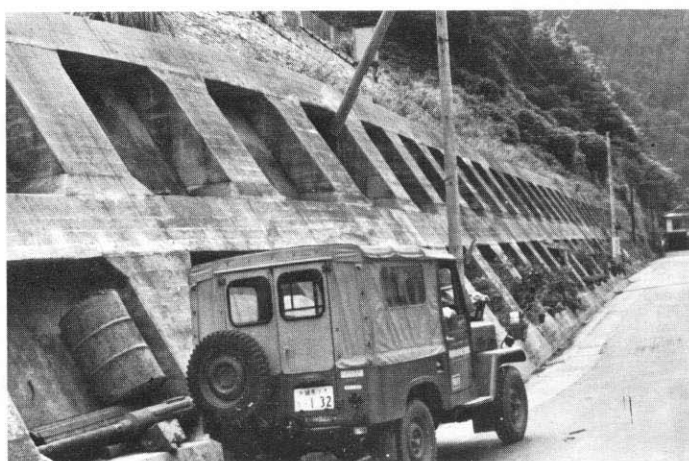
Retaining walls at the lower part of Sakaishi landslide.

The road was depressed by slide.

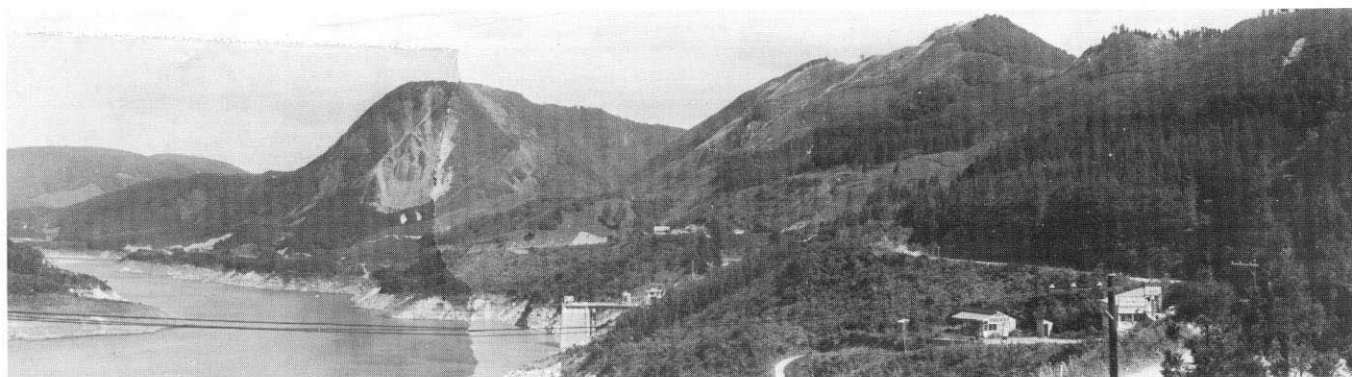
General view of landslides on the shore of Narugo Reservoir

Narugo arch dam, which has a height of 94.5 m and total pondage of about  $5 \times 10^7 \text{ m}^3$ , was built in April 1957. After the storage of water cracks in the ground and cliffs caused by landslide occurred in places on the shore of the reservoir and for this reason the relation between the storage of water and the occurrence of landslide began to be investigated. Six landslide occurrences have been found in the reach of about 2.5 Km along the left-hand shore of the reservoir and the toes of the sliding parts sank under the water. After summer the landslide is generally apt to be stabilised and is liable to be activated in the rainy season and the early spring when the snow begins to melt. Geology: bed rocks are mainly the alternation of the Miocene green tuffs and shale, and in part, granites. Faults, fracture zones and decomposition due to hydrothermal process are found in places and talus debris is developed in the slope. Synthetic investigations and control works are being carried out.

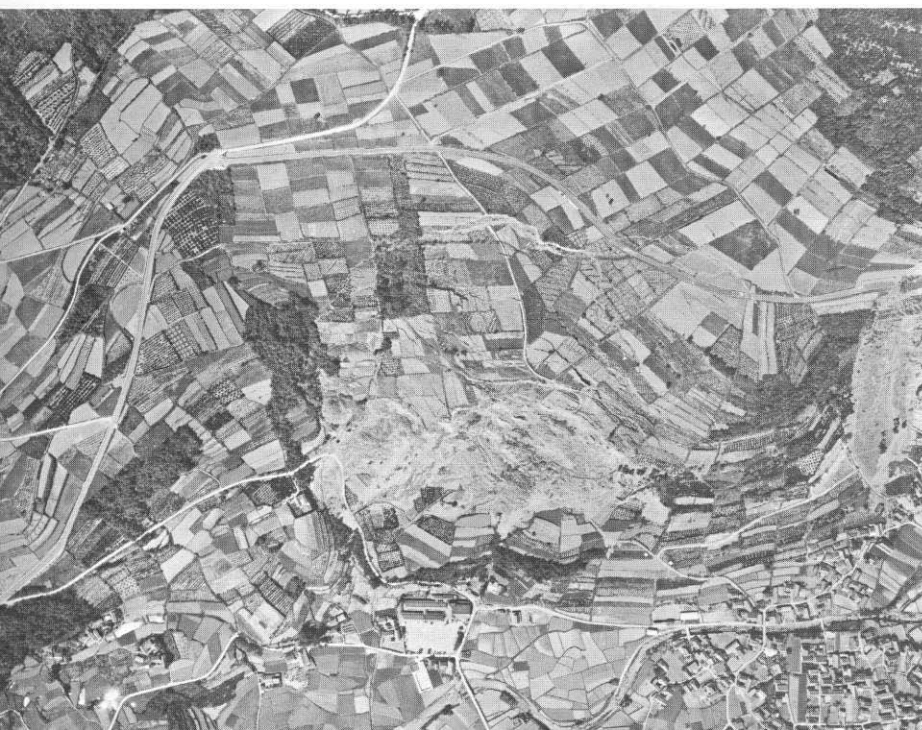
On 10th Sept. 1965, a landslide occurred at a small island in Seto Inland Sea after a typhoon with 200 mm precipitation. The local sinking velocity was 5 cm an hour at maximum. At the tongue area a debris flow occurred and damaged a house, a road and farms. This slide frightened many inhabitants and houses at the foot of the slope.

Aerial photo of landslide area.

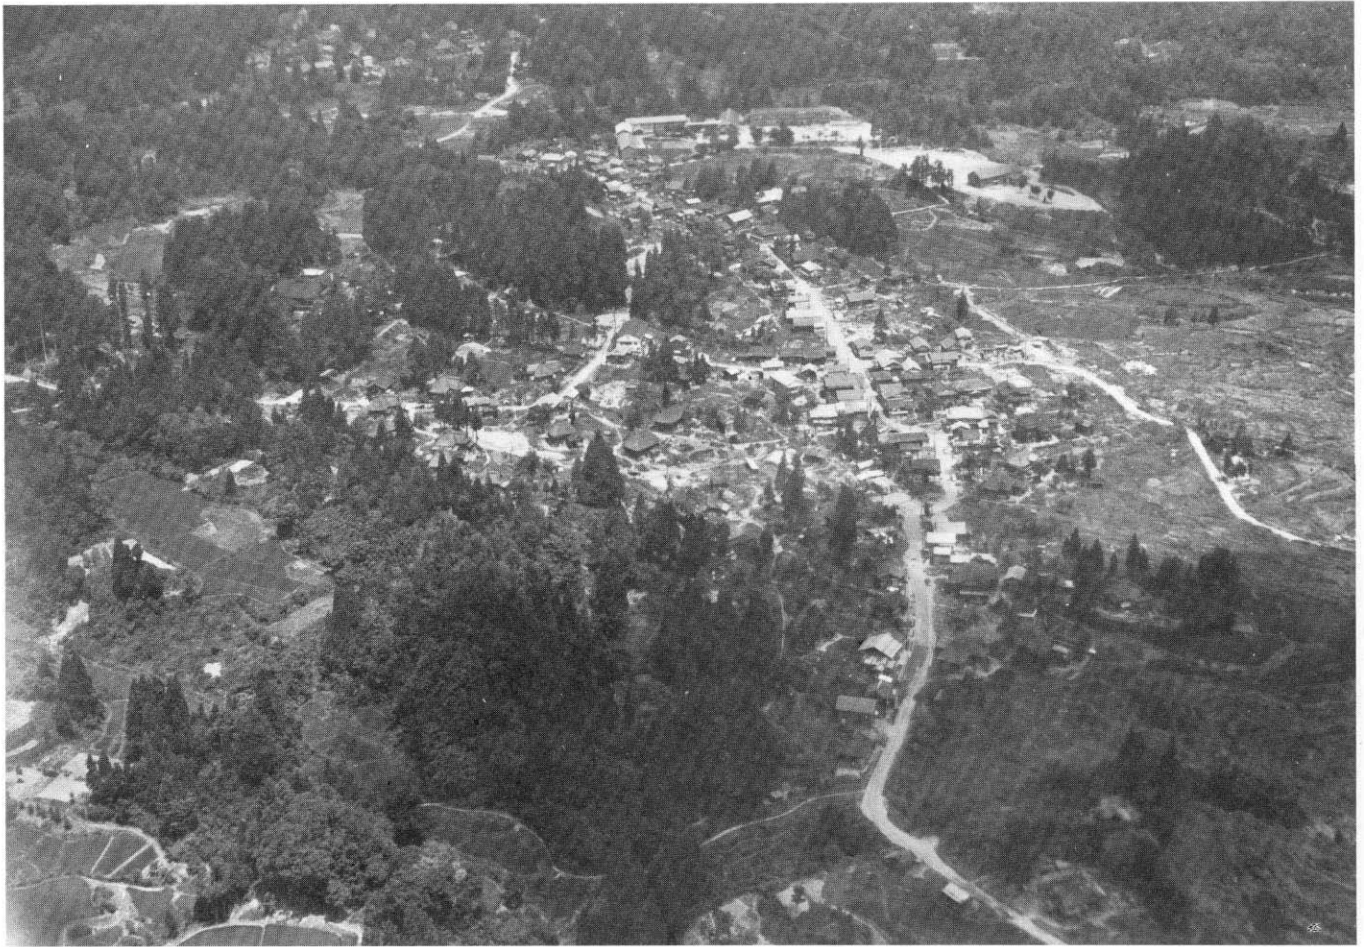
General view of landslide area.

The hill belt is composed of Neogene in which tuff, mudstone and sandstone, and an anticlinal structure called "Matsunoyama Dome" is developed. Centering around the Daimatsu Mt. (738 m) which consists of tuff, large-scale landslides such as Matsunoyama and Mizunashi were radially developed. Matsunoyama landslide has an length of about 3,600 m, a width of about 2,400 m and an area of about 850 ha. An active slide was observed from the middle of spring to that of autumn in 1962. This area is divided into several blocks, according to the activity of slide. The depth of sliding surface ranges from 4 m to 30 m, and the greatest movement velocity on the ground surface is measured as about 12 cm/day. The land mass moved for 20 m in total, damaging rice fields, farms, houses and public buildings, such as a school and the village office. Control works: drainage have been performed.

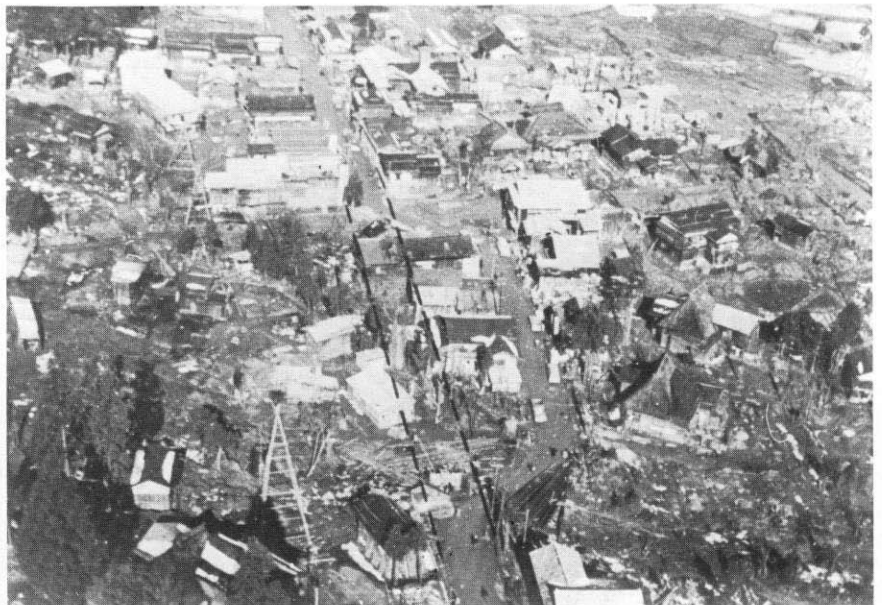
Comparison of road shape before and after slide.

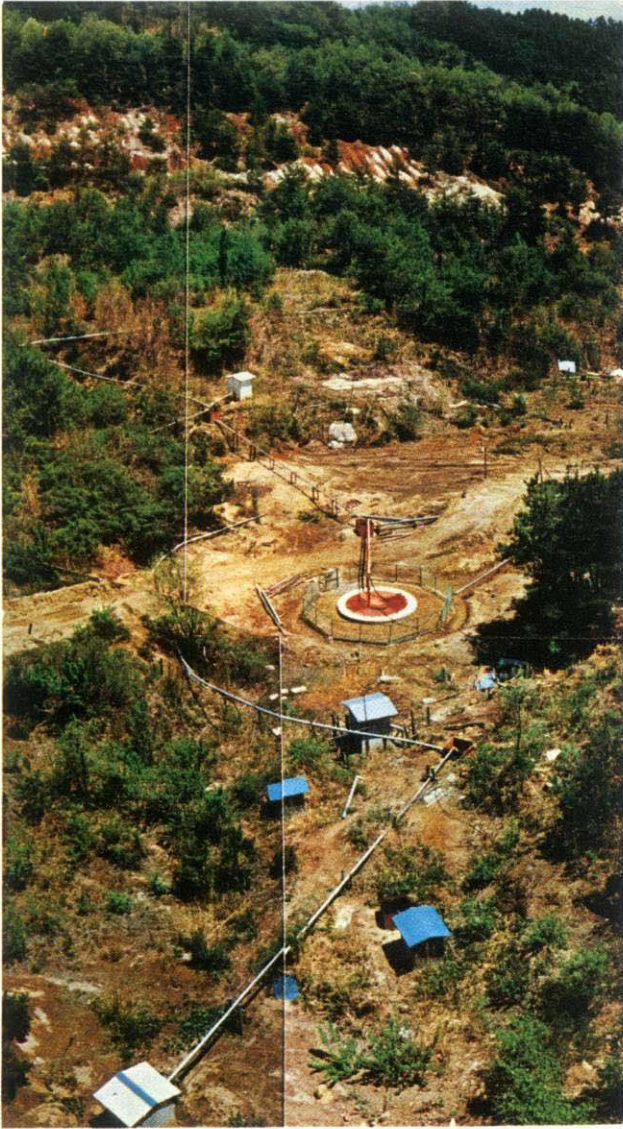
Drainage arrangements and works, a circular structure in the center shows a ferroconcrete well (Chausuyama landslide)

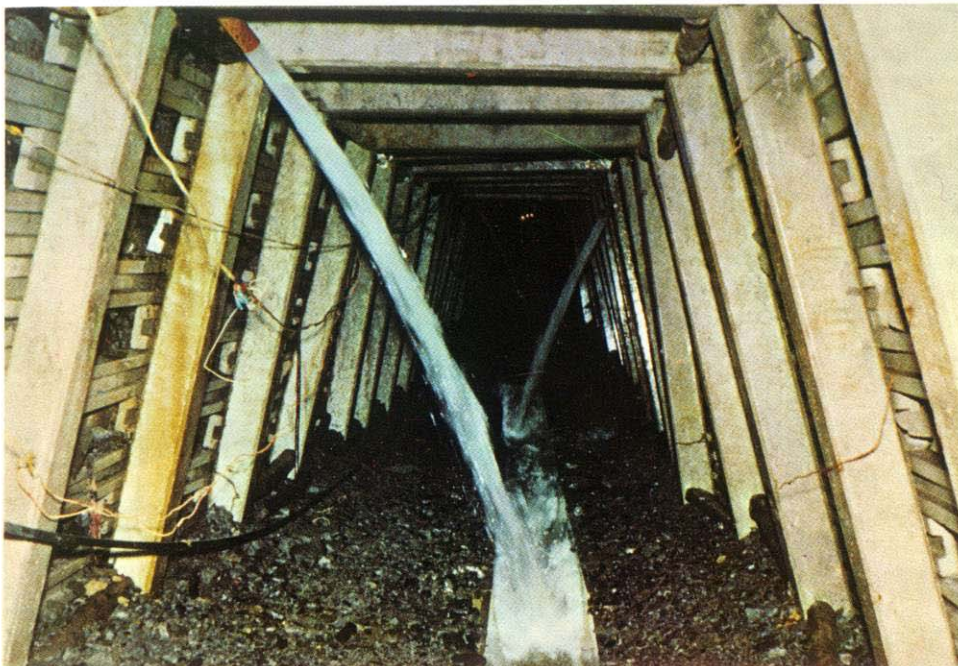
Drainage tunnel, the amount of drainage is about 300 l/min. (Washiodake landslide)

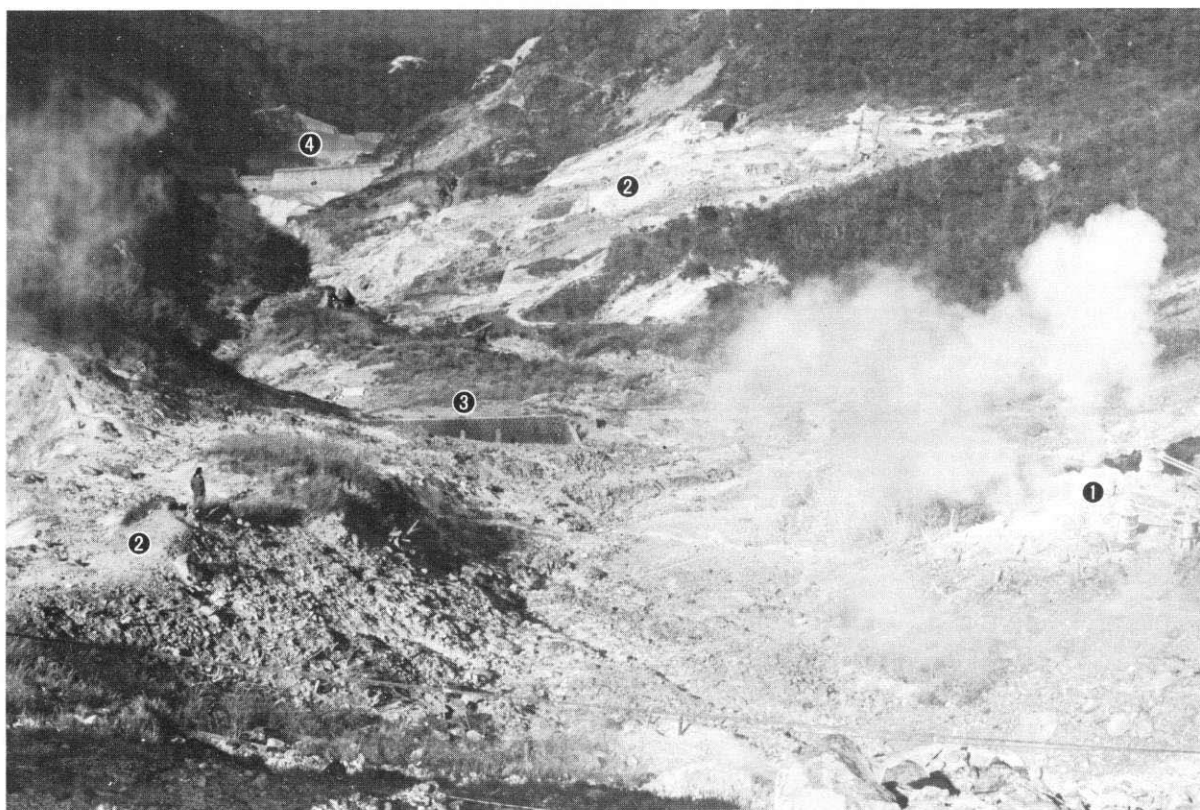
Above: Altered zone at Owakudani

- 1 Fumarolic 2 White part consists of altered clay 3 Erosion-control revetment 4 Consolidation dams

This landslide broke out in an area altered by fumarolic and hydrothermal activities of the volcano. The altered area is divided into several blocks, and among them Owakudani and Sounzan are located in the north side of Kamiyama mountain (1438 m) and are surrounded by very steep slopes, and large landslide disasters in the past were recorded. Since they are adjacent to the upper part of Gora Hot Spring street, attentions are always drawn. Souzan landslide occurred on August 1953 pushed out debris of about  $8 \times 10^5 \text{ m}^3$  from within the fumarolic depression. A mudstream flowed down for about 2 km with the velocity of about 7 m/sec. to destroy a temple and to lose 9 human lives. The mudflore mostly consisted of a milkwhite hydrothermal clay including fragments of andesite. At Owakudani, large collapses occurred in 1910, 1935, 1948 and 1950. Heavy rains, volcanic earthquake swarm and volcanic gas pressure are regarded as their direct motives. Control works: large-scale debris barriers, stair-like valley barriers, gas removal works and works on mountainside were performed.

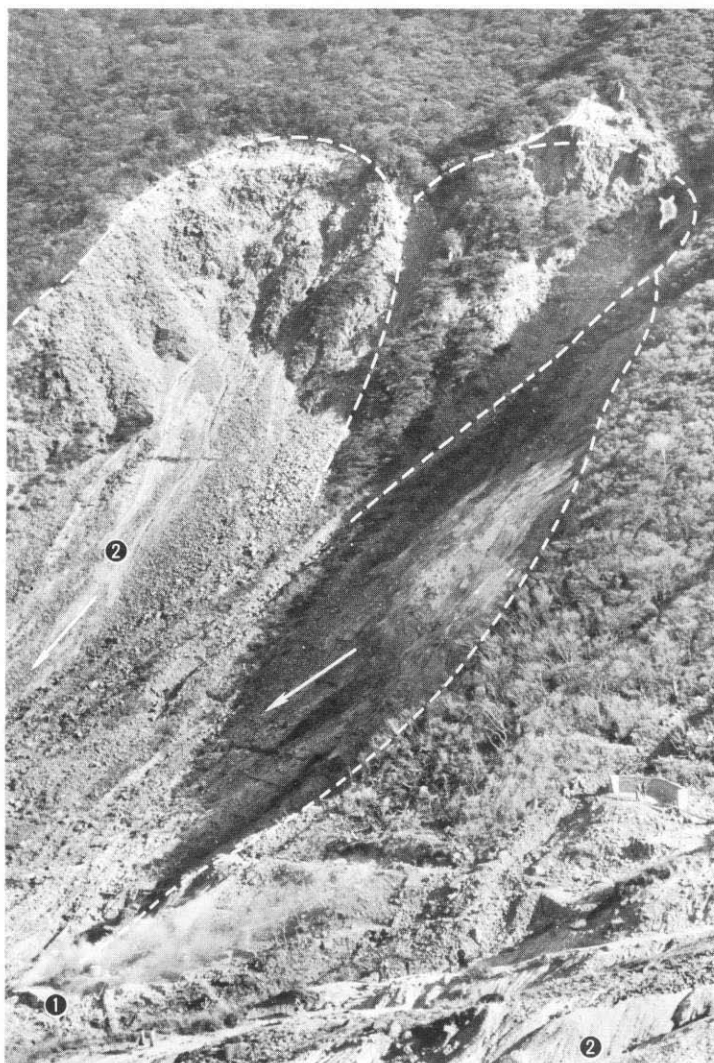
Right: Scarp at the top of landslide

- 1 Fumarolic 2 Altered white clay

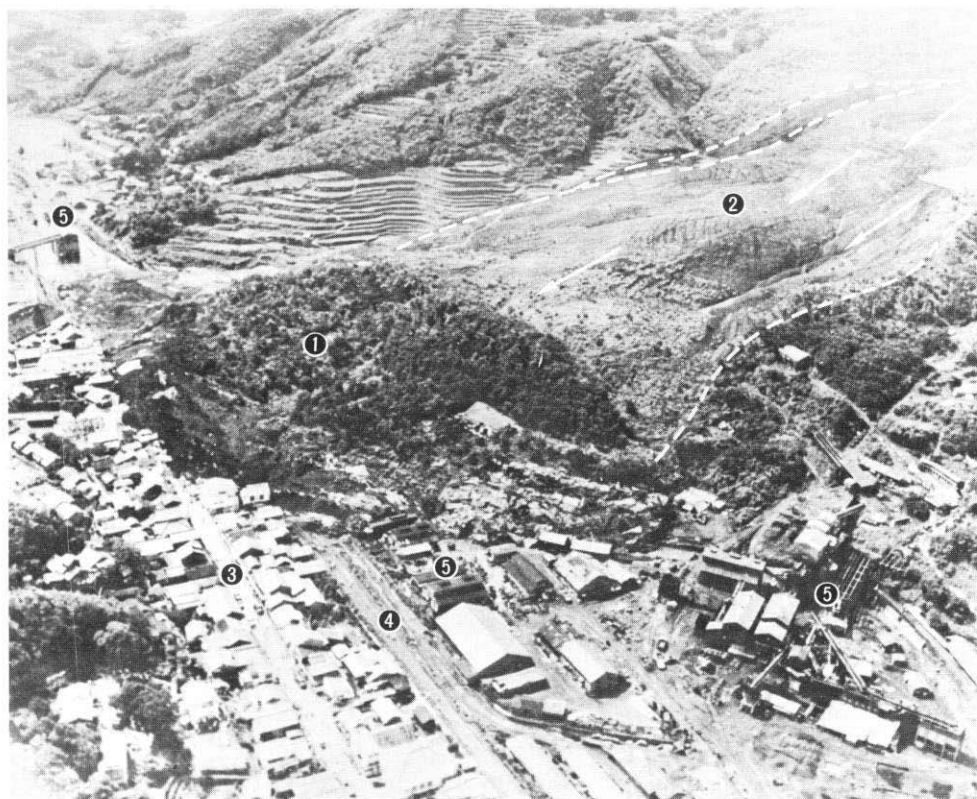
Senryu street and Railway line be attacked by landslide of coal mine waste

- 1 Slide mass
- 2 Surface of rupture
- 3 Street
- 4 Kitamatsuura Railway Line
- 5 Same part of industrial coal mine

This landslide broke out at Senryu coal mine on July 1962, destroyed 217 houses at Senryu town, damaged a railway line about 400 m long and national road about 350 m long. The sliding area had a length of 700 m, a width of 250 m and moving mass of about  $2 \times 10^6 \text{ m}^3$ . The landslide lasted from at 4:30 on 8 to 15:00 on 9 July. This is noted as a large landslide triggered of coal mine waste (called Bota-yama) on the slope.
