# **LANDSLIDES IN JAPAN**

**The Japan Society of Landslide  
National Conference of Landslide Control**

**1972**

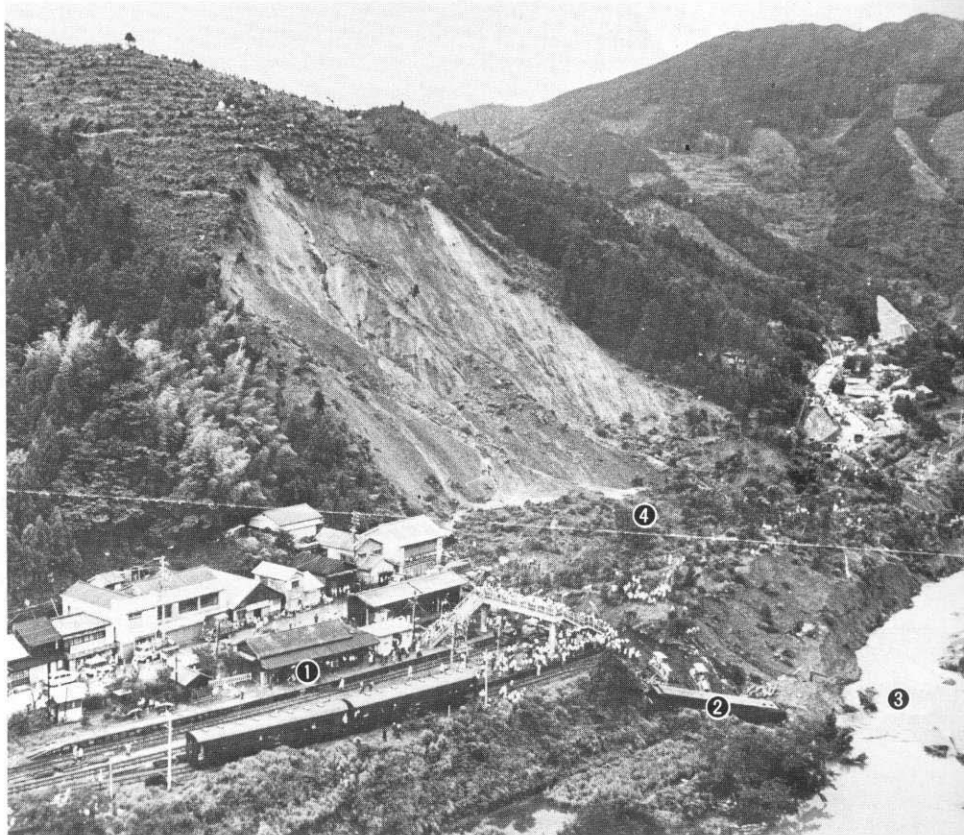
Shigeto Landslide

- 1 Shigeto station 2 Railway carriage pushed out by slide 3 Ananai river 4 Slide mass

At 11:00 on 5 July 1972, a large soilfall broke out near Shigeto Station of the Dosan line. Soils slumped from a hill with a height of 80 m. The slide had a width of 170 m and the fallen soil mass was about  $10^6 \text{ m}^3$ . Fifty-nine persons were killed, and 11 houses destroyed. A locomotive and two railway carriages halting at the station were pushed out into the Ananai River. Geology: the slided area is identical with that of the northern belt of Chichibu terrain, which lithologically consists of clay slate, bearing sandstone and chert. In addition to this, this district is a famed heavy rain zone in Japan (average rainfall between 1931 and 1961 is reported as 3,389 mm/year), and the concentric heavy rainfall which triggered the slide reached 742 mm/day, which had never been experienced in the area.
