# Recent landslides in Niigata Region, Japan

H. Yamagishi (e-mail: hiroy@env.sc.niigata-u.ac.jp), L. Ayalew  
*Niigata University, Japan*

**ABSTRACT:** The Niigata region is known in Japan for landsliding at high frequency. Recently, slope failures were taking place at different places in the region as a result of heavy rainfall, rapid snow melting and other factors. This paper introduces some of these landslides and gives a brief discussion on what has been done subsequently.

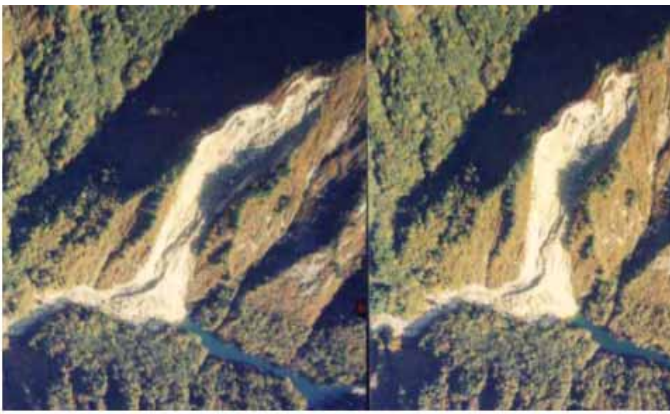
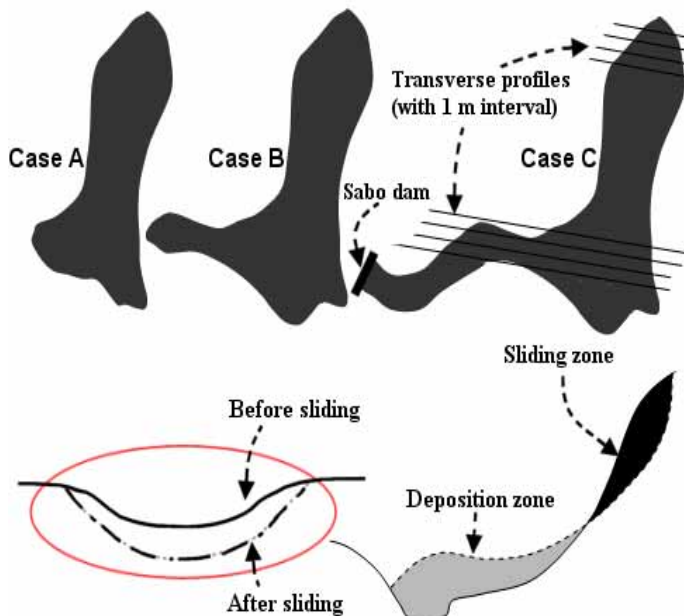
Figure 8. The system of computing the volume of Tozawagawa landslide based on photographic records.

The calculation procedure was performed in such a way that the landslide zone was included into the process in three phases, A, B and C. The middle part of Figure 8 shows a graphical sketch which illustrates how this has been carried out. Case A considered the straight section of the disturbed zone with an average length and width of 460 m. In case B, the area up to a curve on the river floor where most of the displaced materials were pushed at the time of landsliding was taken into account. The last case (C) covered the whole sliding zone up to the sabo dam. Then, a total of 611 transverse profiles, each with 1 m interval, were constructed across sliding zones in all three cases, as it is shown in the middle part of Figure 8 (Case C). Next, slip surfaces before and after landsliding were determined from photographic records of 1976 and 2001 (lower part of Figure 8). Finally, displaced and deposited volumes were calculated for each profile and summed up to give overall results which are summarized in Table 1. It is seen in this table that the difference between the two volumes (displaced and deposited) is higher in case A than in case B and C indicating that much material was coming from the top of the hill.
