LANDSLIDES IN JAPAN

The Japan Society of Landslide
National Conference of Landslide Control

1 9 8 0

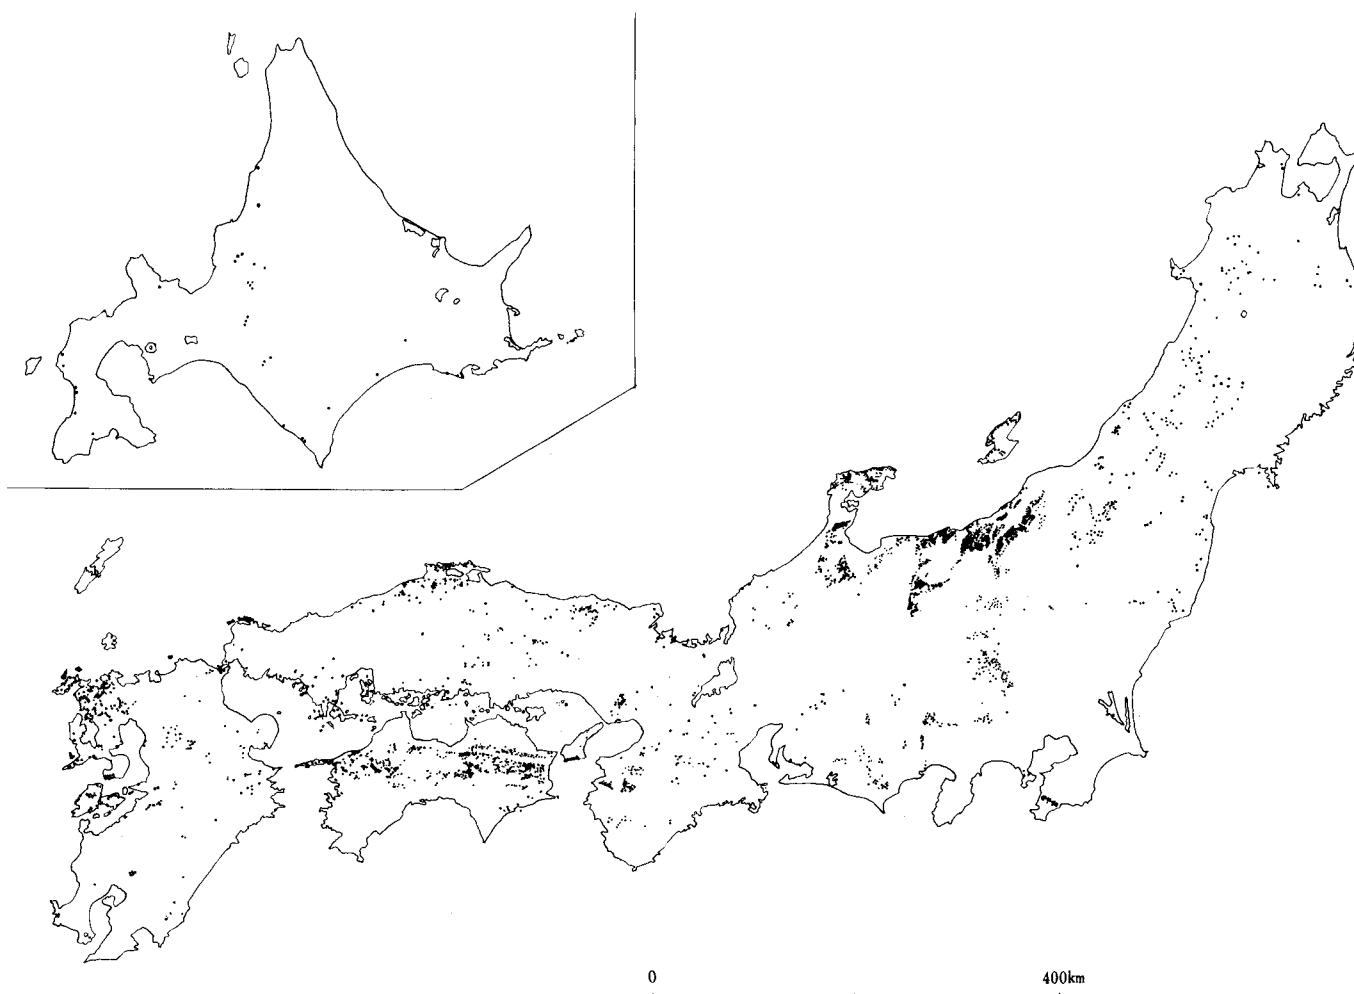
Fig. 3-2 Landslides designated by the government for control works

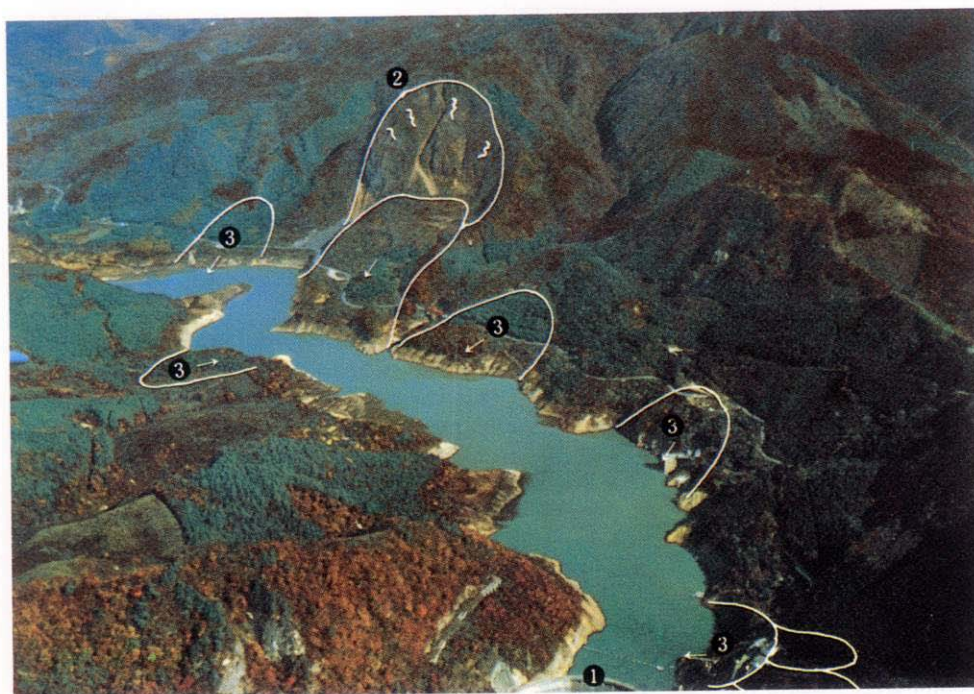
Aerial view of the Narugo dam and reservoir (Photo taken in 1978).

- ① Narugo dam: the first arch dam in Japan
- ② Handawara landslide
- ③ Landslides
- ④ Control office

Damage Six landslides occurred during the first impoundment of the reservoir. One of these, the Handawarayama landslide, the mass of $200\,000\text{m}^3$ on which the road collapsed for 100m, slipped into the reservoir.

Subsequently, cracks appeared on the piedmont and the terrace slopes around the reservoir. Then, as the water level was drawing down, the slide increased in the rate of movement to form a clear scraps. Damage occurred in a part of the building of the dam control office, and on a road and a bridge.

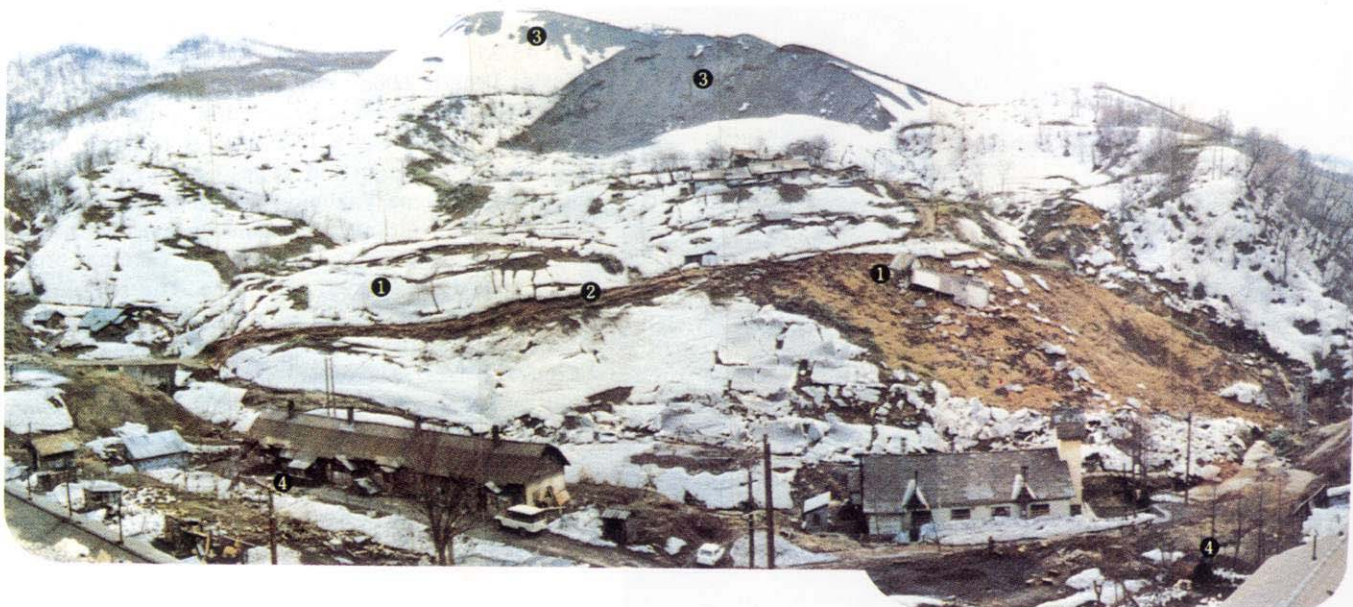
General view of Kita-Ichinosawa landslide just after the disaster.

① Main slid mass ② Road ③ Coal mine waste-dumps ④ Stable area

Damage The landslide movements occurred in 1961 and 1969 in this area. The 1969 slide particularly caused serious damage including 6 dwelling houses destroyed totally or partially, a river buried for 500m and a road collapsed for 500m.

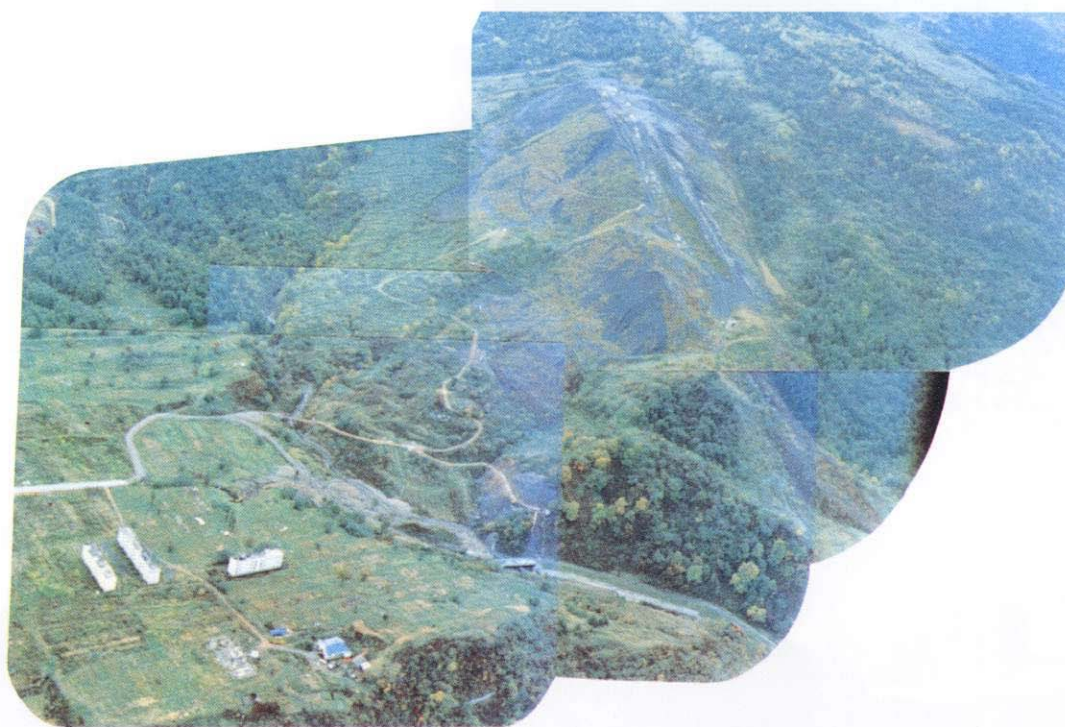
After the remedial works (Photo taken in 1975).

Present Condition Subsequent to the damage of the landslide in 1969, countermeasures were seriously taken. It was found that the ground water level had been appreciably dropped in the movement unit with the highest possibility of danger in and after 1971, and that the landslide was tentatively stable.

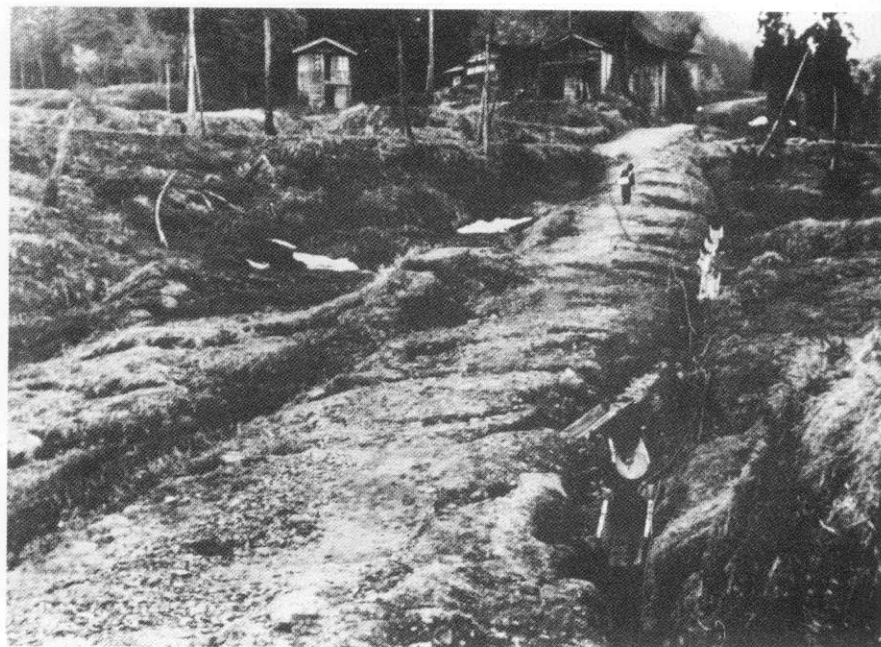
A deformed road across the Matsunoyama unit.

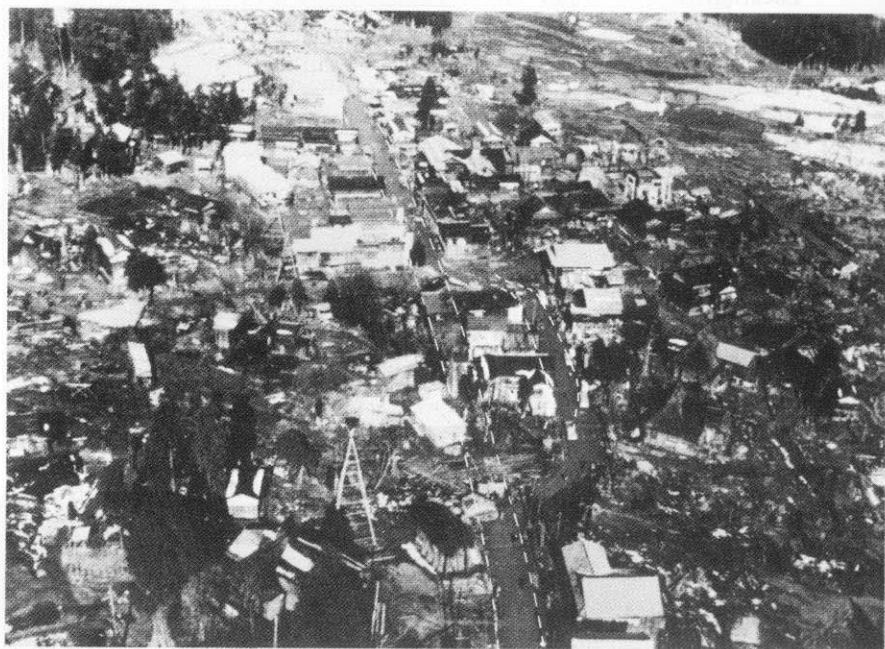
The graben zone in the Usagiguchi unit.

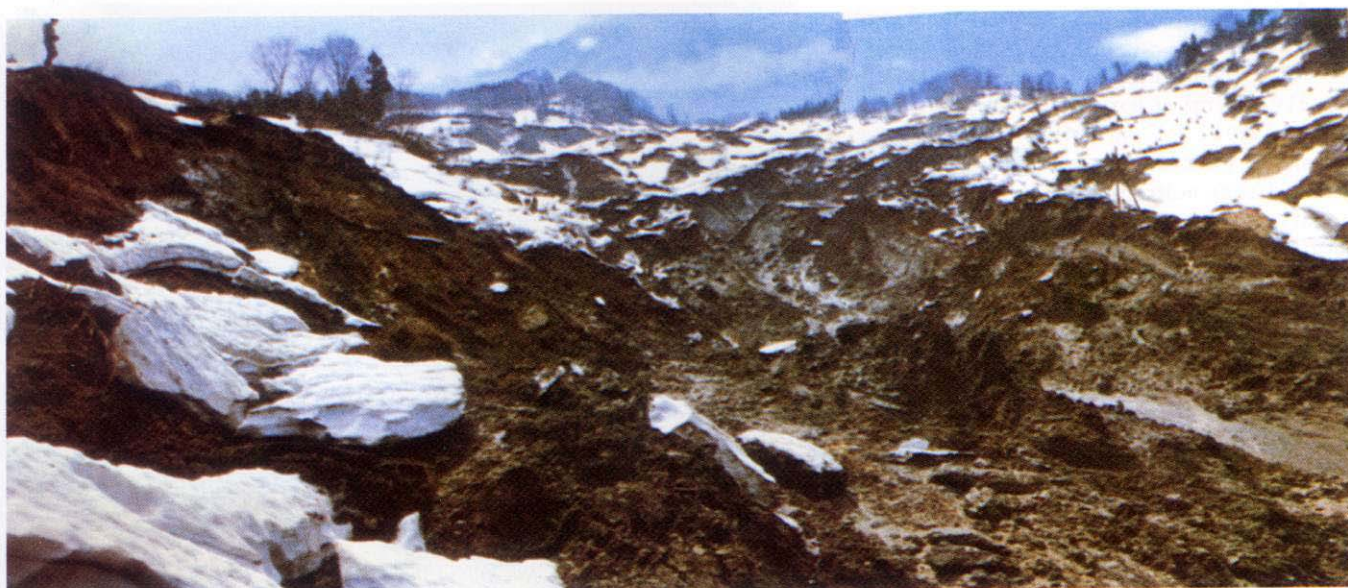
Main area of Kamihiramaru landslide (Photo taken in 1970).

Damage Landslide disasters repeatedly occurred in 1962, 1964, 1969, 1970, 1974, 1978 and 1979. The Hiramugawa river was blocked by a part of the mud flow which was turned from the 1962 slide mass.

Geology, Mechanism and Type The area is underlain by the Miocene Teradomari Formation consisting black and massive mudstone. The slip surfaces are usually developed at the depth of 6.0–12.0m. Slide movements occur vigorously in snowmelt seasons, while creep movements can be observed throughout a year.

Control Works Check dam and crib works were executed to check the mud flows at the foot of the landslide area, while at the lateral slope pile work was done to prevent the slide movement. At the same time, surface drain and drainage well works were carried out.

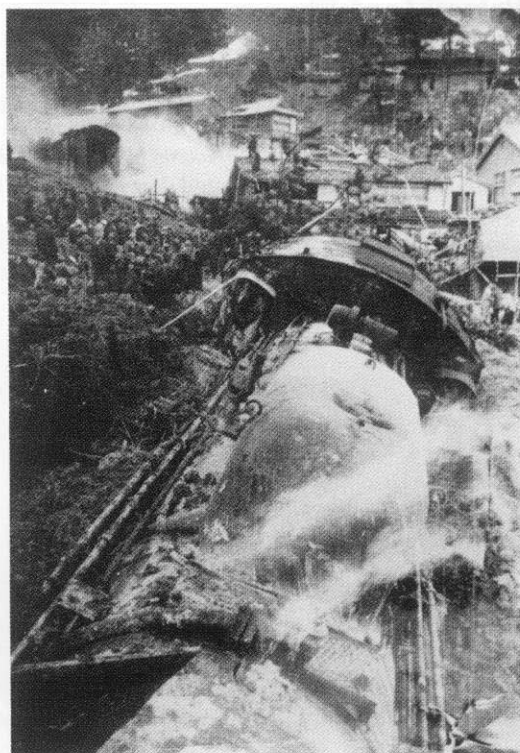
Steam locomotive moved and partially buried by the slid mass (Courtesy of the Niigatanippo).

Damage The landslide struck a freight train that happened to be passing the site and swept the locomotive away for about 170m on 16 March 1963. On account of the landslide, the traffic of the railway and road was interrupted for a long time. The slid mass swept 28 houses into the Japan Sea.

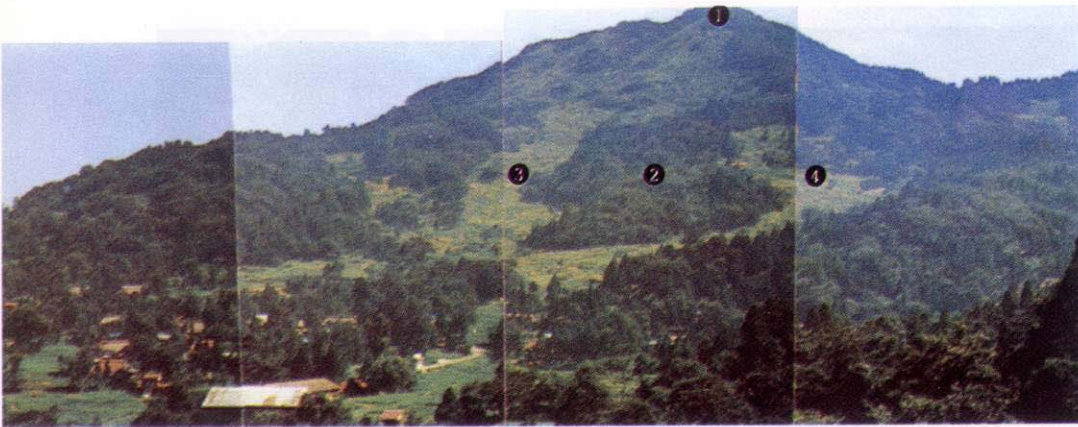
Upper slope of Sarukuyoji landslide.

- ① Mt. Jogayama composed of andesitic rock
- ② Stable area
- ③ ④ Test field of Public Works Research Institute

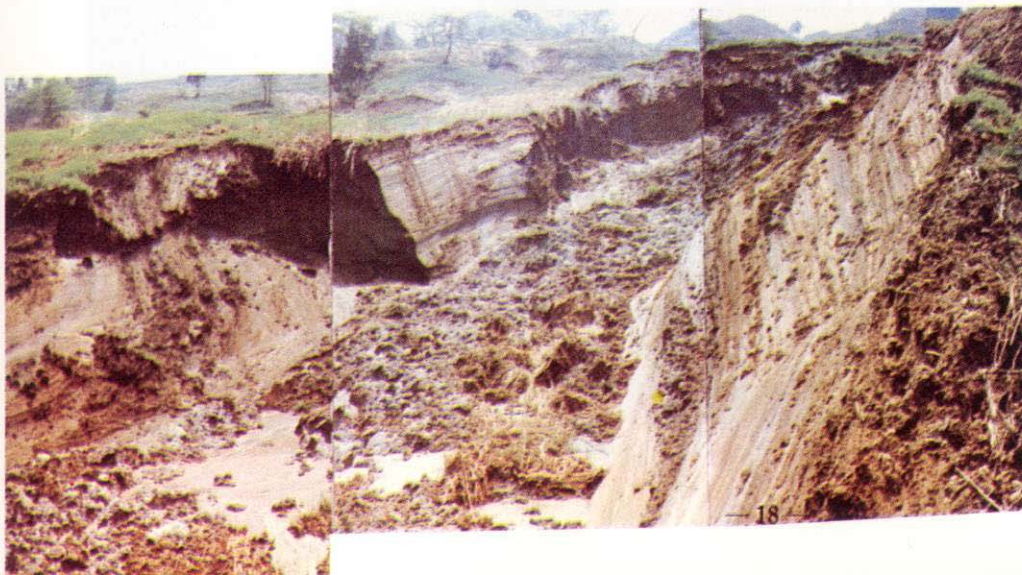
Lower part of Hataori landslide.

Fine slickensides developed along both sides of flanks in the lower part of the landslide.

Control Works A check dam was constructed in the stream near the foot of the slope, while the toe of the landslide was covered by crib works, and the middle slope was protected by steel pile works. As the result, the movement was completely stopped.

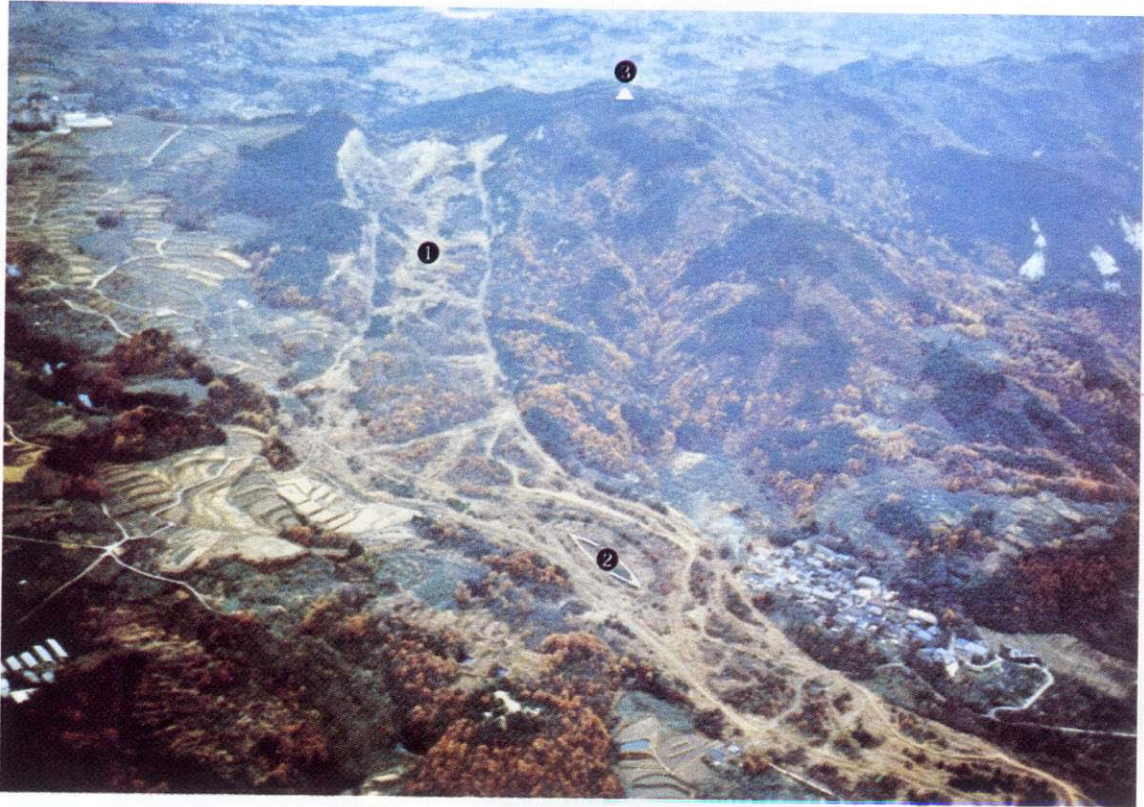
General view of Chausuyama landslide (Photo taken in 1975).

① Natural Botanical Garden ② Stable area or "island" ③ Mt. Chausuyama

Control Works Drainage works of groundwater was carried out in the upper part of the slide. Deep wells were made at the first step, and then, as the second step, drain drilling and surface drain works were conducted. The main works are piling, interceptor drain wall and surface drain works.

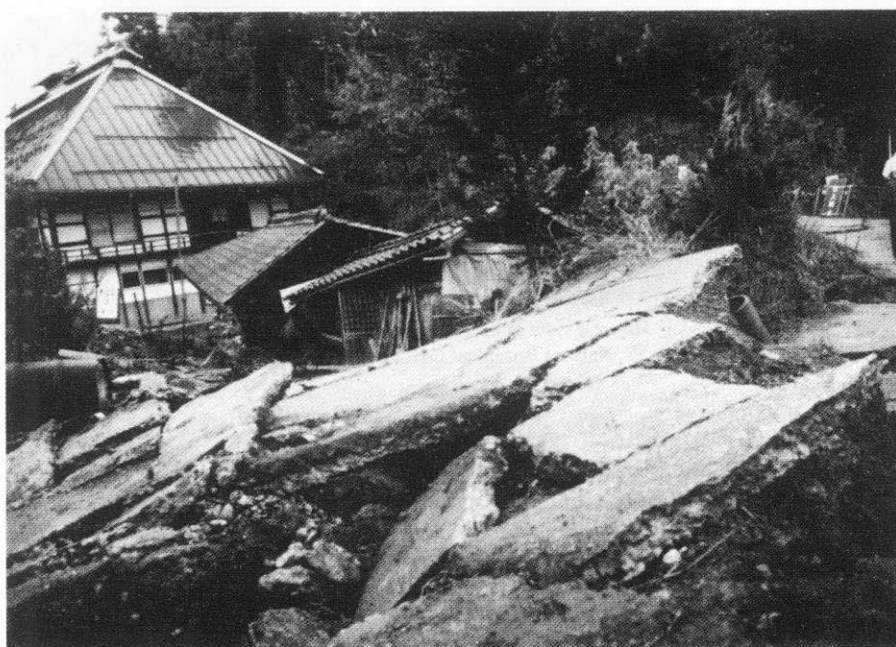
Damaged house and road. (Narao landslide).

Damage The landslide was first noticed when cracks were observed in the yards of dwelling houses on 6 October 1976. At first, the slide was as large as 30–40cm a day, but, now, it is about 5mm a day. In this landslide, 14 of the 15 houses of the Narao village were damaged.

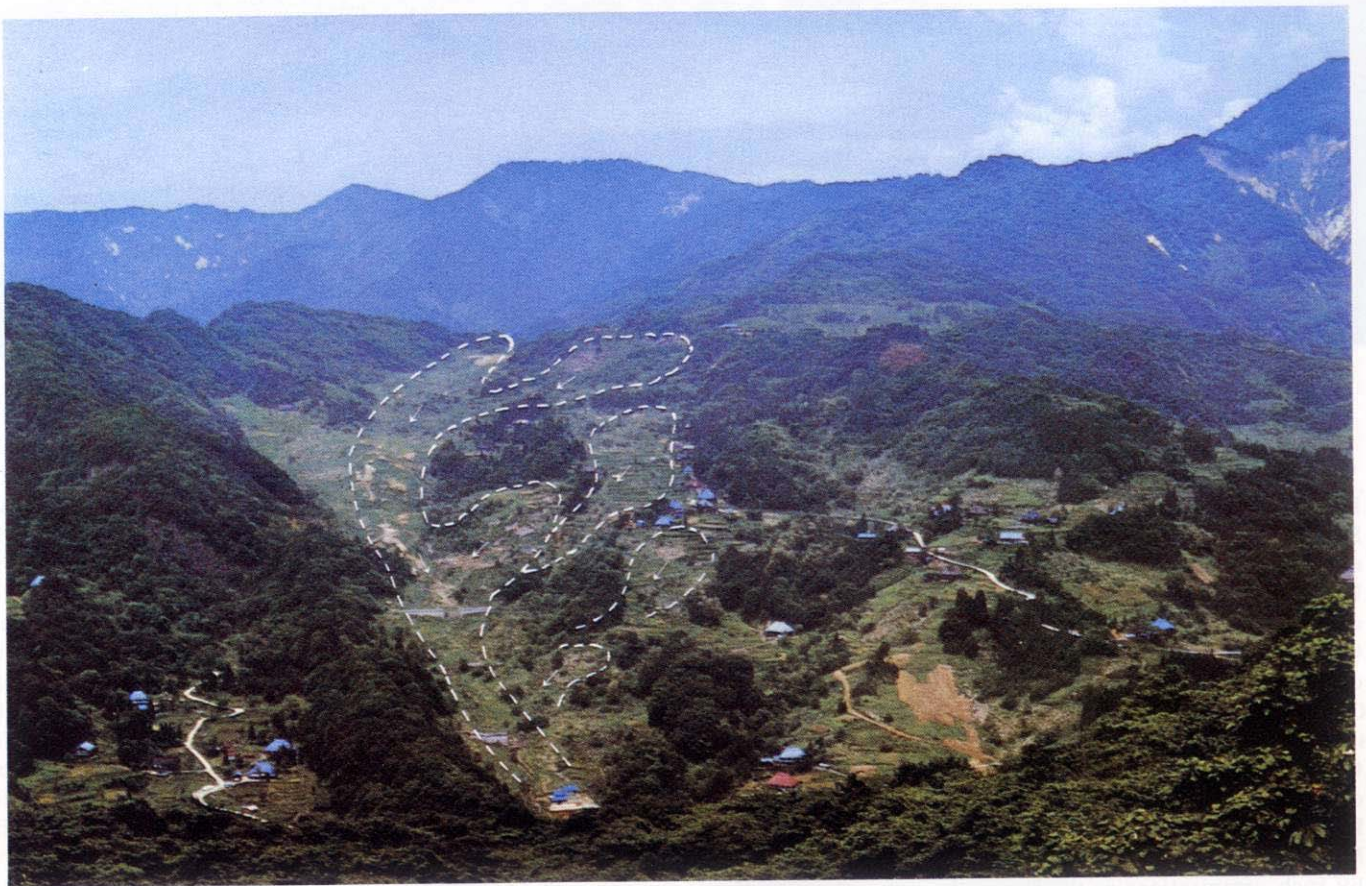
General view of Simizuyama landslide (Photo taken in 1979).

- ④ Boundary of the sliding areas

Control Works Control works were begun in 1956 consisting of drainage works with horizontal drilling, open channel, piling, tunnel and interceptor drain works.

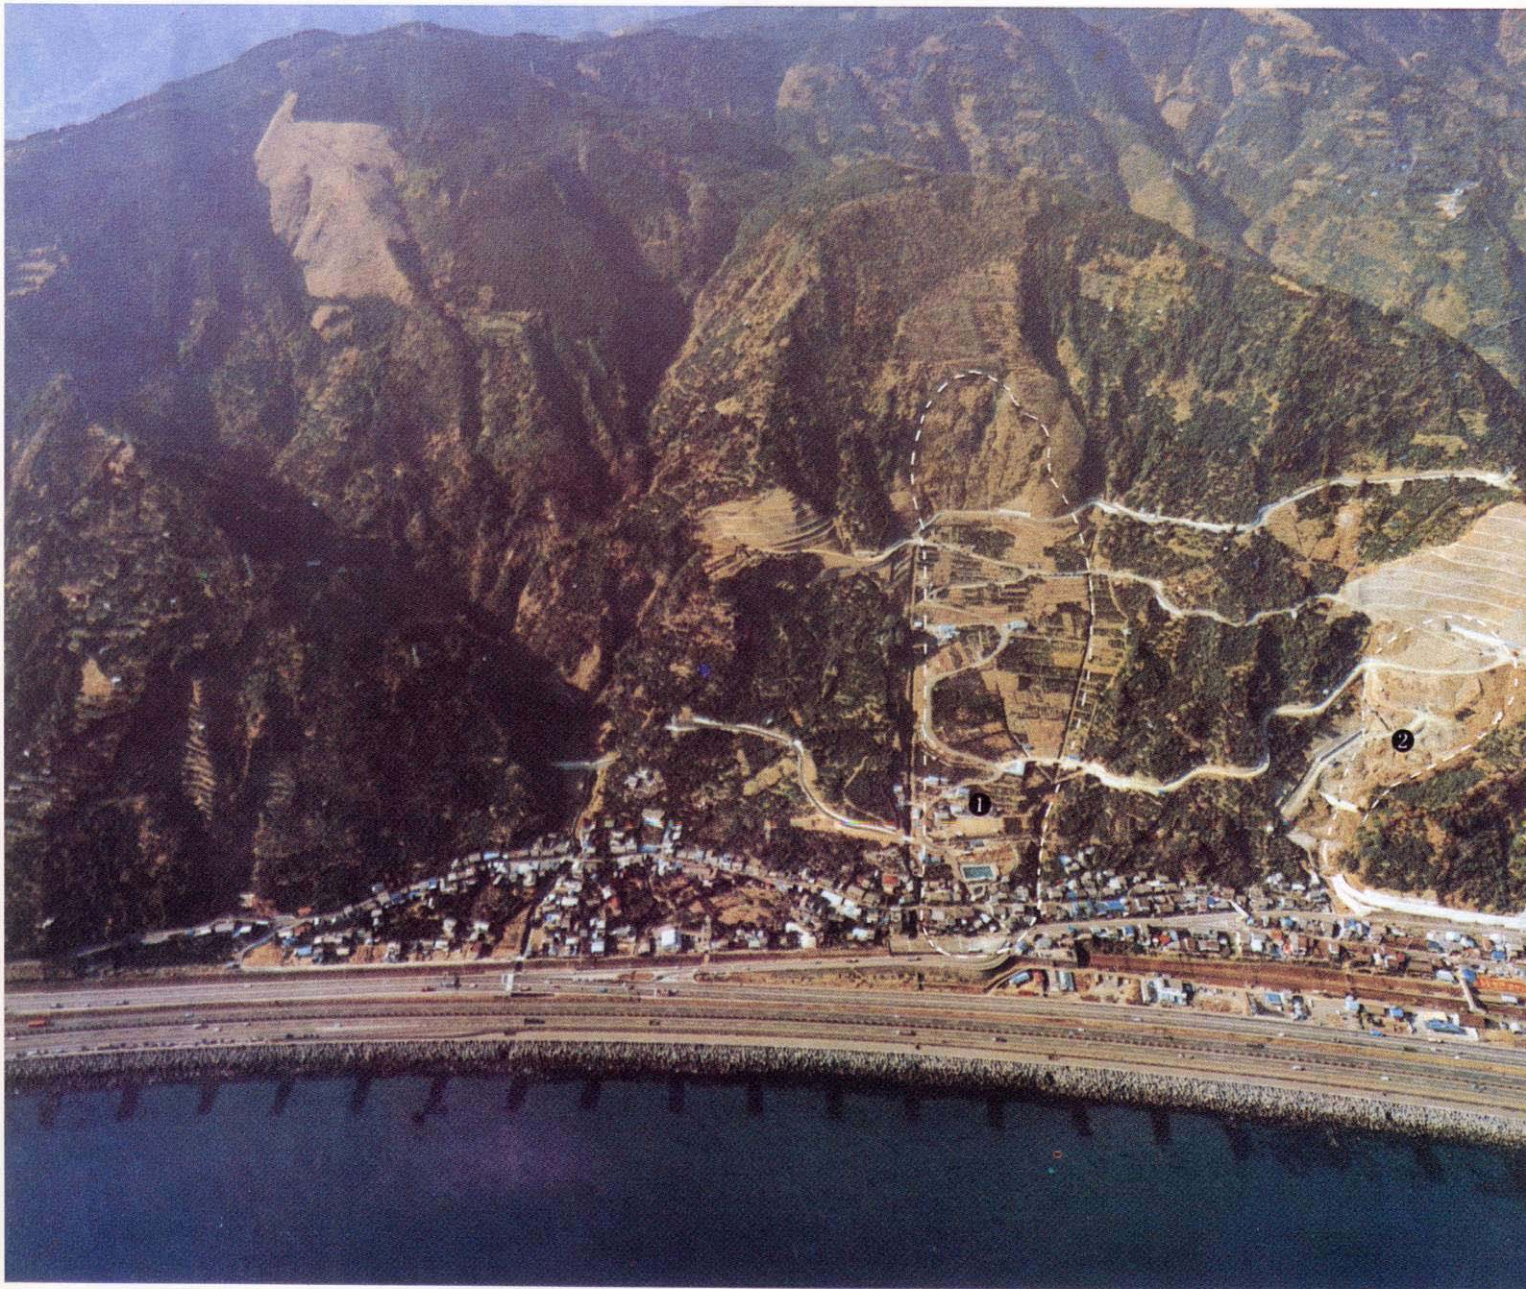
General view of Yui landslide area (Photo taken in 1978).

- ① The area of the 1961 slide after the completion of control works
- ② The area of the 1974 slide under control works.

Damage Activities in sliding have been recorded since mid-1800's in the area. Lately, those in 1961 and 1974 were severe in damage.

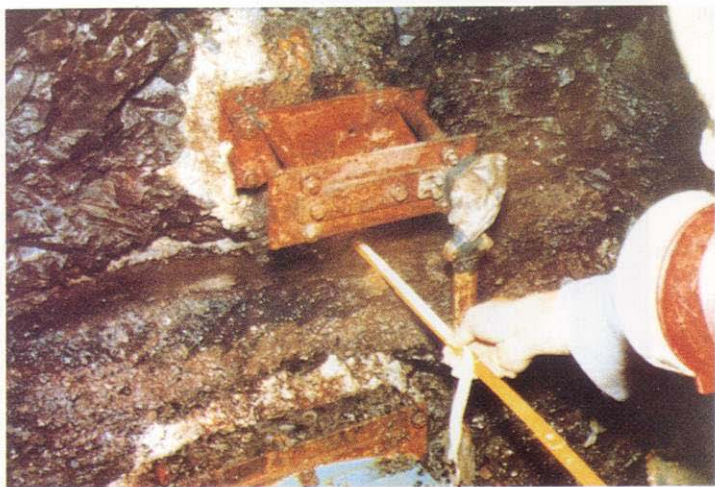
Slip surface and measurement of the displacement of the slide in the observation well (Washiodake landslide).

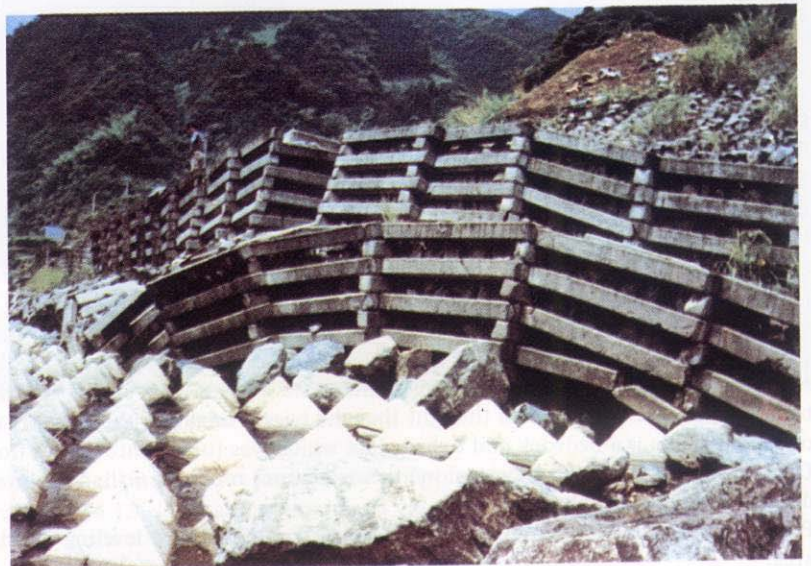
Uplifted crib work at the toe of the landslide (Photo taken in 1979).

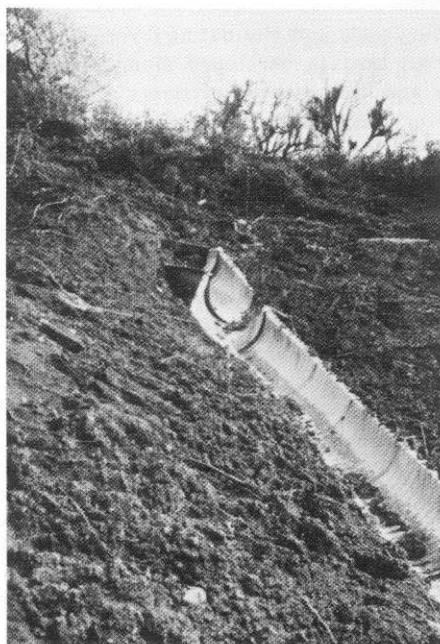
Fig. 6-1. Surface drain of the corrugated pipes.

Surface drain. (Figs. 6-1, 6-2, 6-3)

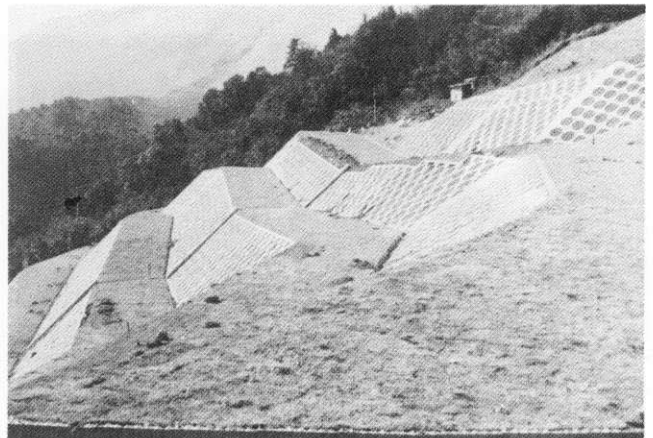
Fig. 6-15. An excavated slope covered with concrete blocks.

Excavation work. (Fig. 6-15)

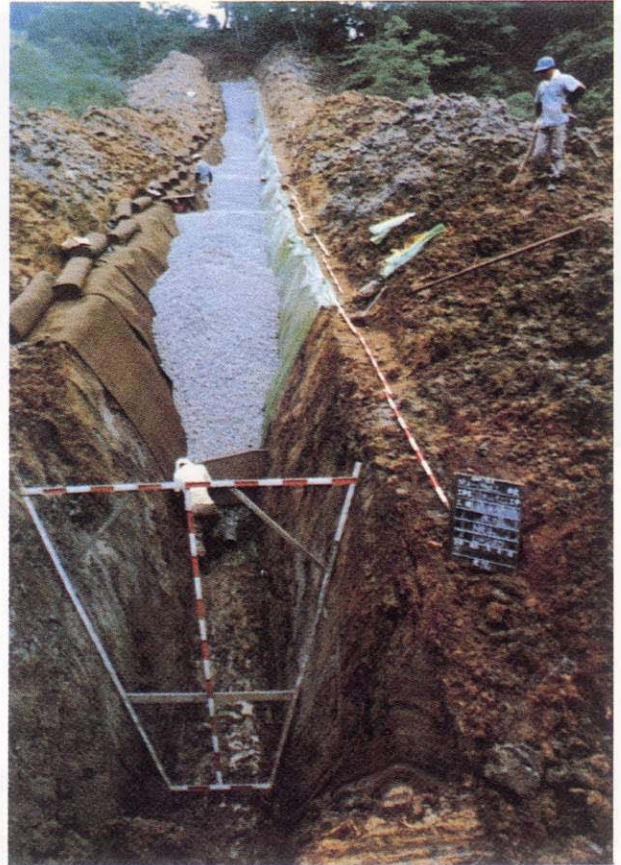
Fig. 6-18. Under construction of an interceptor drain work.

Interceptor drain work. (Fig. 6-18)

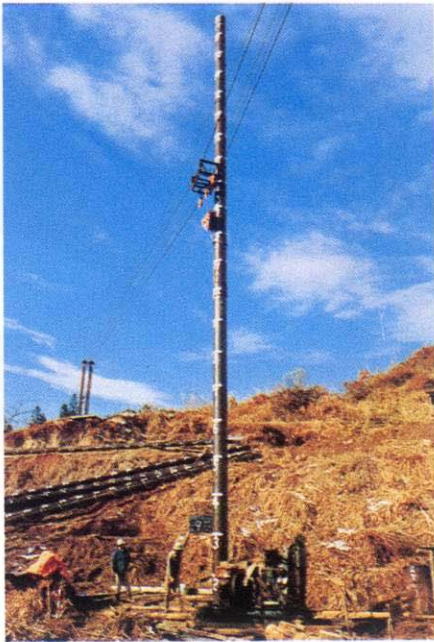
Fig. 6-17. Inserting of a steel pile

Steel piles. (Fig. 6-14, 6-17)

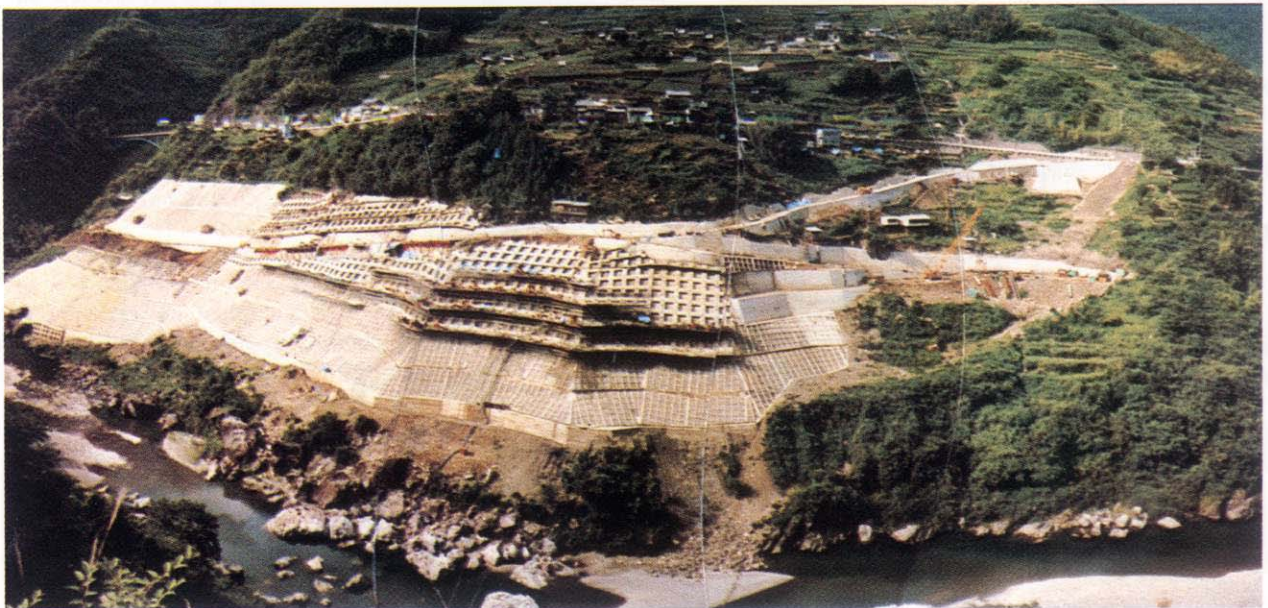
Fig. 6-19. Anchoring for a landslide control. (Odo landslide)

Anchor work. (Fig. 6-19)
