LANDSLIDES IN JAPAN

The Japan Society of Landslide
National Conference of Landslide Control

1 9 8 8

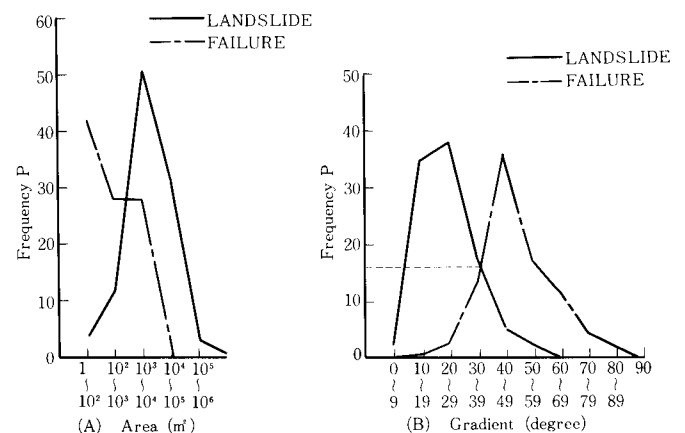
Fig. 2-1 Topographic characteristic of landslide and failure

The scale of landslides is widely varied from extremely large ones to small ones close to that of slope failure, and one of factors directly expressing its features is the gradient of ground surface. As shown in Fig. 2-1, the gradients of landslides are concentrated in the range of relatively gentle slopes between 5° to 20°. On the other hand, slope failures have scales and shapes, each of which are close to each other, and their dispersion is small. Generally, a typical failure has a small scale with a depth of 1 to 2 m on a short slope having a slope height of 10 to 30 m and a steep gradient of 30° to 60°. Therefore, the form of movement of the failure is naturally different from that of a landslide having, for example, a slope length of 100 to 200 m and a depth of 20 m.

Landslides and slope failures that have occurred in Japan are classified and tabulated based on the scale and gradient in Fig. 2.1 (A) and (B). If the intersection between the cumulative curves of both can be assumed as the boundary point of classification, then the boundary point

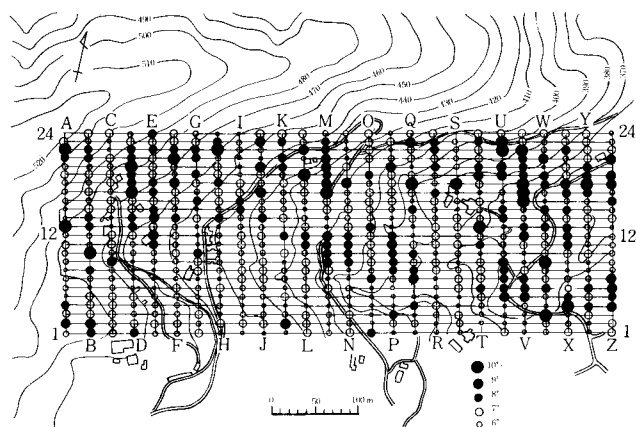
Fig. 4-2 Distribution of 1-m deep underground temperature

Underground temperature near groundwater veins tends to decrease in summer and increase in winter compared to their adjacent area. Therefore, there is a possibility of estimating the location and scale of groundwater veins, that may affect the outbreak of landslide, based on 1-m deep underground temperature surveyed by thermister thermometer.

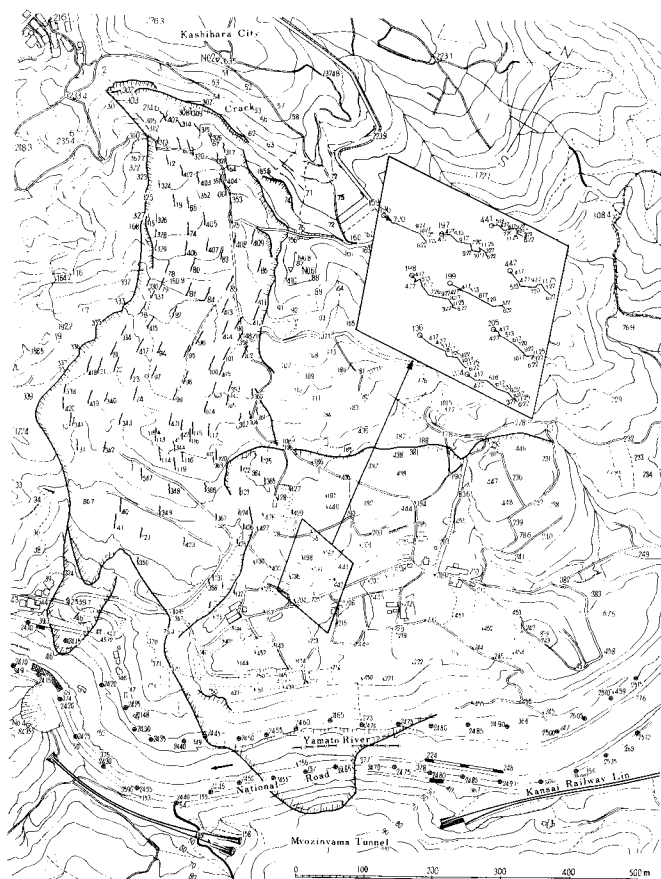
Fig. 4-5 Movement vectors measured by aerial photogrammetry

Where the movement of landslide is large, the surface displacement can be measured by the aerial photogrammetry taken in a different time. The aerial photogrammetry is characteristic in that the displacement can be measured plane-wise with a uniform accuracy. If the scale of air photo is 1/5,000, the measuring error is less than 10 cm.

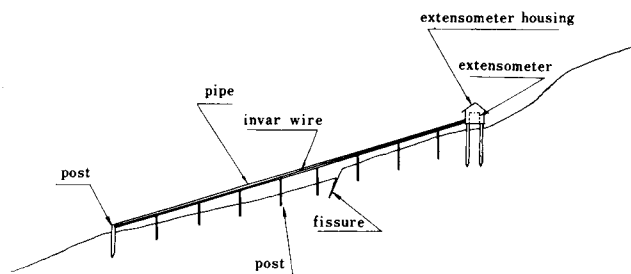
Fig. 4-6 Setting of an extensometer

The extensometer is a device for measuring relative displacement between a point on a landslide mass and a point on stable land and is widely being used in the survey for finding the speed of a sliding mass. Normally, many extensometers with self-recording systems are installed between main scarp. Motion of landslide mass can be continuously known by using extensometers, so that the strain rate effective for forecasting failure time can be calculated. It can be also used as data for producing alarm.

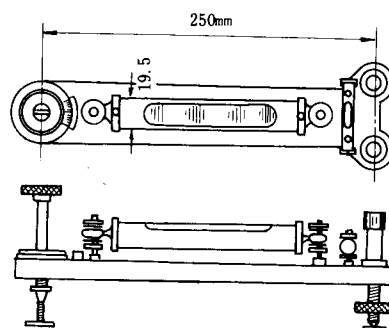
Fig. 4-8 Structure of a bubble-tube type tiltmeter

Tiltmeter is used for determining small ground fluctuation. Its main purpose is to judge whether a potential landslide remains or whether landslide fluctuation is in an active stage or final stage. Bubble-tube type tiltmeters are popular.

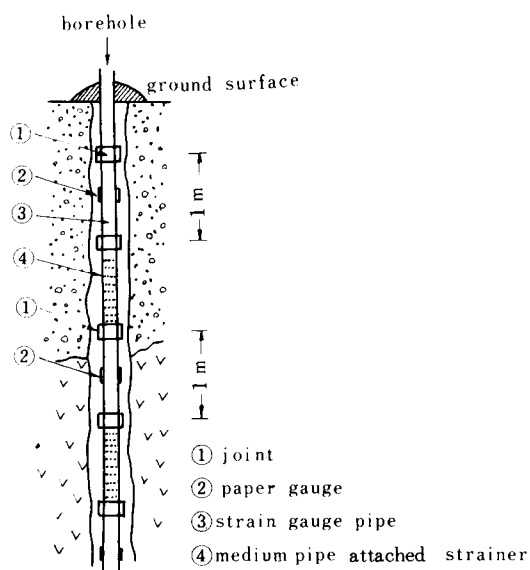
Fig. 4-10 Setting of a pipe strain gauge

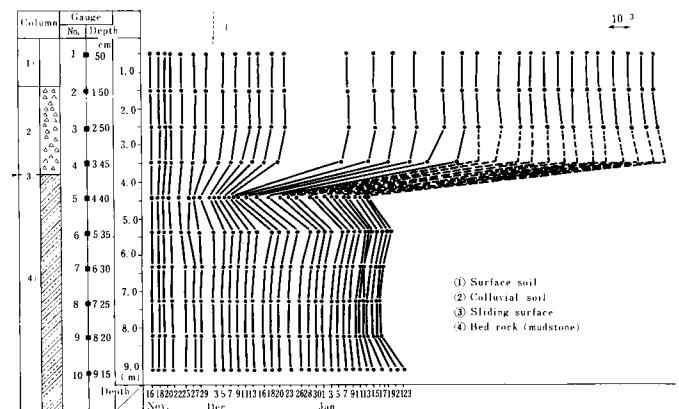
Fig. 4-11 A description of a measurement result of a pipe strain gauge

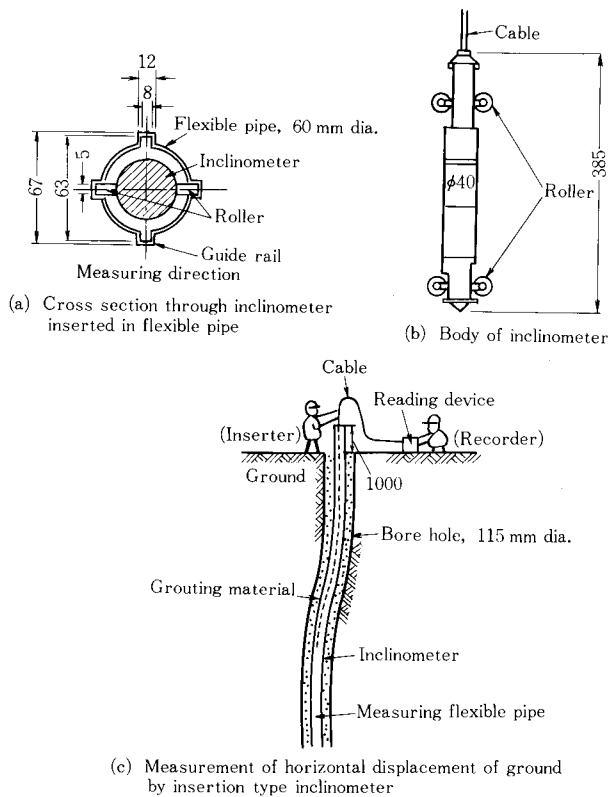
Fig. 4-12 An example of insertion type inclinometer (unit: mm)

The inclinometer is a device for measuring the bend of a bore hole created by landslide and is effective for knowing the depth of slip surface. Inclinatorometers are available in two types; one type with a sensor to be suspended from ground surface into bore hole for measuring tilt at a given depth, and the other type is to be fixed and installed in a bore hole.

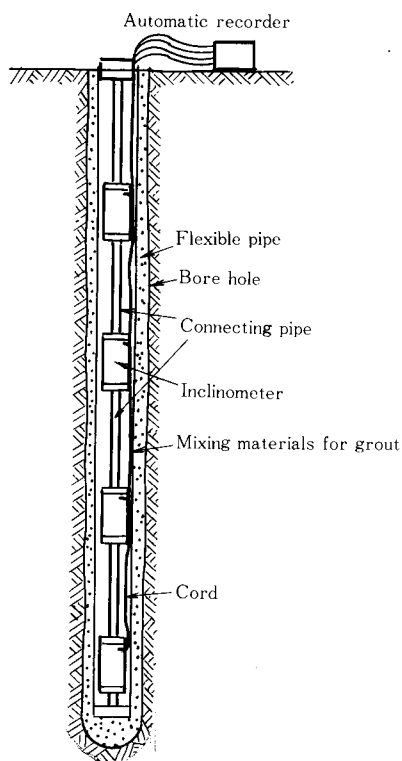
Fig. 4-13 An example of fixed type inclinometer (using both flexible pipe and connecting pipes)

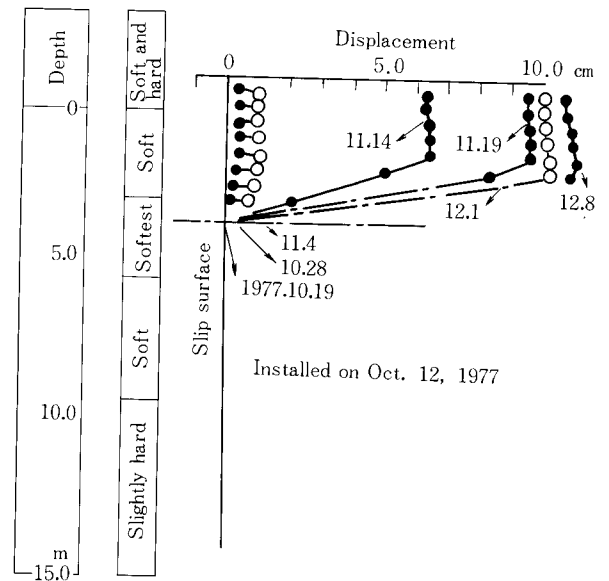
Fig. 4-14 A description of a measurement result of an inclinometer

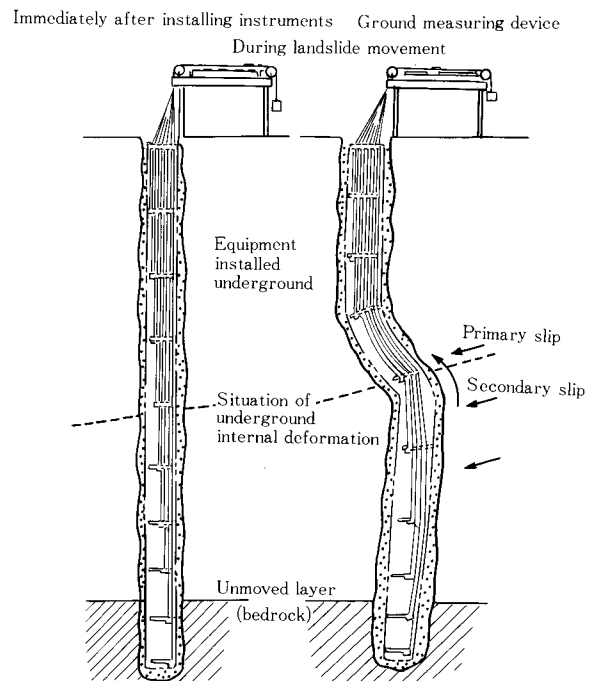
Fig. 4-15 Wire type multi-layer movement meter

The movement meter is a device for measuring the travel of landslide by measuring the elongation of its wire, the tip of which is anchored to a portion below its slip surface. A multi-layer movement meter is a device for continuously measuring the elongation of wires fixed to the various levels of a wall of a bore hole and is used for judging the depth of slip surface and observing long-term earth movement.

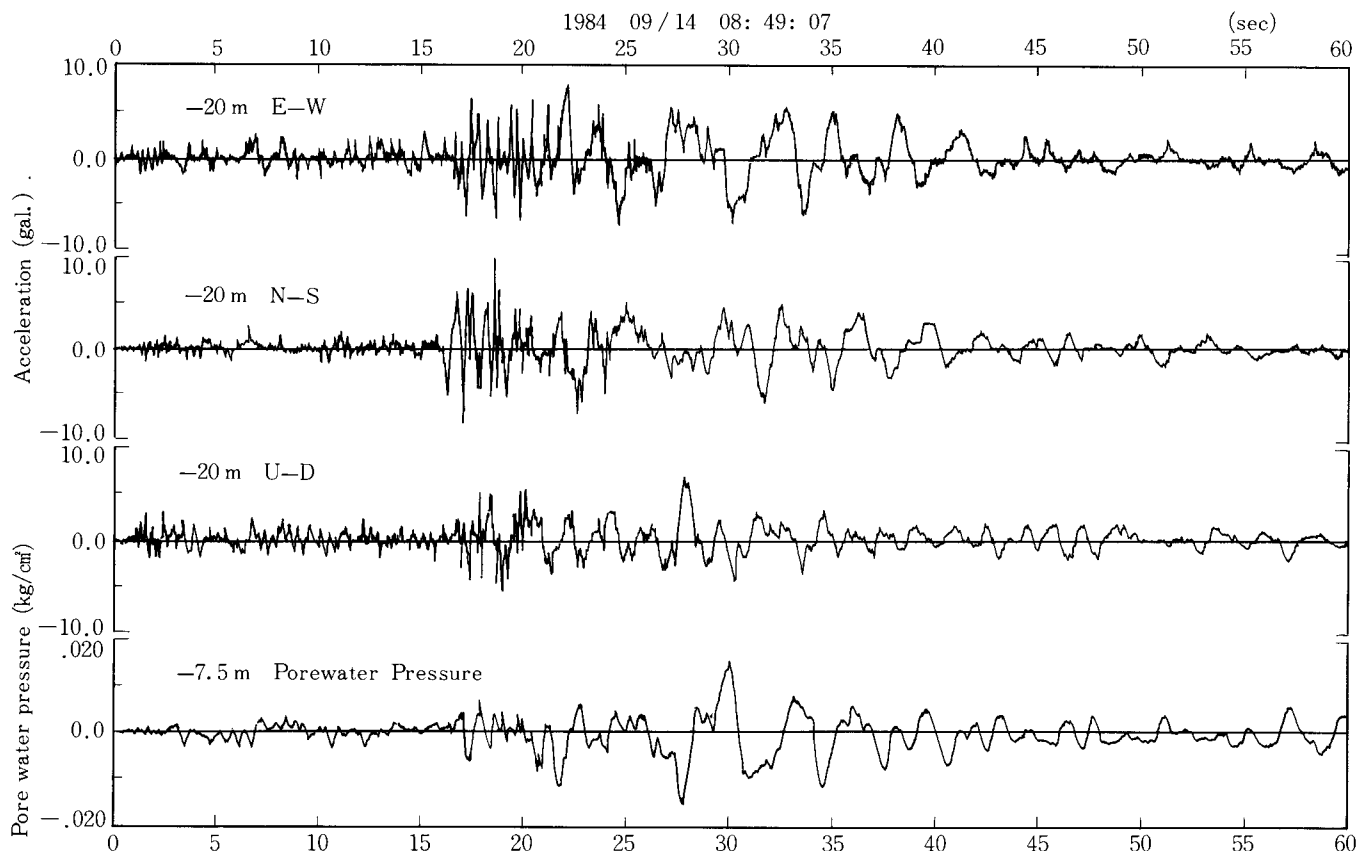
Fig. 4-16 Earthquake motions and pore water pressure fluctuation during an earthquake in the western part of Nagano Prefecture (Observation area: Yui landslide in Shizuoka Prefecture)

In the case of pore water pressure measurement, measuring devices are installed near the slip surface. However, it is difficult to accurately embed pore water pressure gauges in soil layers and to eliminate the influence of free groundwater in nearby area, so that groundwater level that can be measured relatively easily is normally measured and used for stability analysis of slopes as a substitute for pore water pressure. Recently, dynamic pore water pressure caused by earthquake is now being measured. (Fig. 4-16 & Fig. 4-17)

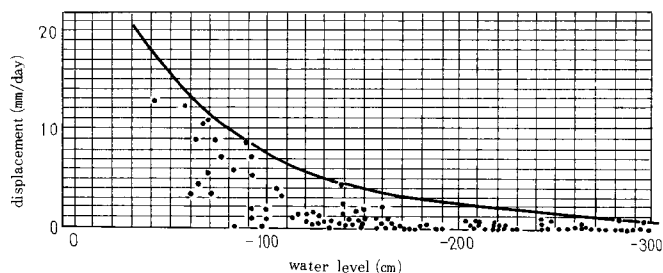
Fig. 4-17 Relationship between displacement velocity and groundwater level at a landslide

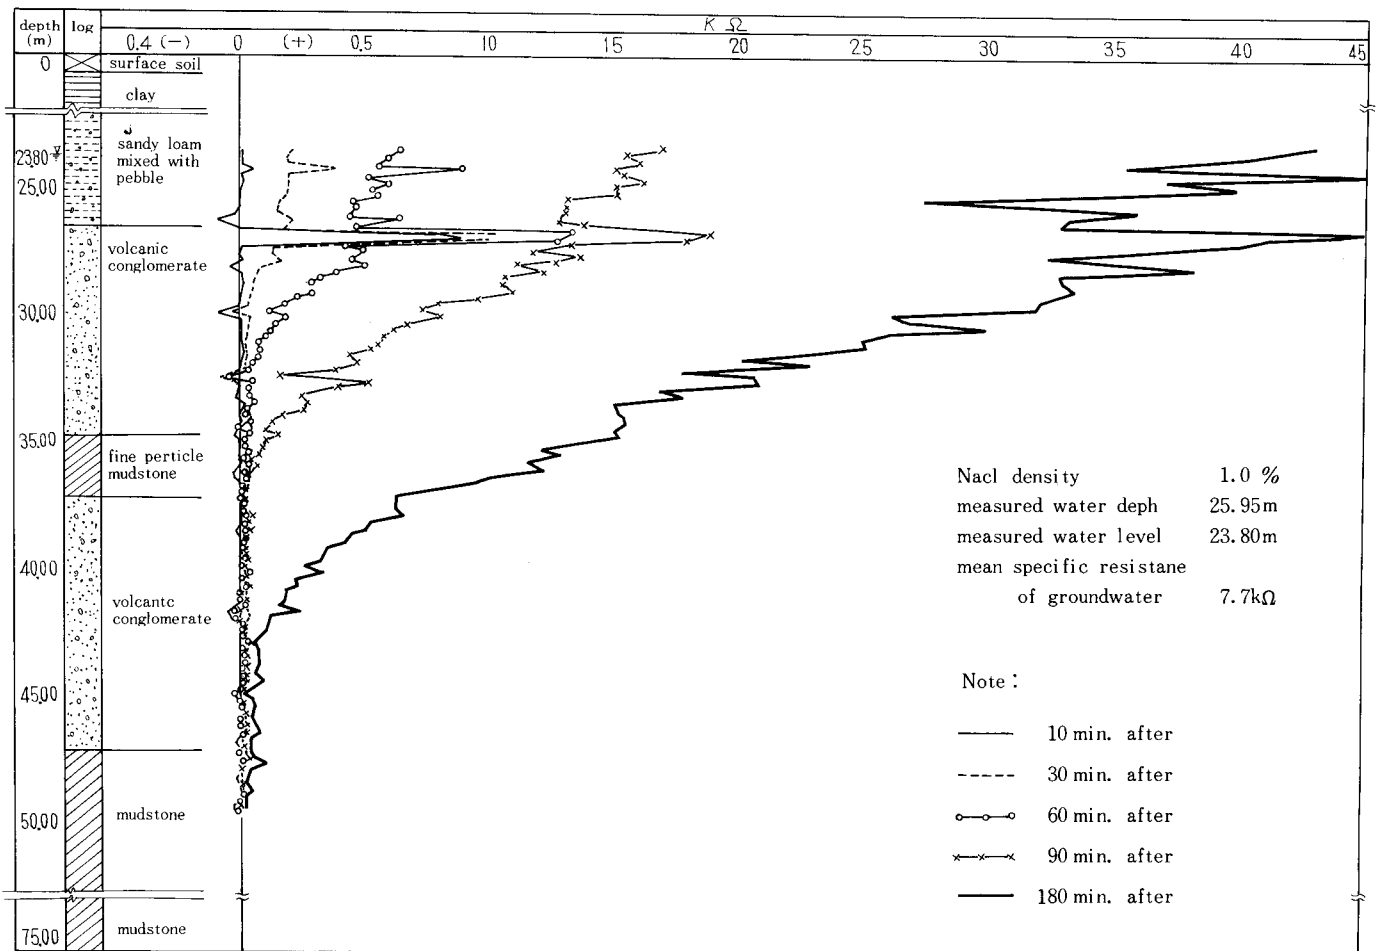
Fig. 4-18 Groundwater prospect at Nakagiyama, Gunma Prefecture

This survey is made to find the location of groundwater flow in bore hole in landslide area. The electric resistance of water in bore holes which was decreased by electrolyte partially recovers caused by supply of groundwater. This change with time is measured, and the location of groundwater flowing layer and the flowing situation are vertically analyzed. This survey was also developed in Japan. (Fig. 4-18)

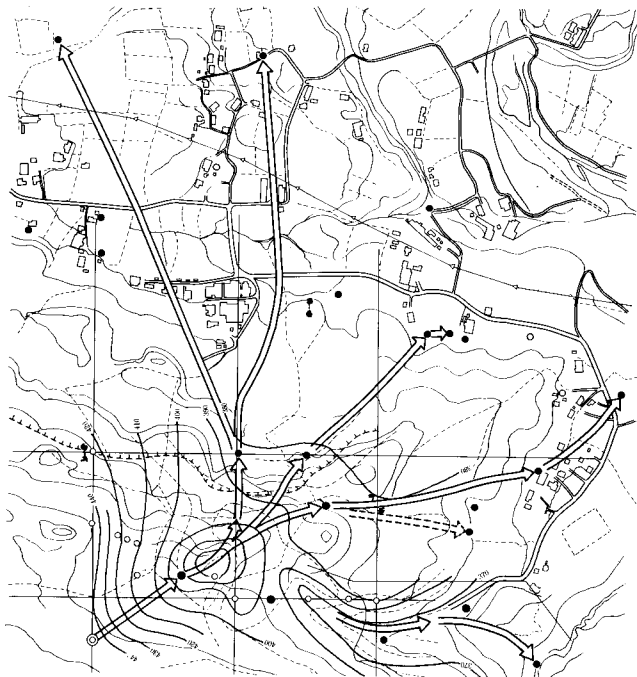
Fig. 4-19 Results of groundwater tracing test

This survey is performed for confirming planewise the flow of groundwater expected in various investigations by using bore holes and the points of spring water in landslide areas and the adjacent areas. As a method of tracing, it is tracer input and detect. Then, based on the results, a groundwater constant-velocity contour map is prepared and then the flow of groundwater is clarified. (Fig. 4-19)

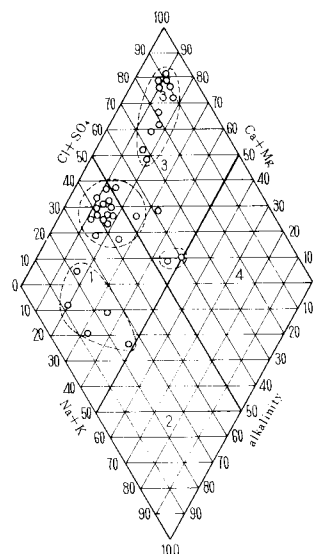
1. Carbonate Hardness
Waters containing calcium and magnesium bicarbonates as main constituent
2. Carbonate Alkali
Waters containing potassium and sodium bicarbonates as main constituent
3. Non Carbonate Hardness
Waters containing earths chloride and sulfate as main constituent
4. Non Carbonate Alkali
Waters containing alkali chloride and sulfate as main constituent such as waters mixed with as water and fossil brine

Fig. 4-20 Rhombic diagram to classify groundwater characters

This analysis is conducted to estimate the ground-water-bearing environment by analyzing the water quality of samples taken from the outcrop of groundwater distributed in landslide area and its vicinity. Items are electric conductivity, water temperature, pH, 4.8 alkalinity, Cl, SO₄, SiO₂, Ca, Mg, Na and K. Chemical components are shown in rhombic diagram (Fig. 4-20).

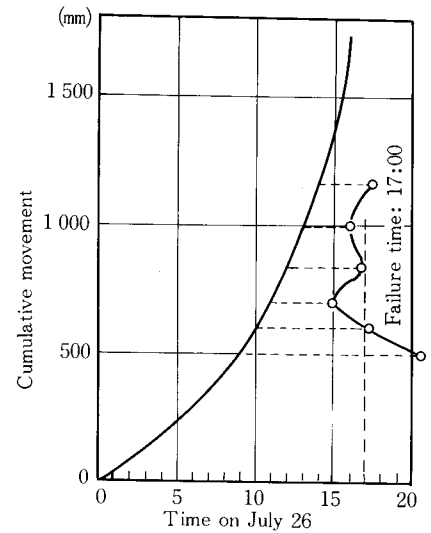
Fig. 4-22 Graphic solution of tertiary creep curve

Figs. show the prediction of the time of occurrence of failure based on the observation records of the movement of some landslides (Figs. 4-22, 23, 24).

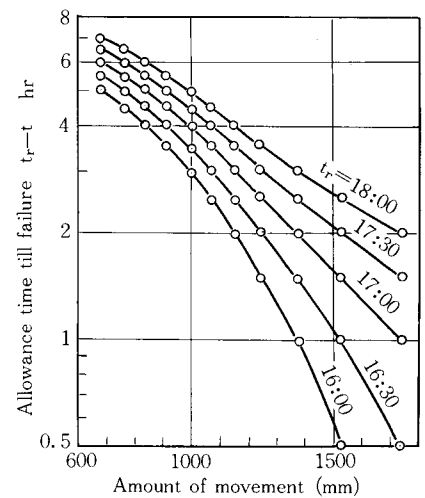
Fig. 4-23 Method using semi-logarithm

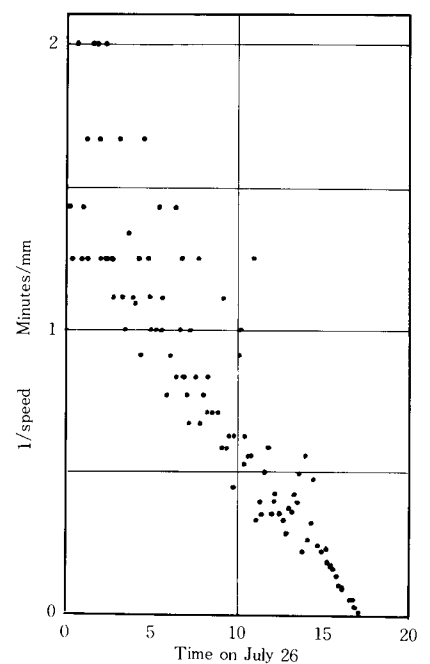
Fig. 4-24 Method using inverse number

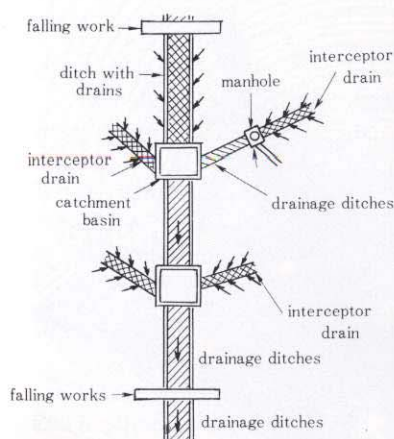
Fig. 5-4 (1) Arrangement of ditches and interceptor drains

In principle, interceptor drains are placed 2 to 3 m under the ground surface. Asphalt sheets, synthetic rubber sheets or vinyl sheets are placed over the bottom. The length of one drain is shorter than 20 m, and in case of a distance longer than 20 m or bending, water catchment basins are placed to turn collected water into surface water. Therefore, ditches and interceptor drains are very often adopted (see Figure 5-4 (1)).

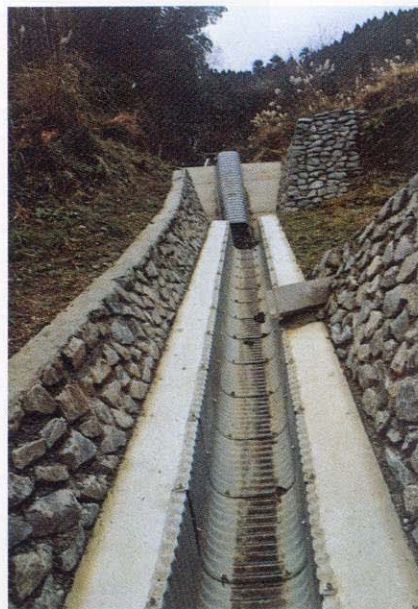
Fig. 5-6 Surface drainage ditches with corrugated half pipes

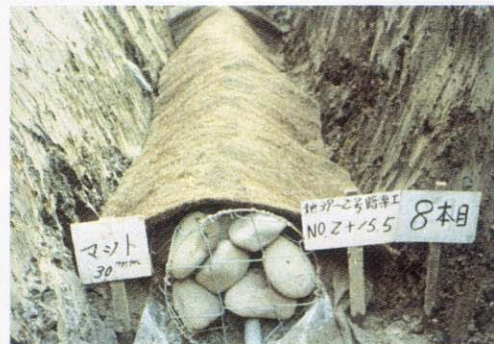
Fig. 5-7 Construction of an interceptor drain

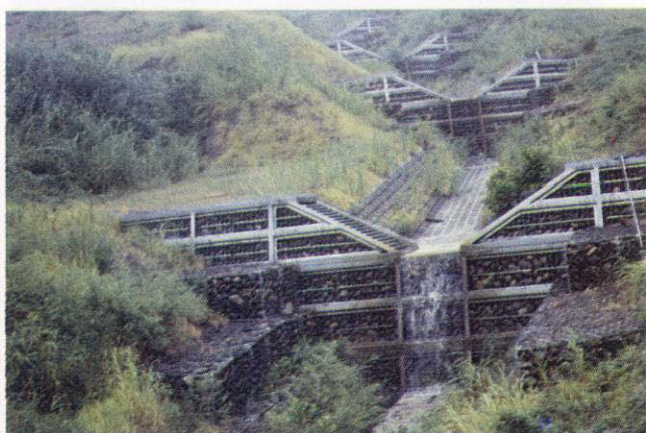
Fig. 5-8 A groundsil using flexible steel frames

Groundsils are constructed in an area where a torrent or a river erodes severely at the lower part of a landslide. A check dam and river revetment works are jointly used. In order to cope with a deformation due to a landslide flexible steel frames are widely used.

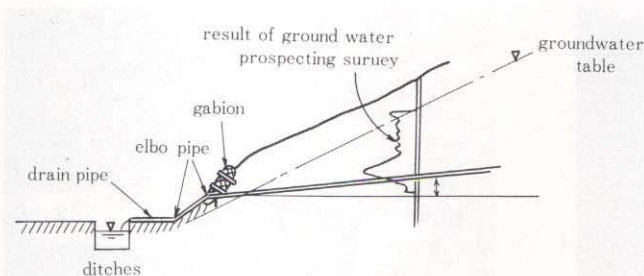
Horizontal drainage boring works with 30 to 50 m length are used to drain shallow ground water lying below 3 m from the ground surface. Where the bore hole reaches an aquifer, perforated pipes (mainly vinyl chloride pipes or iron pipes) are inserted around the aquifer, and the outlet of the drain pipe is protected with gabions or concrete walls.

Fig. 5-9 Horizontal drainage works

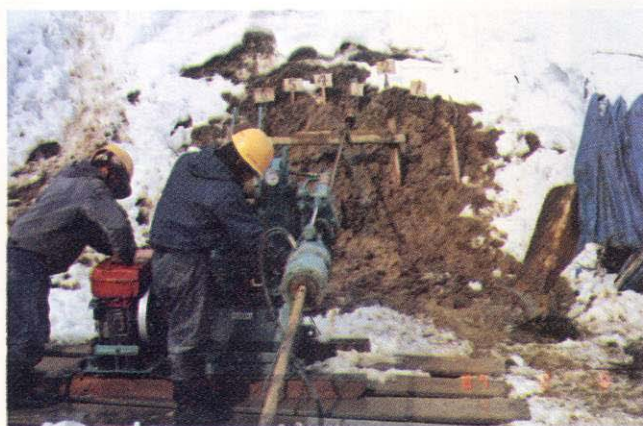
Fig. 5-10 Drilling works for subsurface drain

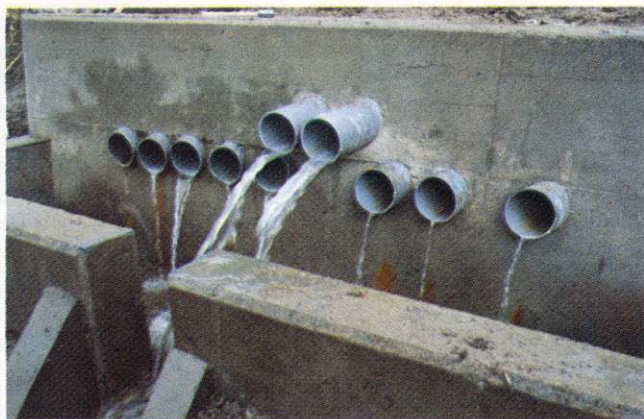
Fig. 5-11 Outlet of horizontal drain pipes

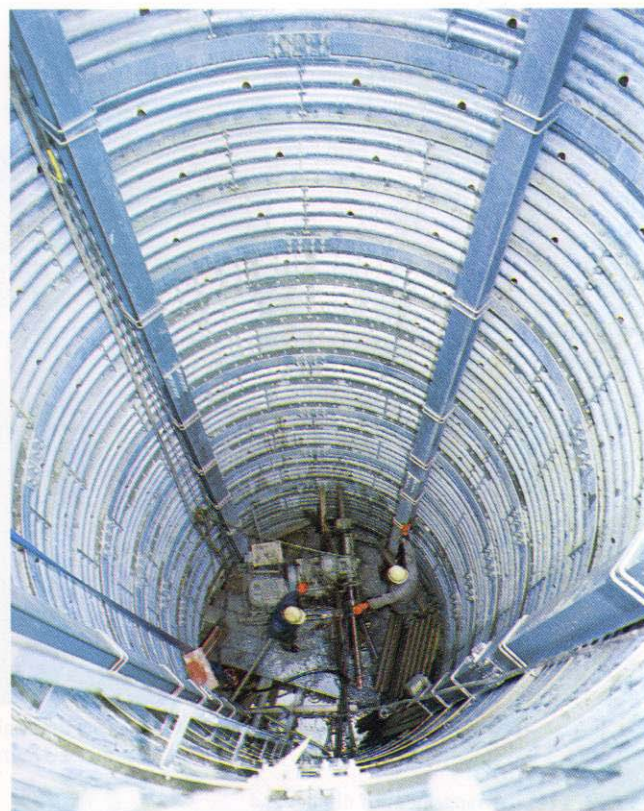
Fig. 5-13 A drainage well using steel materials

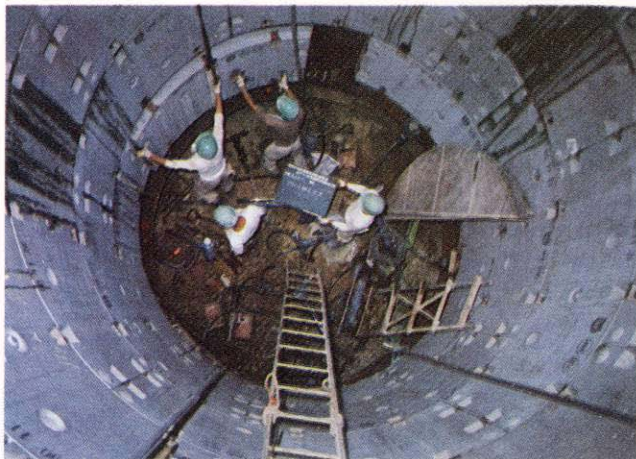
Fig. 5-14 A drainage well using reinforced concrete segments

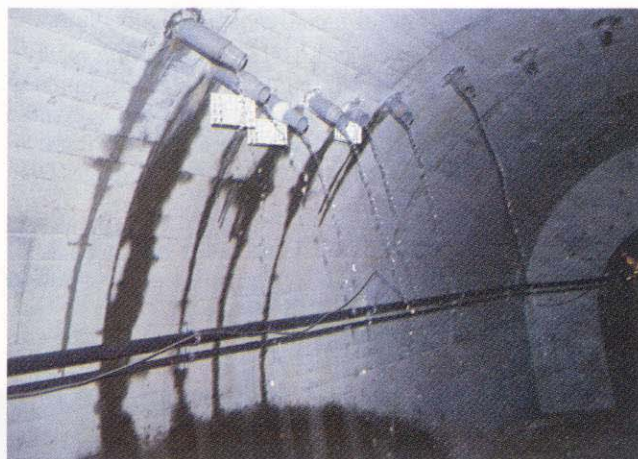
Fig. 5-16 Inside of a drainage tunnel

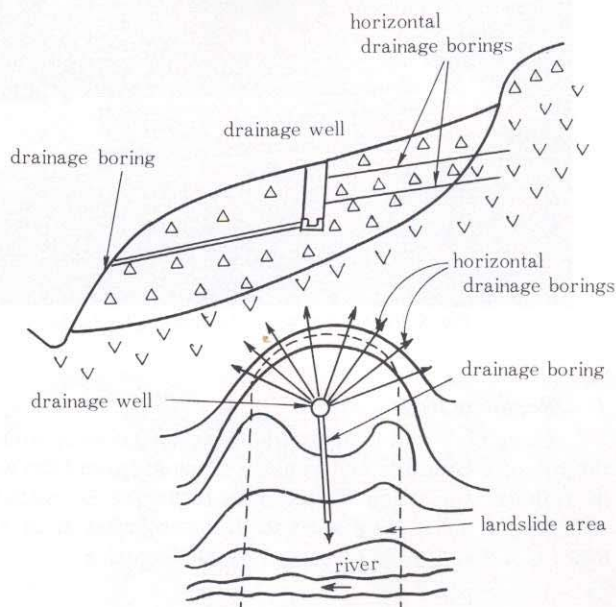
Drainage wells with 10 to 25 m depth and 2.5 to 4.0 diameter are constructed at a site with relatively stable ground. The well bottom and its surroundings are covered with concrete, and discharge of water is achieved through a lateral drilling or tunnel with the length of less than 100 m from the well bottom.

Lateral drillings are made through the well wall with the length of 30 to 50 m. Usually, arrangement of two rows consisting of about 16 to 24 drilling holes is adopted.

Fig. 5-12 Drainage well work

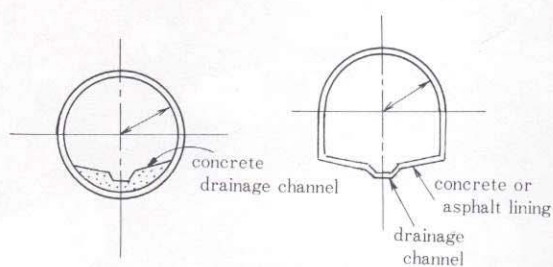
Fig. 5-15 Cross section of drainage tunnels

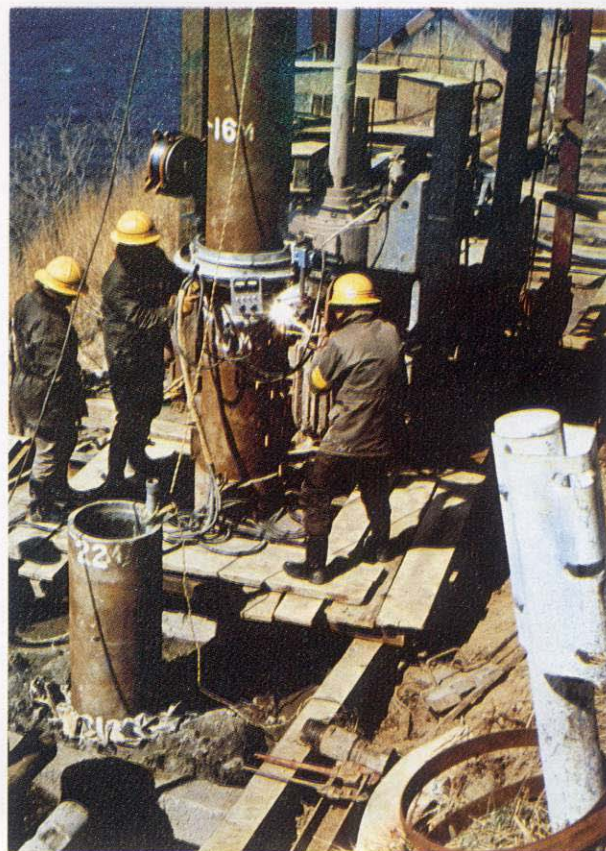
A 10 to 40 m hole with 30 to 50 cm diameter is made by drilling mainly at the lower part of a landslide to insert a steel pile, thick steel pile, cast-in-place reinforced concrete pile or composite pile reinforced by H steels inserted in a steel pile.

Fig. 5-17 Pile works

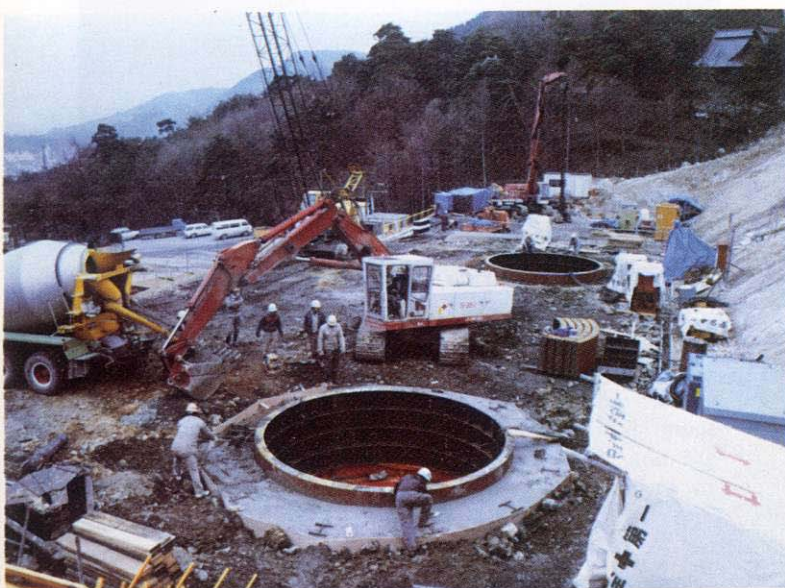
In these works, a well with 10 to 40 m depth is mechanically or manually dug for constructing a cast-in-place pile with 1.5 to 5 m diameter to place reinforced concrete. This technique is applied, where the ground condition in the landslide area does not allow the use of large-sized boring, driving force of the landslide is too strong to use an ordinary pile, or the bending moment yielded in the pile is too large.

Fig. 5-19 Under construction of the cast-in-place piles

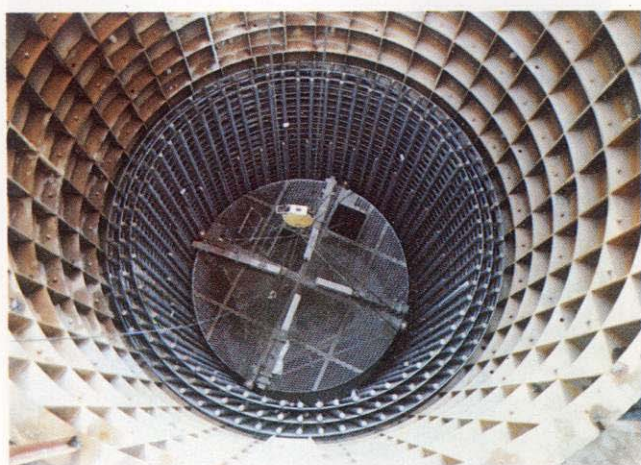
Fig. 5-18 Inside of a shaft using steel segments

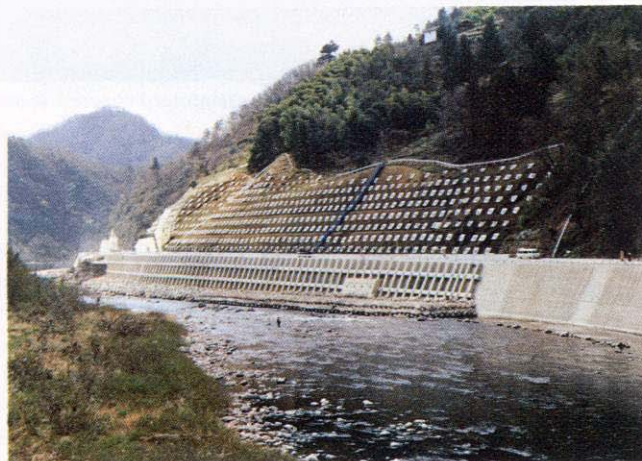
In recent years, anchor works have been widely adopted to detain a landslide. Anchoring works are economical method, because highly strong steel members can be used in relatively small holes as tensile members.

It is a method to add detention force at the lower part of a landslide, and thus applied in an area with steep ground surface where steel pile works are not adequate because of a failure at the downside of the piles. Steel bars or steel wires can be used as tensile materials, and drilling holes for steel members are 116 to 150 mm in diameter.

Fig. 5-20 Anchor works to detain a landslide

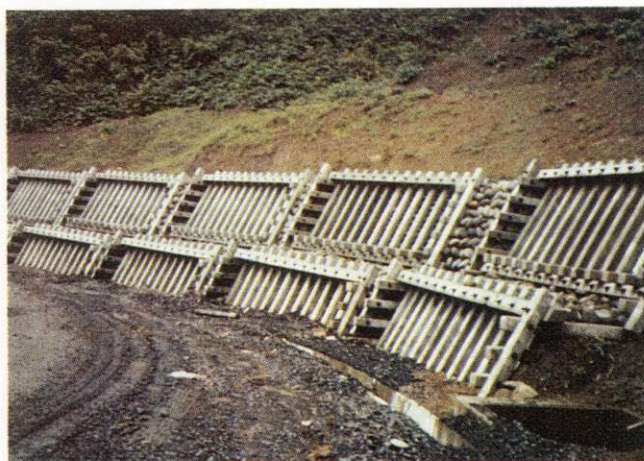
A retaining wall (usually frame, gabion) is built around the toe of a landslide and banking is made around the wall to stabilize the whole slope. This technique is especially effective in controlling a landslide with upheaval at the lower part and a landslide caused by earth cutting.

Fig. 5-21 An example of retaining wall works

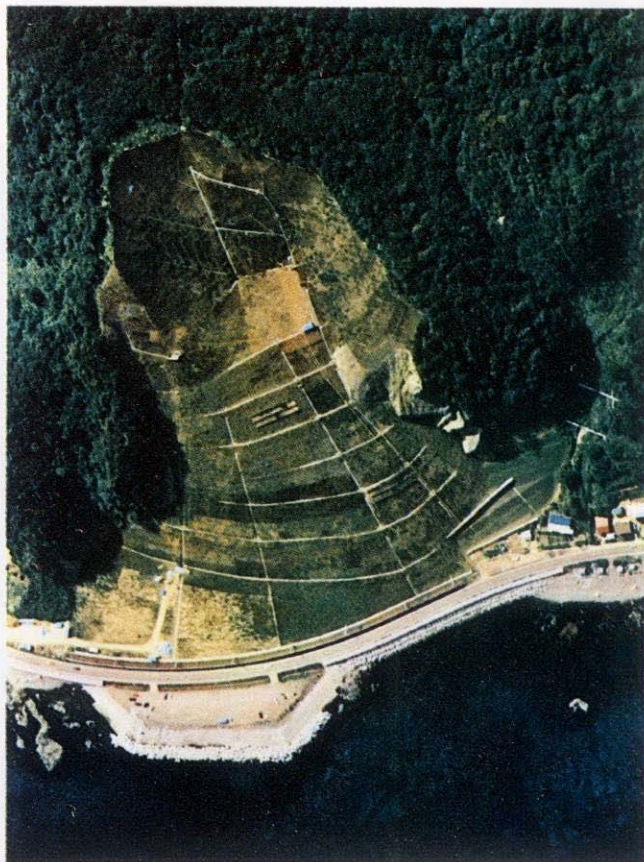
Condition after completion of control works (August 1983)

Control Works The control works consisted mainly of a counterweight fill works at the foot of landslide and soil removal works at the top of the slide. Then the surface drainage works and retaining-wall works were constructed.

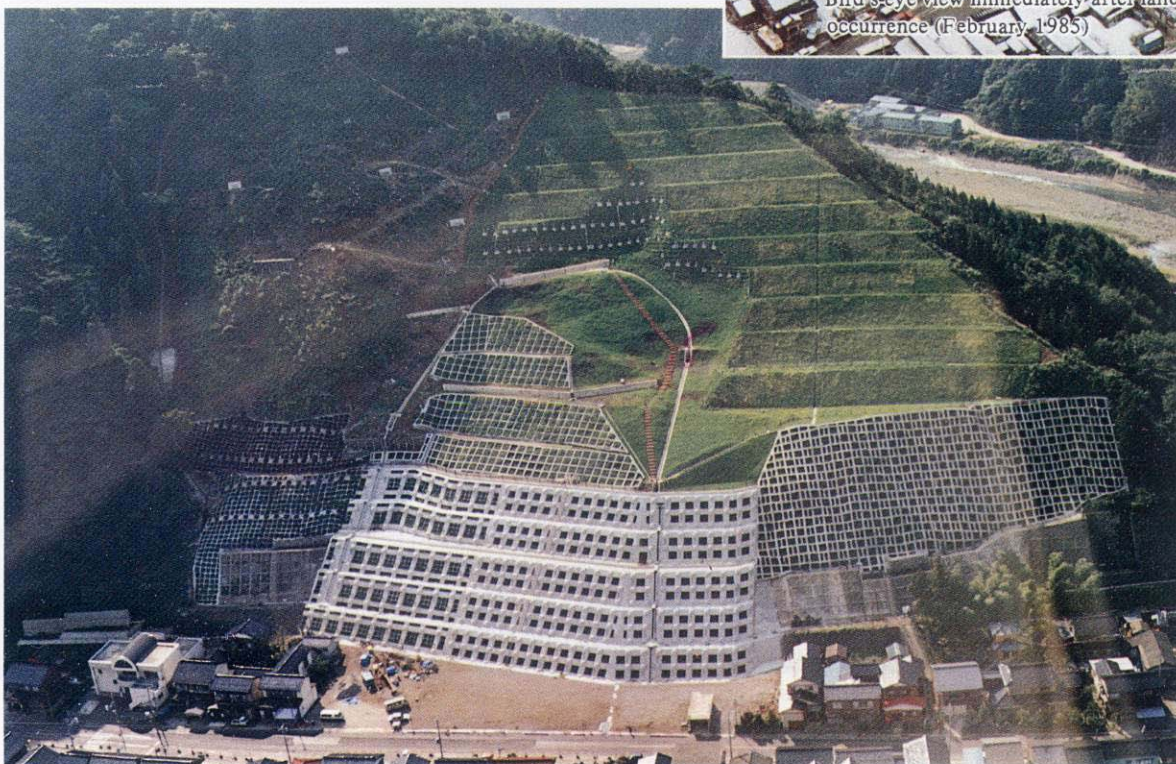
Condition after the completion of control works

Control Works Major control works include anchoring works, soil removal work, piling, and drainage borings.

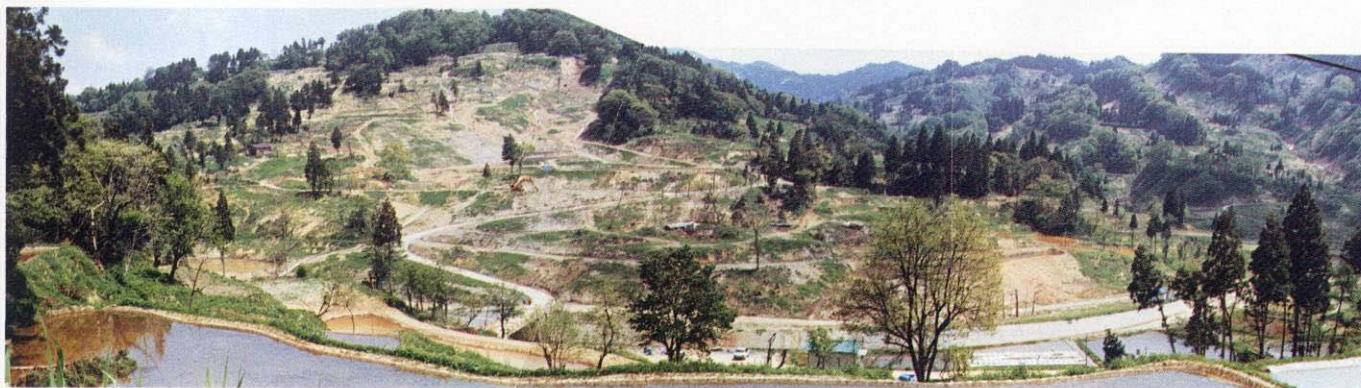
Condition during control works

Control Works Ground water which caused the landslide exists in a huge quantity under more than 10 m from surface, and it is highly related with the rainfall. Thus, ground water drainage works mainly by drainage well works, and shallow ground water drainage works by open culvert channels works have been conducted.

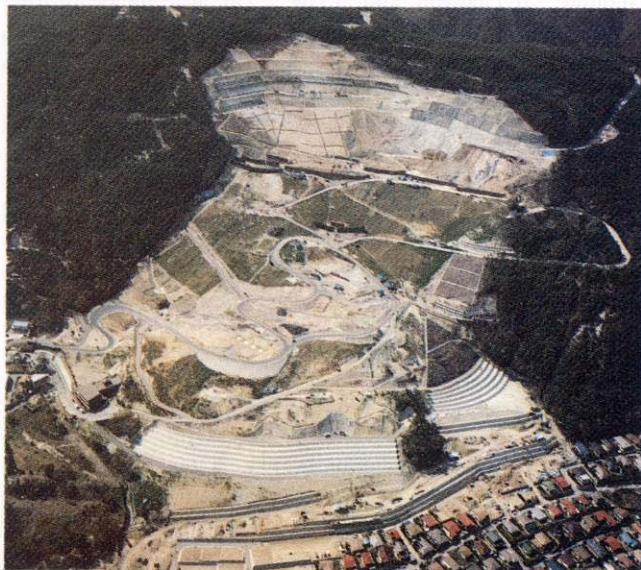
Condition under control works (April 1987)

Control Works Since the land mass stood still after sliding, control works and restoration works were immediately conducted. The control works include; drainage wells, large diameter cast-in-pile works, drainage tunnels, anchor works, pile works and surface drainage works.

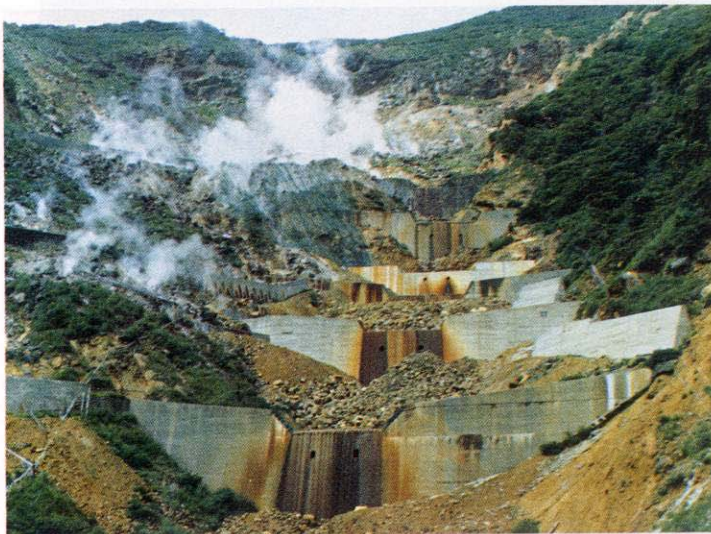
Sounzan area

In Sounzan, a failure took place at the source of the Suzawa dale in July 1953. The resultant debris flow reached about 2 km downstream at the average velocity of 7 m/sec. The collapsed material was 800,000 m³. The debris flow buried about 7 ha of forestry and destroyed 17 erosion control dams.

The cause of the landslide is in a conical depressed ground at the head of the Suzawa dale, surrounded by a steep slope characterizing an explosion crater. Exhalation of hydrogen sulfide and hot fluid resulted in the hydrothermal process of the base bedrock between 20 and 25 m in depth, forming an unstable condition of the lapilli.

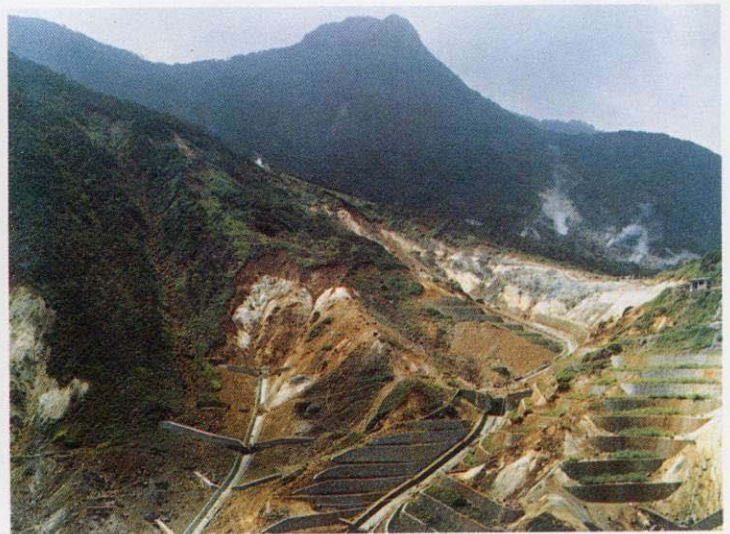
Owakudani area

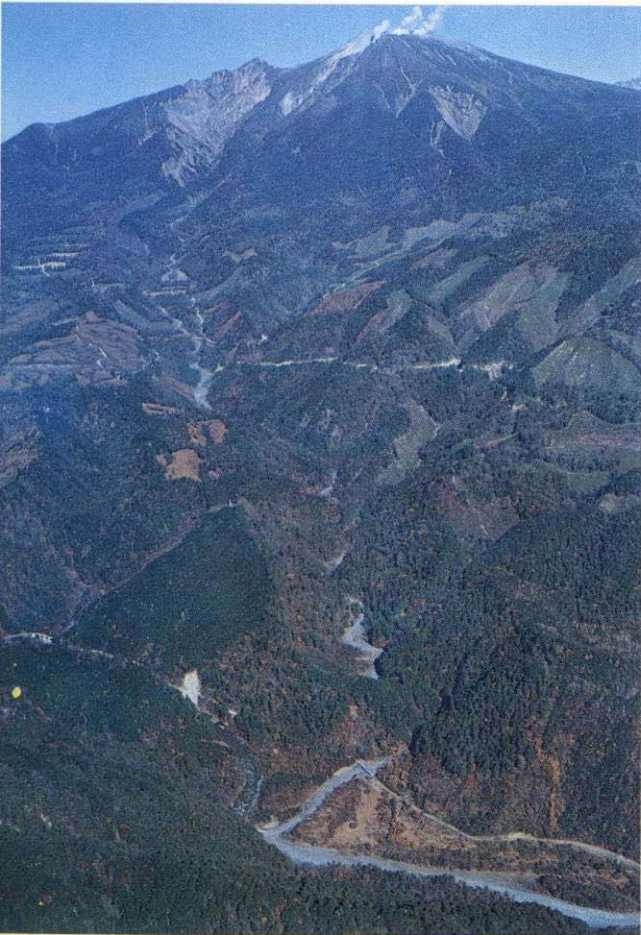
Nigorisawa before landslide occurrence (1984)

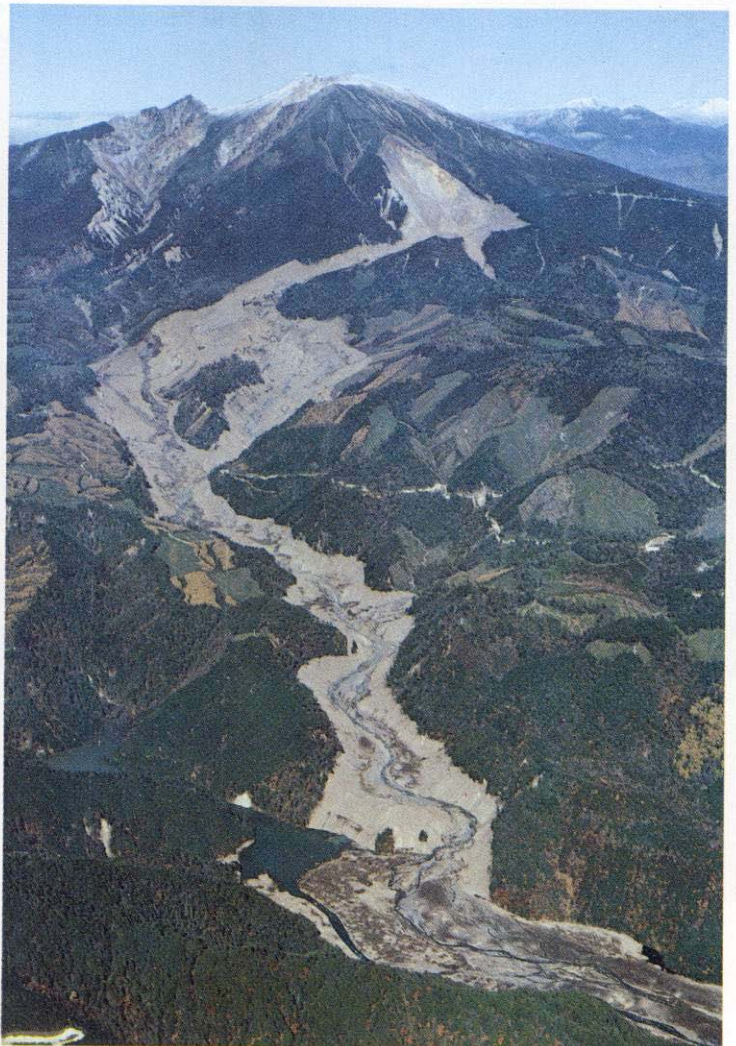
Bird's-eye view of Nigorisawa immediately after landslide occurrence (October 1984)

Control Works A huge amount of the deposit in River Denjo and River Otaki was fixed with erosion control dams, and planting was carried out to control ground surface erosion on the devastated slope and the landslide area.

Control works implemented by the end of 1986: Twenty six concrete dams, 13 block dams, 22 steel framing dams, 450 m revetment works, and 120 ha slope works.

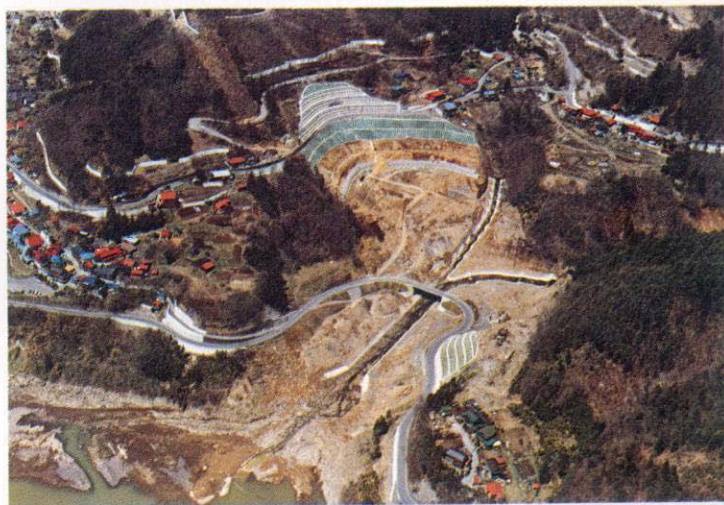
Bird's-eye view of Matsukoshi after the completion of control works (April 1986)

Control Works Two drainage wells, horizontal drainage works, interceptor drains, and restoration works for road, bridge, and river.

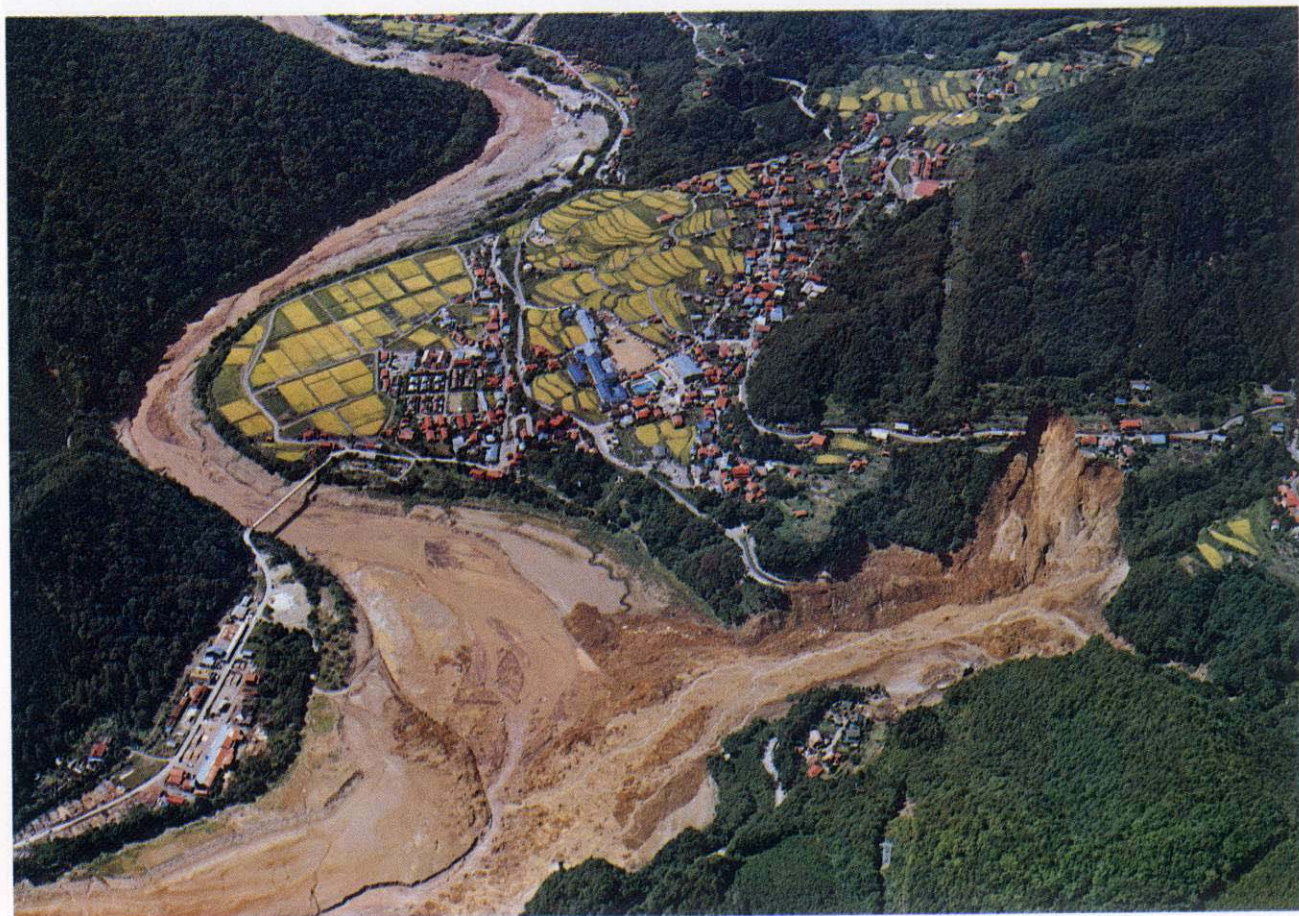
Bird's-eye view of Matsukoshi immediately after landslide occurrence (September 1984)

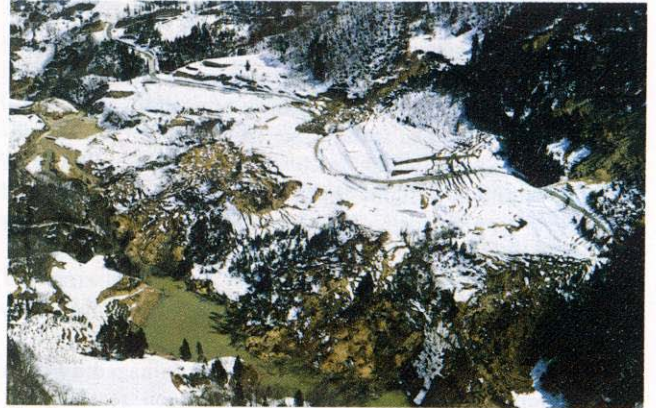
Bird's-eye view immediately after landslide occurrence (April 1985)

Damage In April 1984, a landslide broke out, forming a main scarp of 20 to 40 m height at the head. In the middle part, a road was moved horizontally by 15 to 30 m, and a field swelled or inclined. On the other hand, at the toe of the landslide, the slide material buried River Kosei about 90 m, resulting in the formation of a landslide lake for 500 m length in the upstream area.
