LANDSLIDES IN JAPAN

The Japan Society of Landslide
National Conference of Landslide Control

1 9 8 8

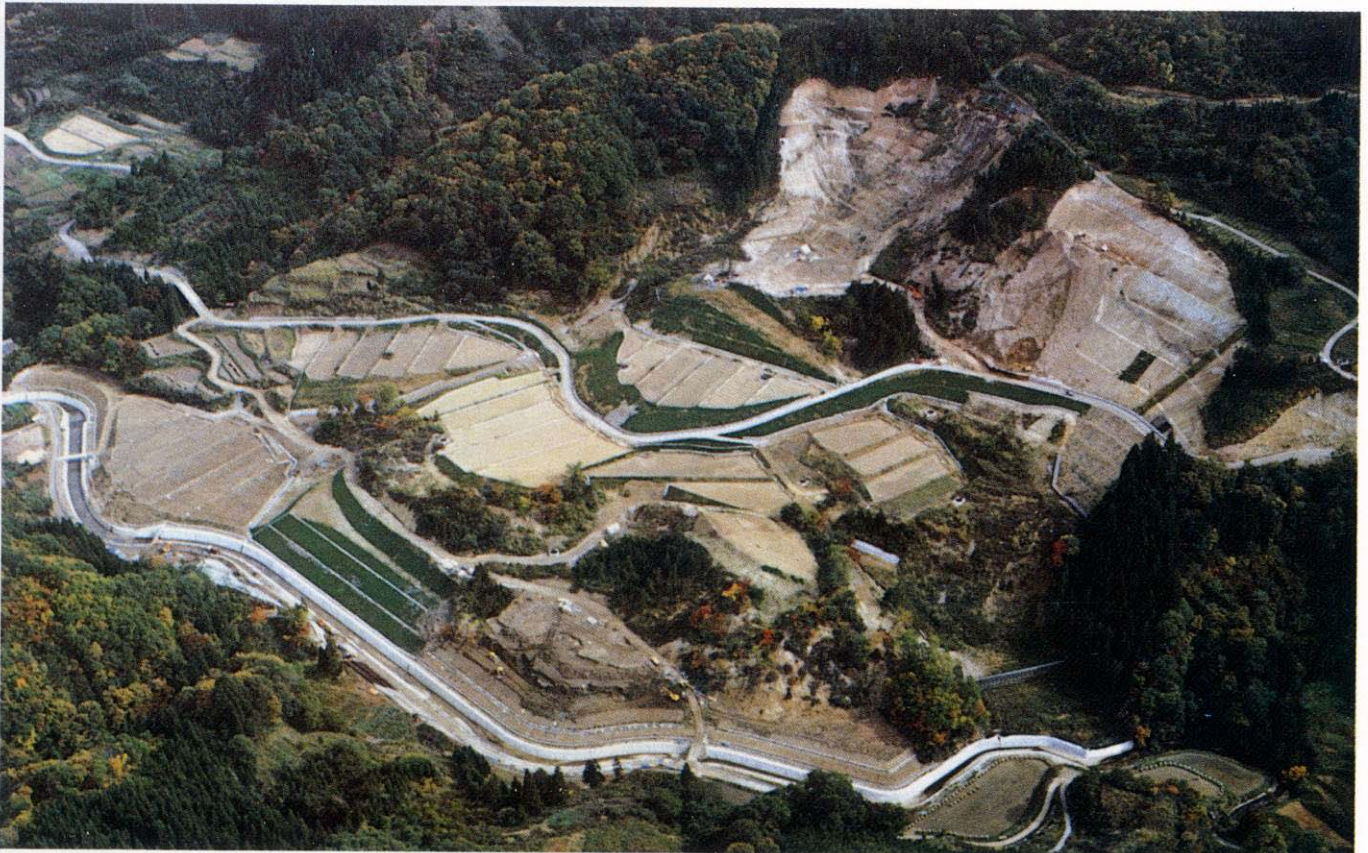
Condition during control works (November 1986)

Control Works Retement works, drainage well works, horizontal drainage works, pile works, interceptor trench, concrete cribe works, and soil removal works.

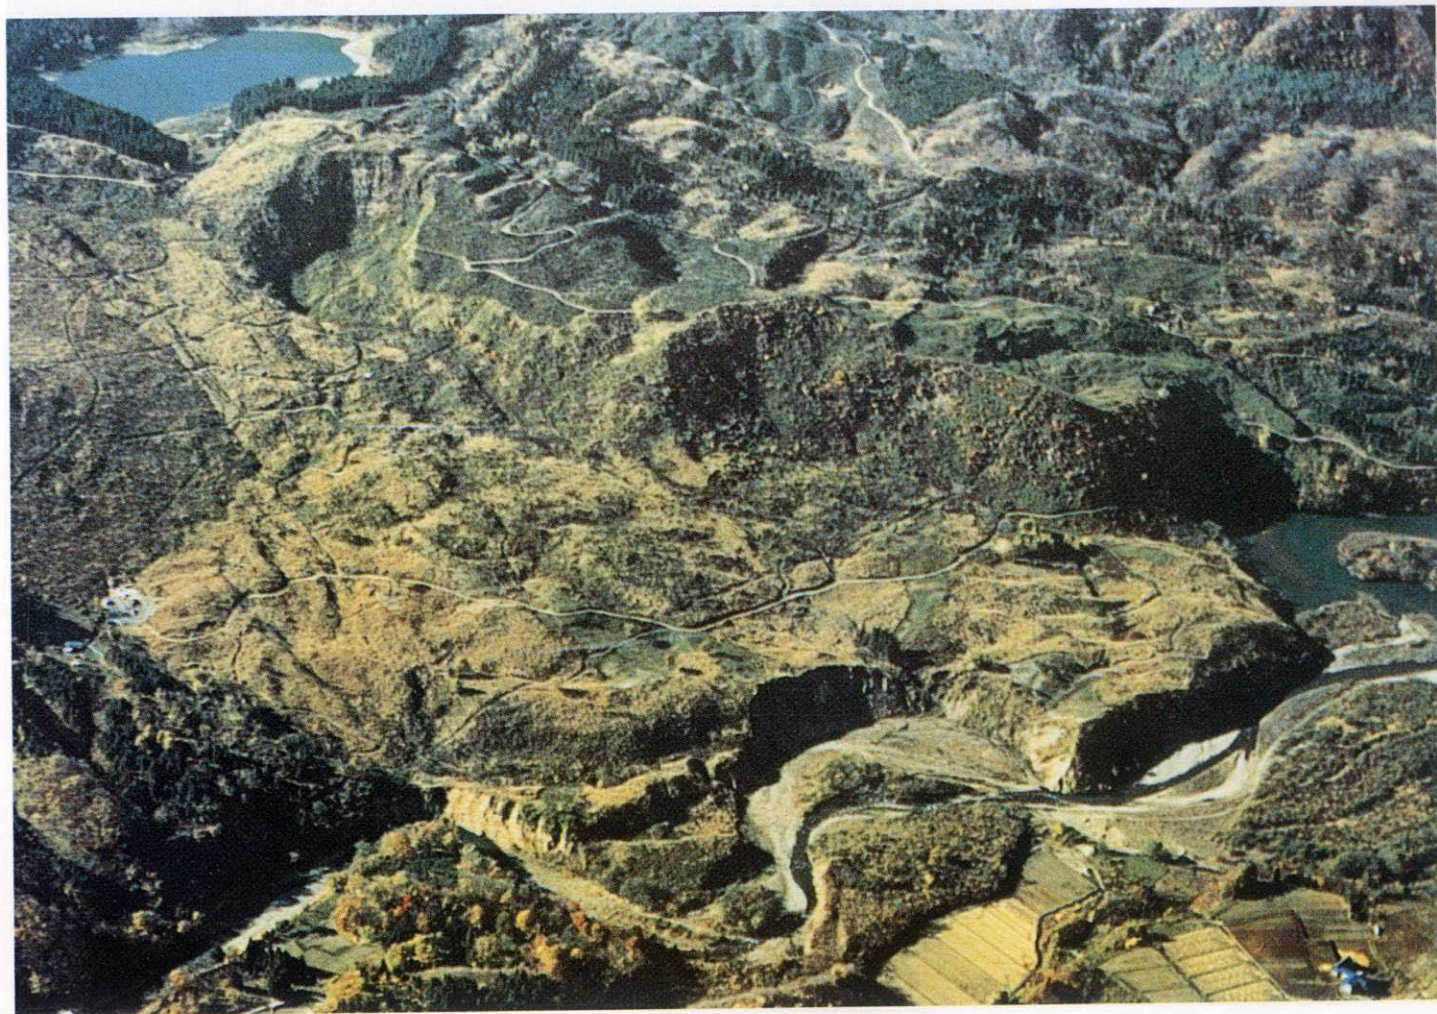
Bird's-eye view

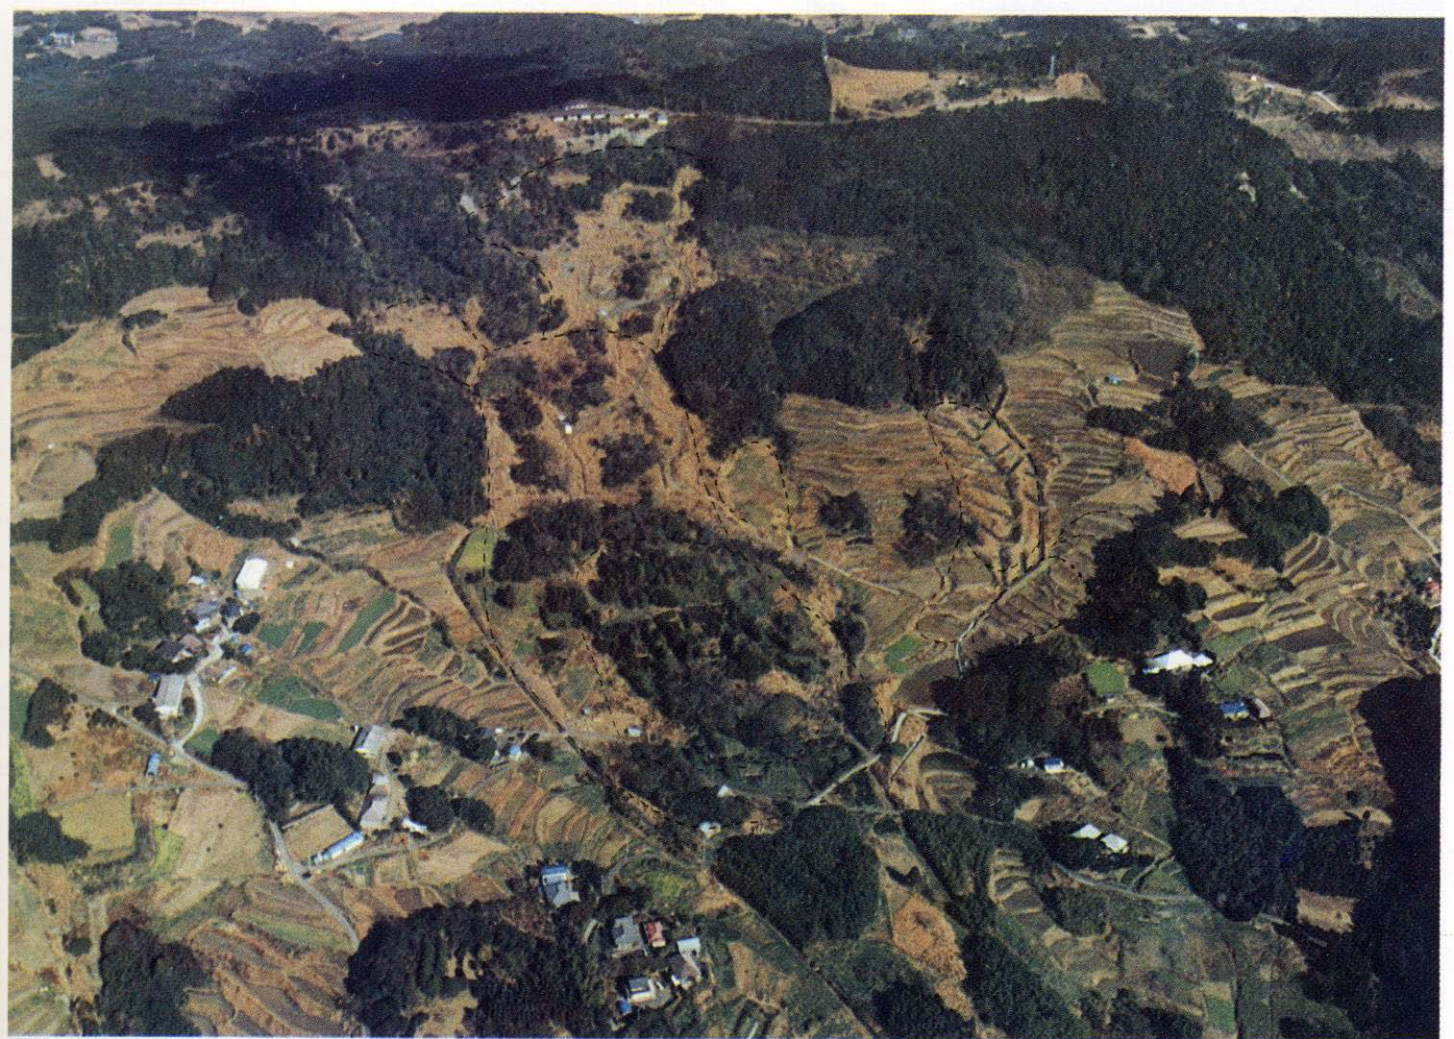
Bird's-eye view of landslide site

Present Condition The area which slide in 1952 and 1979 maintains a certain degree of stability, but in the adjoining east slope, an active sliding has been observed since June 1984 with resultant devastation in the range of 300 m length, 70 m in width, 5 m in depth and 1.7 ha in area. Implementation of surface water drainage works have led to stabilization of the sliding.

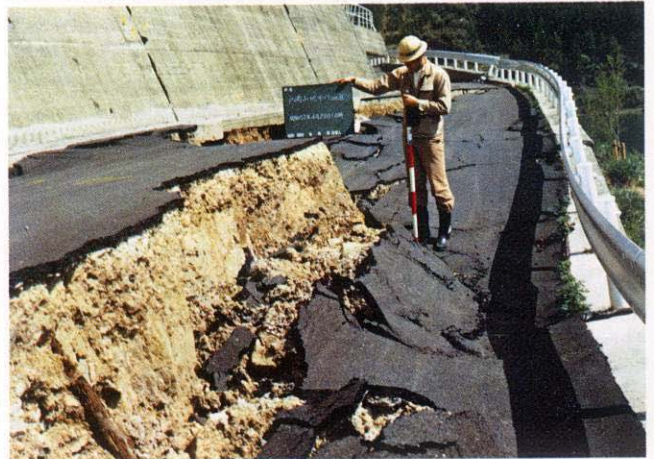
Crack occurrence at landslide head (April 1982)

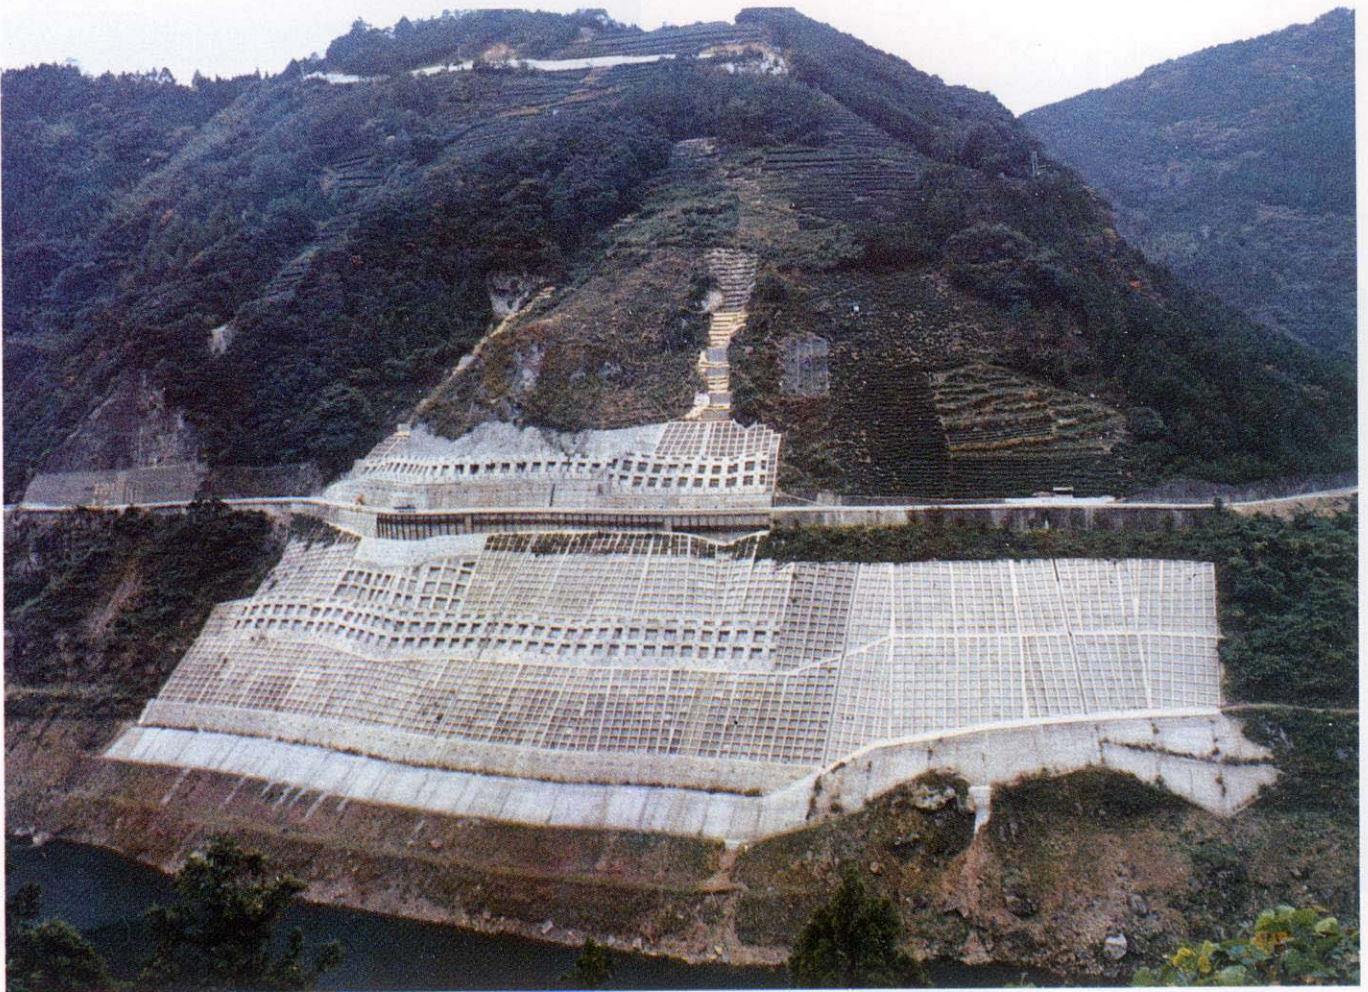
Condition after the completion of control works

Control Works Anchor works; In addition to this, hill side works and sodding works were conducted.

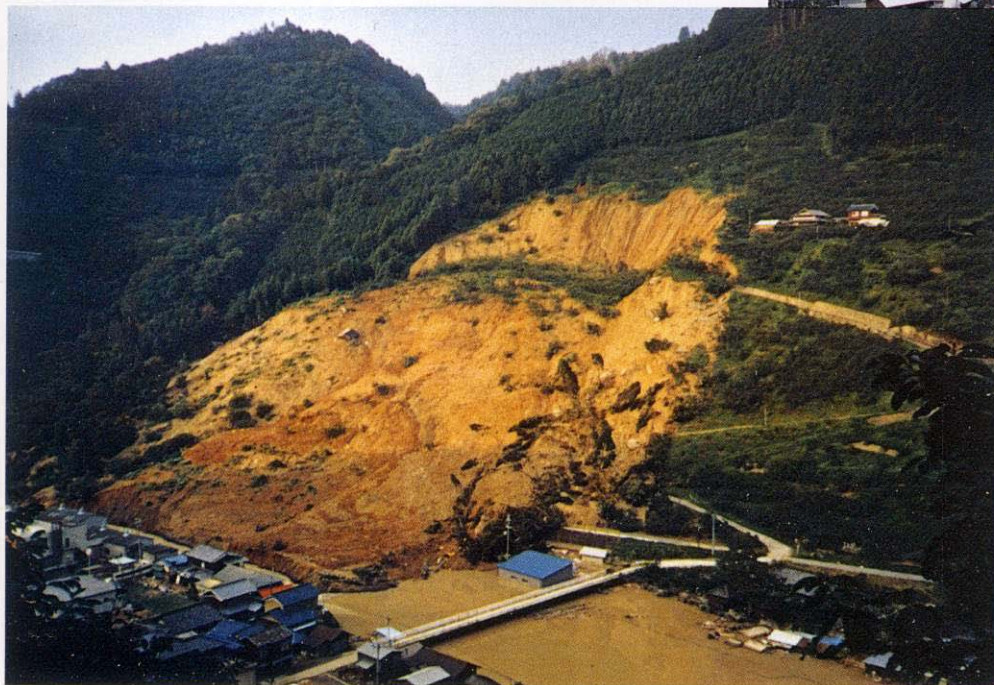
Condition immediately after landslide occurrence (August 1982)

Damage The landslide occurred twice at 2 a.m. and 8:25 a.m. on 4 August 1982. The sliding mass blocked Nyuu River, resulting in the damage of houses, field and a road inundated. A sign of landslide was perceived in advance, which fortunately allowed the people to take an appropriate evacuation with no casualties to humans.

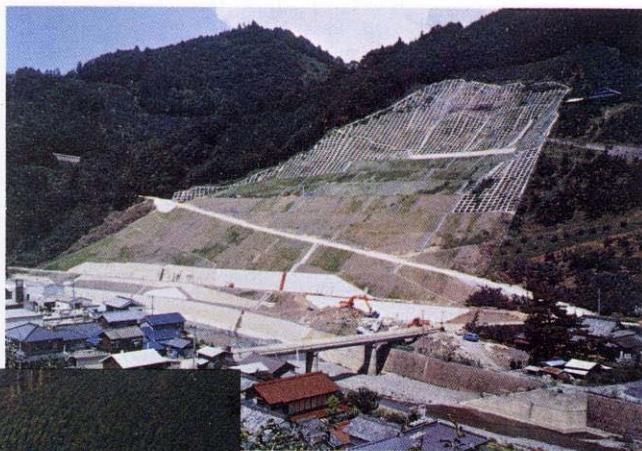
Condition after the completion of control works

Control Works Since the soil removal works was required to ensure the river cross section and to restore the road, mainly soil removal works and trimming hillside works at the head of the slope were conducted. In addition, to be protected such as houses, the river and the road, pile works were made to ensure higher factor of safety.

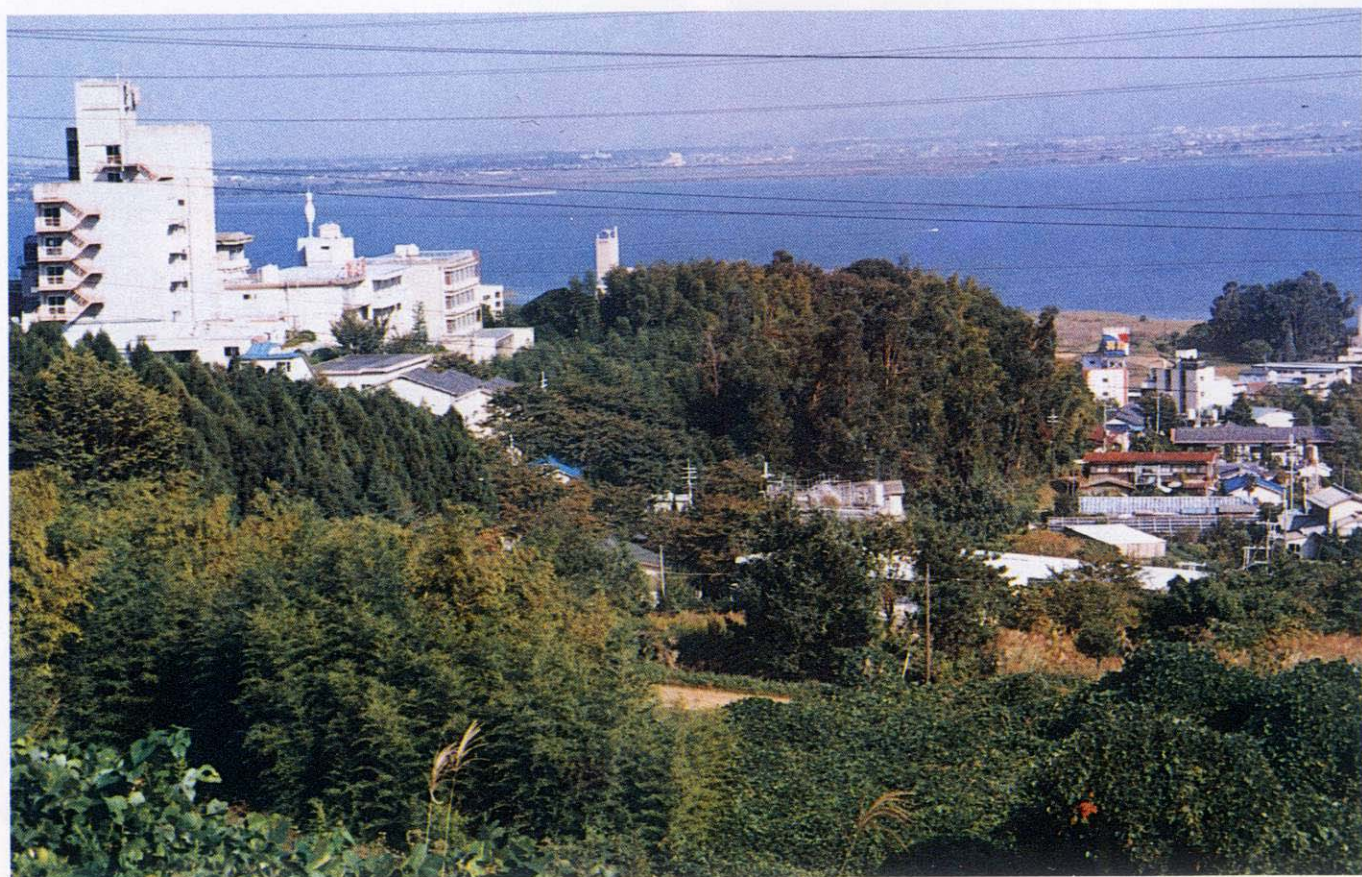
Bird's-eye view of landslide

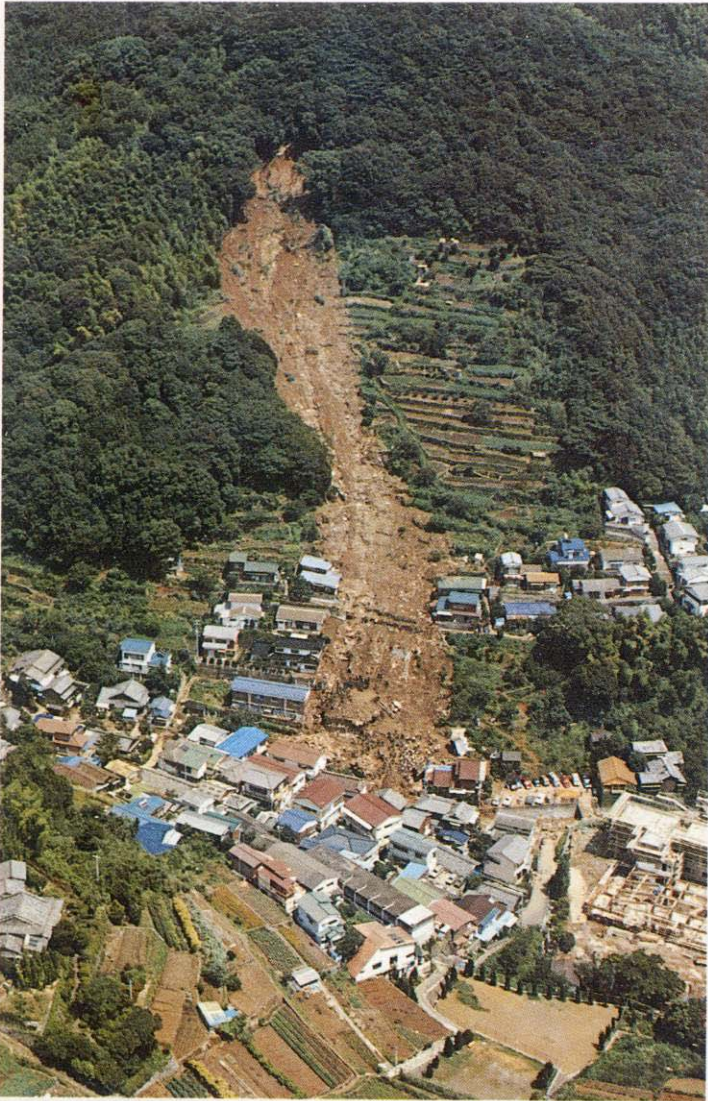
Condition of Narutaki Area immediately after the calamity occurred (July 1982)

Width of the slope failure; 40 m, Length; 300 m, Average slope inclination; 22° .

In Narutaki a slope failure occurred at the upper part of the slope, and the majority of the sliding mass was left on the slope. But the sliding mass eroded the talus deposit and weathered rocks in the lower slope, turned into a debris flow and struck houses at the toe of the slope forming a mud flow.

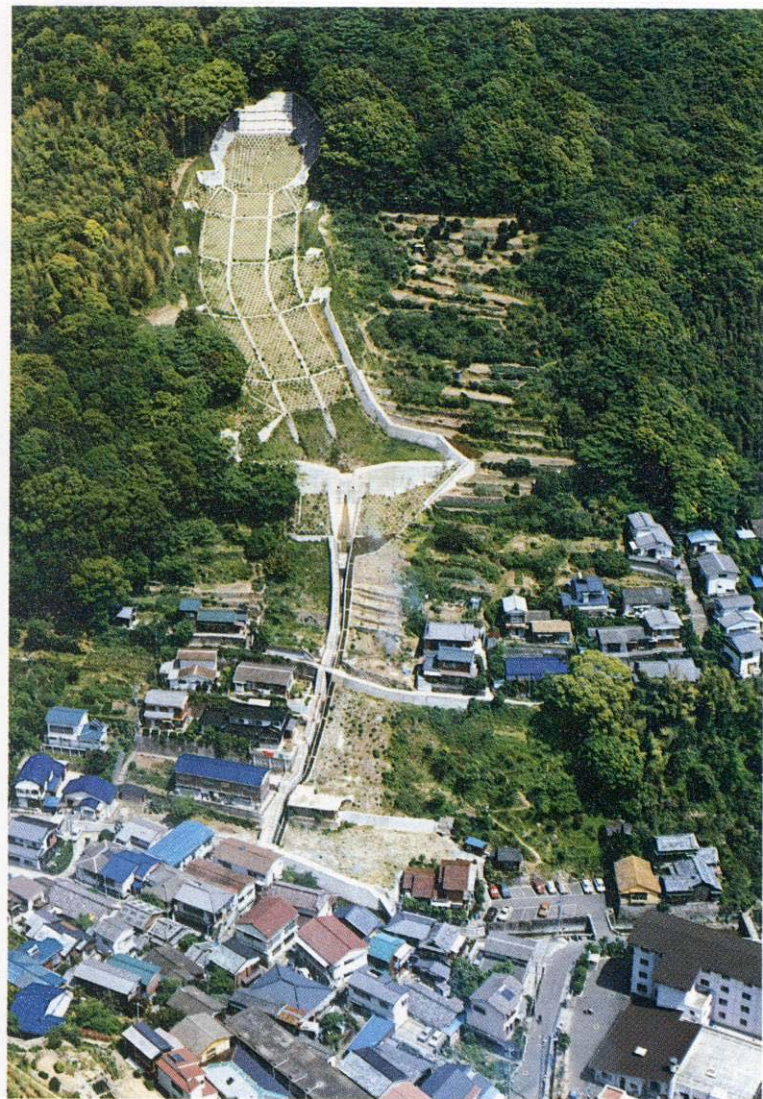
Condition of Narutaki Area after completion of control works

Small check dam, retaining walls, interceptor trench and slope stability work, hillside work, spraying, covering, planting and revetment works.

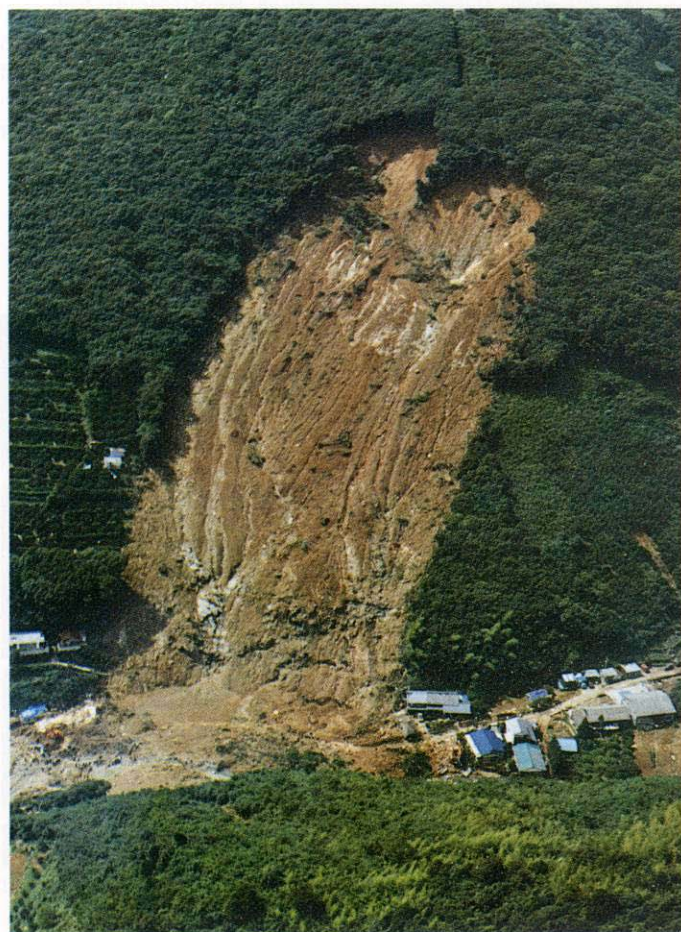
Condition of Okuyama Area immediately after calamity occurred (July 1982)

Width of the slope failure: 120 m, Slope length; 285 m, Average slope inclination; about 25° , Volume; $16,800 \text{ m}^3$.

In Okuyama, slope failure in heavily weathered rocks at the upper part of the slope and erosion of the debris and heavily weathered layer in the lower part caused slope collapse in a wide area.

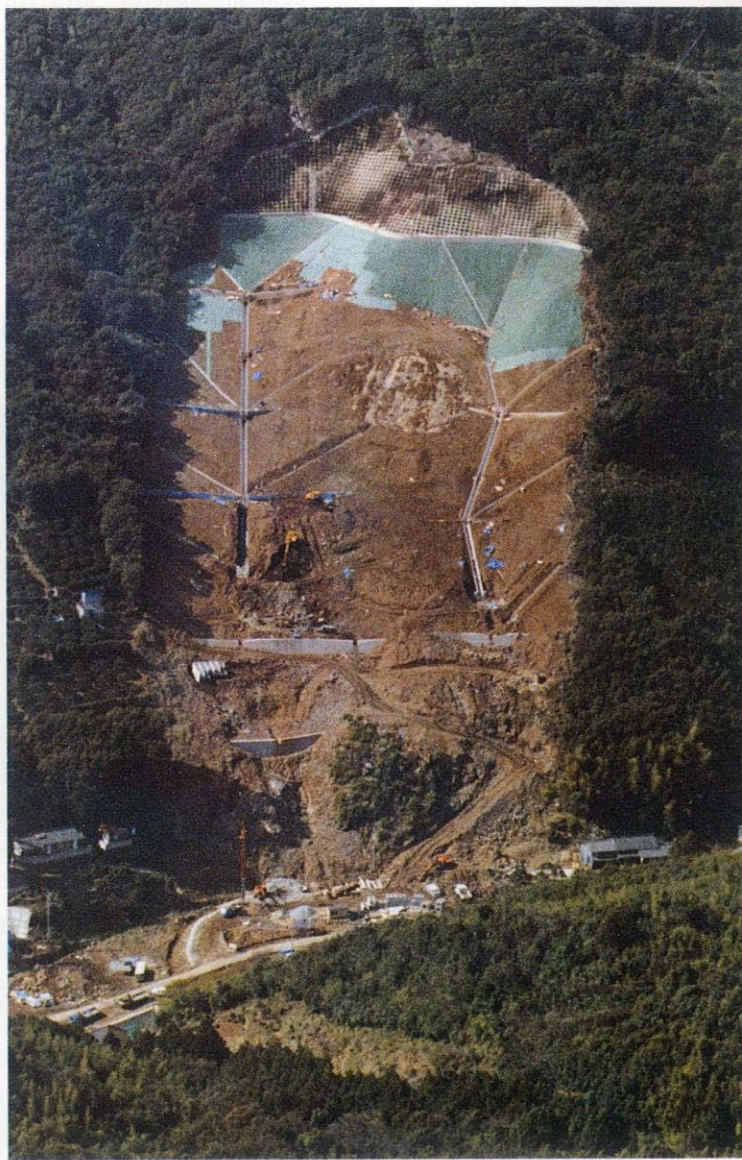
Condition of Okuyama Area during control works

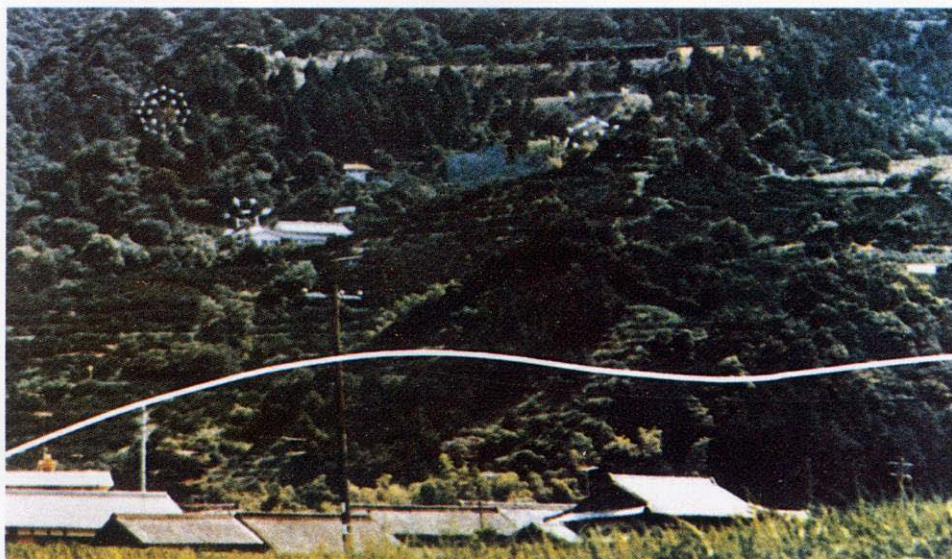
Condition prior to landslide occurrence. White line shows a superhighway scheduled to be constructed.

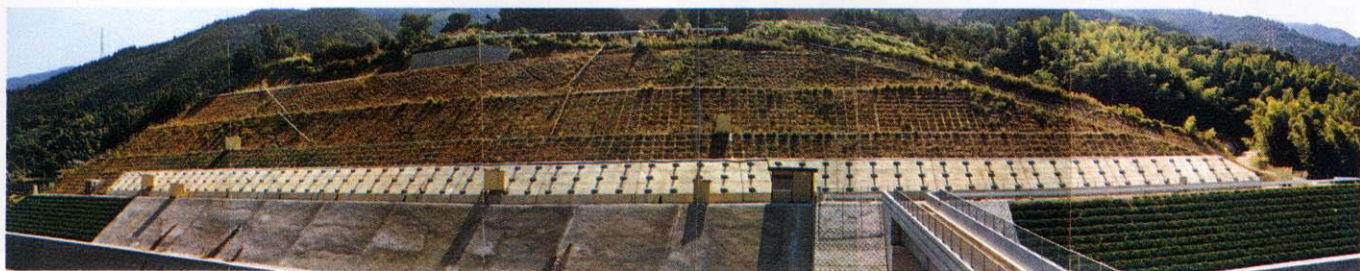
Condition during control works

The control works were completed in March 1984, and results of the behavior observation indicate a tendency of stabilizing after the completion of the works. For monitoring of the ground, observation will be conducted for another several years.
