# LANDSLIDES IN JAPAN

(The Fifth Revision)

The Japan Landslide Society  
National Conference of Landslide Control

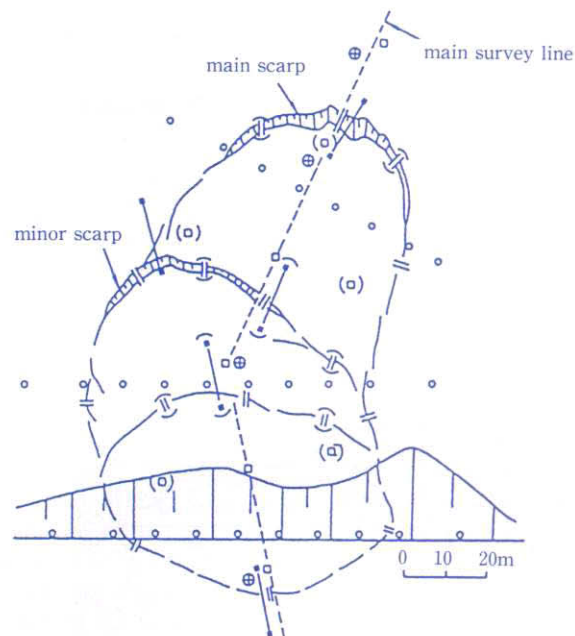
**Fig. 13** Example of instrumentation

- Explanation
- Borings { Ground water measurement  
Subsurface strain measurement  
Inclinometer  
Geophysical logging
  - Extensometer
  - Simple deformation detection method (Boards)
  - ⊕ Tiltmeter
  - Transverse survey stakes
  - ( ) May be possible to eliminate under certain condition

Instrumentation used for the surface deformation investigation includes extensometers, ground tiltmeters, movement determination by survey methods including transverse survey, grid survey, laser survey from the opposite bank, movement determination by aerial photographs, and G. P. S. (**Fig. 13**)

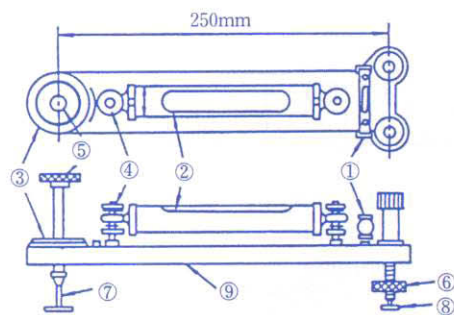
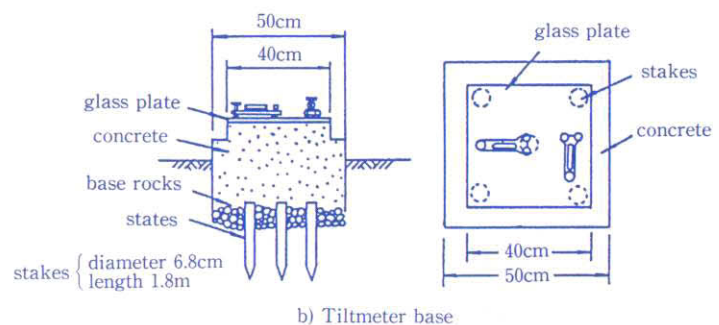
Fig. 16 Installation of tiltmeter

- (a) Structure of a bubble-tube type tiltmeter
1. Subsidiary levels
  2. Primary levels
  3. Panel
  4. Level adjustment nuts
  5. Primary legs turning nuts
  6. Primary legs adjusting nuts
  7. Main legs
  8. Supporting legs
  9. Level plate

The ground tiltmeter is useful for determining the deformation at the head and toe portions and sometimes along the flanks of the landslide, or to assess the possibility of future deformation. A level type tiltmeter is most conventional. The tiltmeter is capable of measuring the N-S and E-W components (Fig. 16). The magnitude of tilting and tilt directions can be determined directly from the instrument panel. Furthermore, in order to determine the characteristics of the deformation, the results are shown chronologically along with the daily rainfall totals. The relationship between the magnitude of tilting and the cumulative effect of tilting, rainfall totals and groundwater levels are shown on Fig. 17.

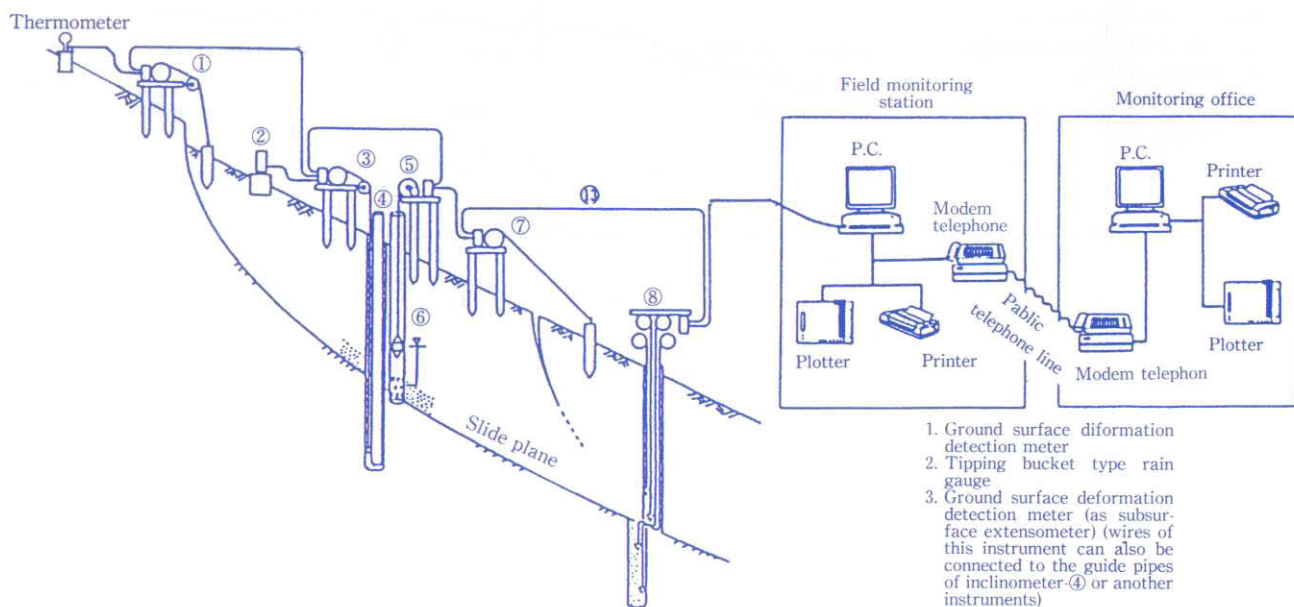
Fig. 19 Typical construction of landslide automatic survey system

1. Ground surface deformation detection meter
2. Tipping bucket type rain gauge
3. Ground surface deformation detection meter (as subsurface extensometer) (wires of this instrument can also be connected to the guide pipes of inclinometer-4 or another instruments)
4. Inclinometer
5. Ground water level measurement meter
6. Boring specifically drilled for ground water level measurements.
7. Ground surface deformation detection meter
8. Subsurface deformation detection meter (Multi-layer movement meter)
9. Portable computer
10. Floppy disk driver
11. Interface adapter, batteries
12. Spare batteries
13. Transmission cables

In the past, measurements of slope deformation have been performed manually. Recently, automatic survey systems using data loggers and computers have adopted (Fig. 19). The instrument set-up in the field has been designed for easy installation, and is weatherproof, durable, maintenance-friendly and economical (Fig. 20, 21, 22, 23). Through remote control in real time and rapid geographical data processing, it is possible to store long term data accurately and effectively and would provide an early warning of slide activity, thereby reducing landslide hazard. Furthermore, the recent development in the informationalized constructions systems and adopting the safety control at the construction site using the real time facilitates the planning through construction stage (Fig. 24).

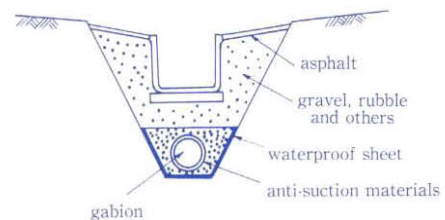
Fig. 36 An example of a drainage ditch with interceptor drain

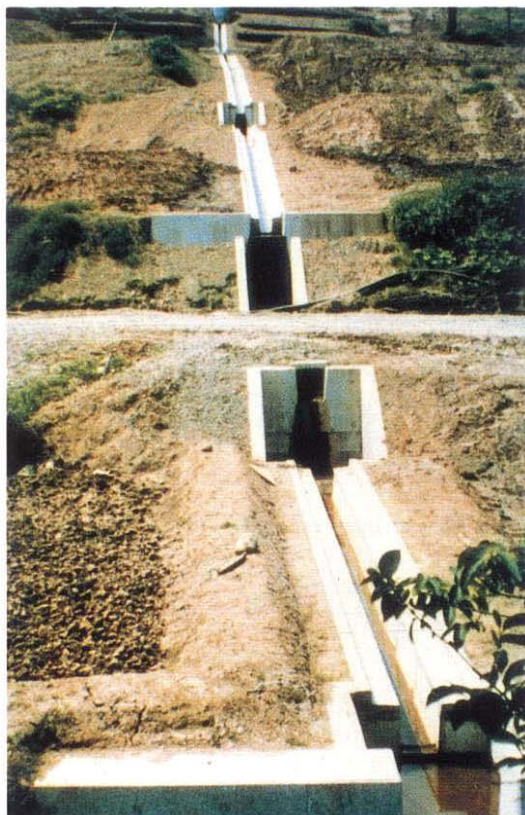
Fig. 37 Surface drainage ditches

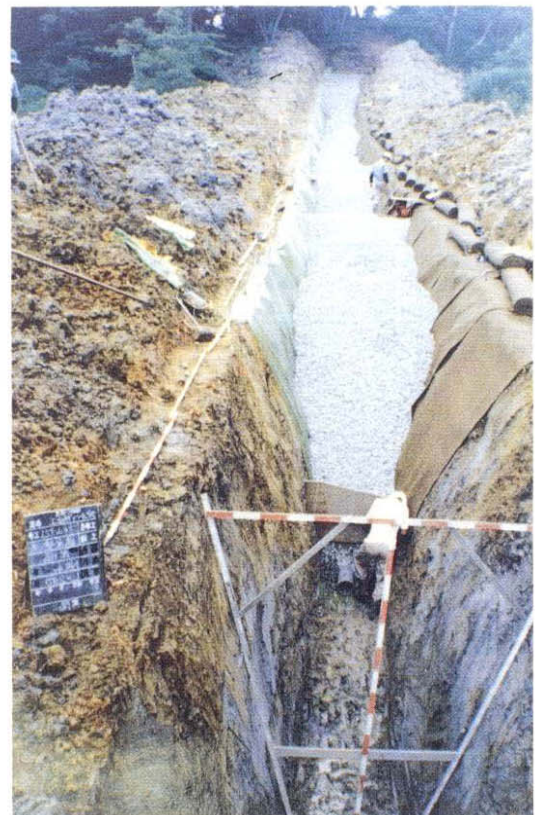
Fig. 38 Interceptor trench drains

Structurally, the interceptor trench drain is a combination of the interceptor under drain and surface drainag control, and are commonly used (Fig. 38).

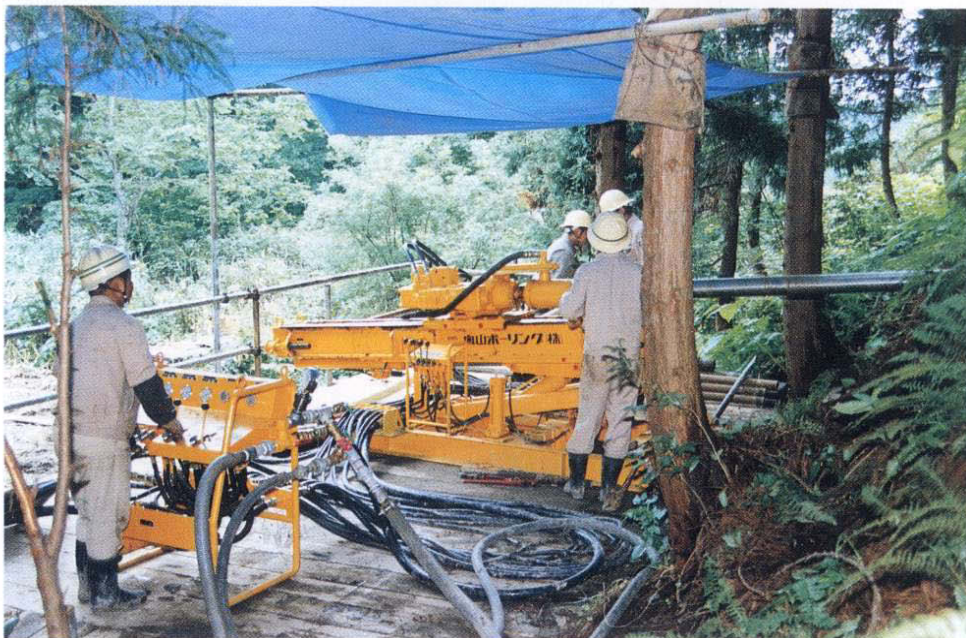
Fig. 39 Drilling works for horizontal gravity drains

In order to remove the shallow groundwater within about 3m from ground surface, 30 to 50 m-long horizontal gravity drains are drilled. The pipes could be either perforated P. V.

C. (polyvinyl chloride) or steel construction, and should be drilled at an angle of 10 to 15 degrees from the horizontal line (Fig. 39, 40).

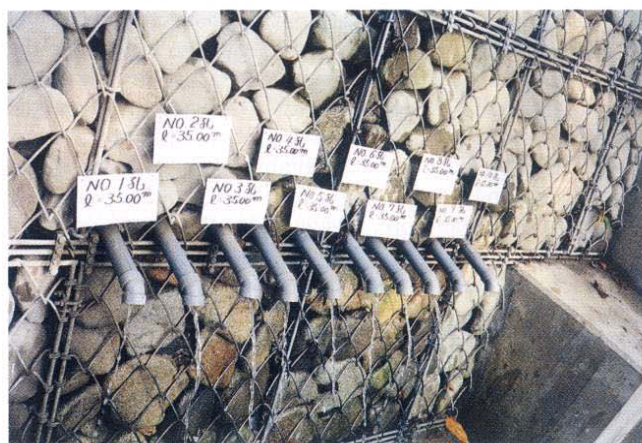
Fig. 40 Outlet of horizontal drain pipes

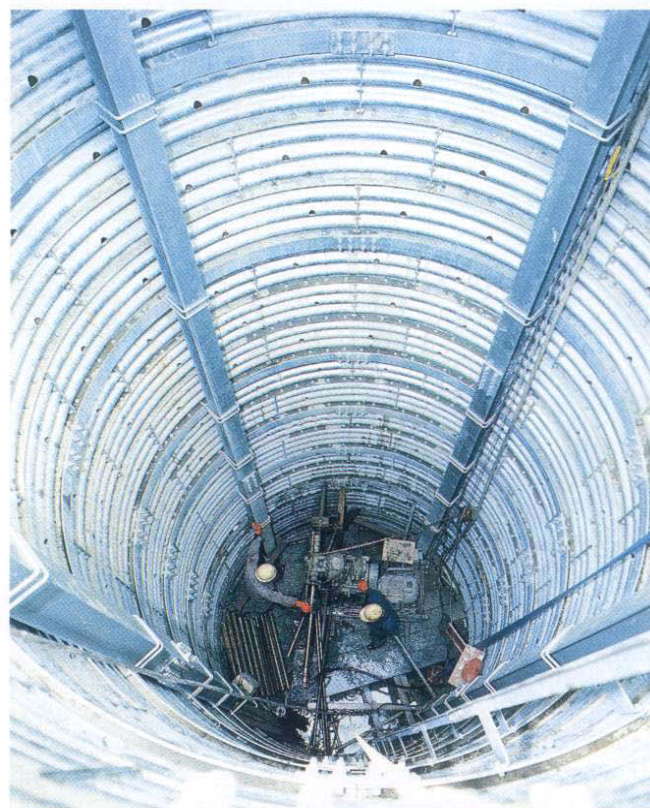
Fig. 41 A drainage well using steel segments

Drainage wells of up to 25m deep and at least 3.5m in diameter are excavated within areas of concentrated ground water. A series of radially-positioned horizontal gravity drains with multi-levels are drilled to collect the ground water into the drainage wells where the water can be removed through drainage tunnels. They are constructed of either steel or reinforced concrete segment, and concretes is used at the well bottoms and the upper portion of the well (Fig. 41, 42, 43).

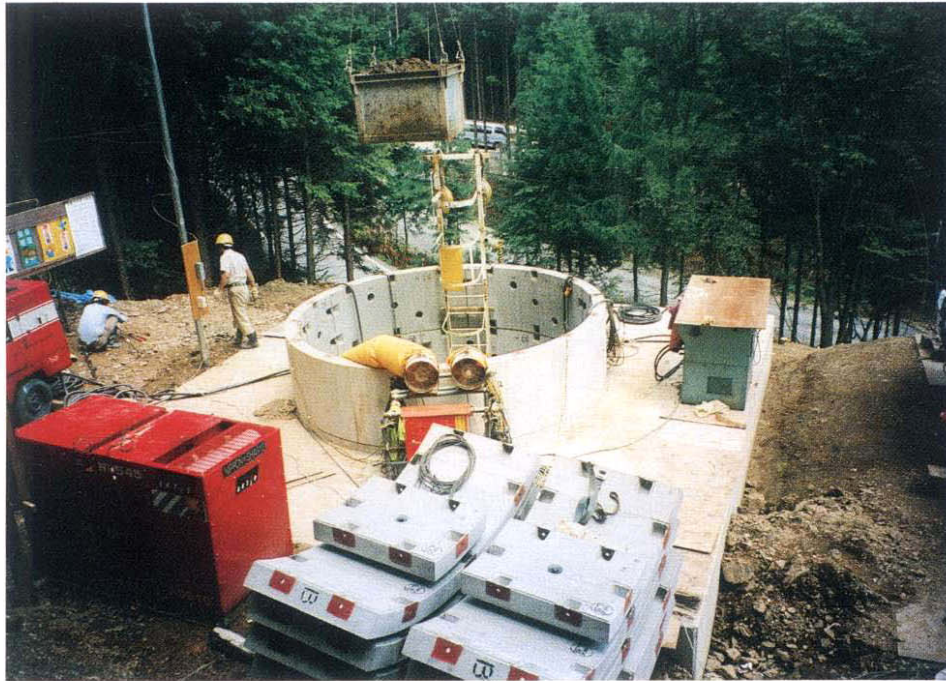
Fig. 42 A drainage well using reinforced concrete segments

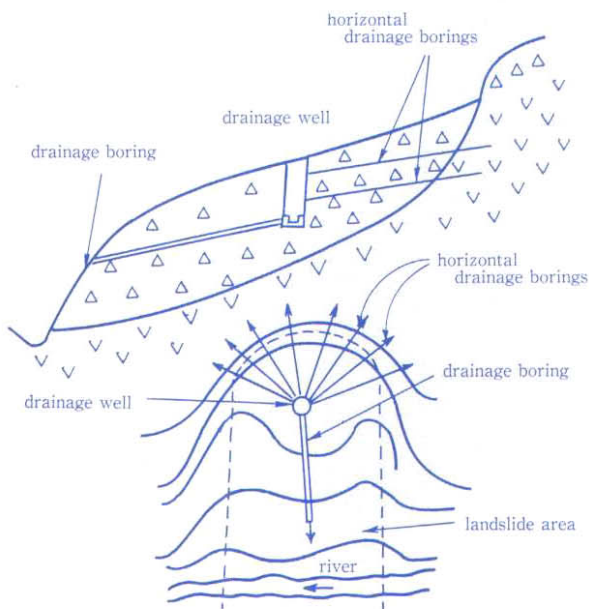
Fig. 43 Drainage well works

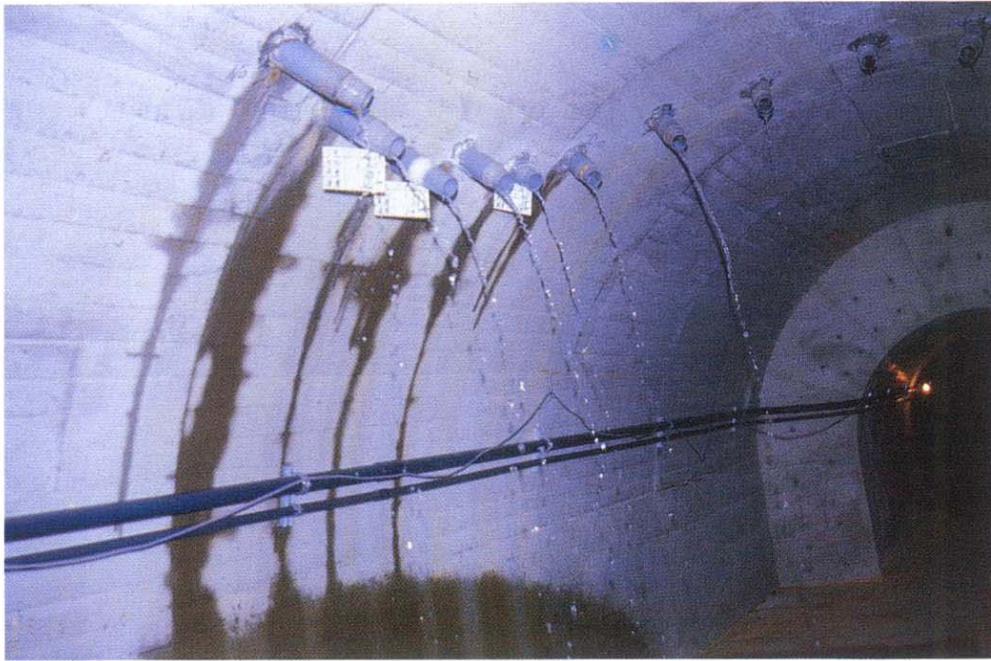
Fig. 44 Inside of a drainage tunnel

The primary purpose of the drainage tunnels (which are constructed below the slide plane) is to remove collected water out of the landslide mass by interconnecting the drainage wells. Instead of excavating the drainage wells from the ground surface, they can be constructed upward from the drainage tunnels. The series of gravity drains drilled from the tunnel tends to increase the effectiveness of the drain system. This is the most effective and reliable drainage work where numerous ground water veins exist within the landslide mass (Fig. 44, 45). Furthermore, this work is effective to maintain existing facilities.

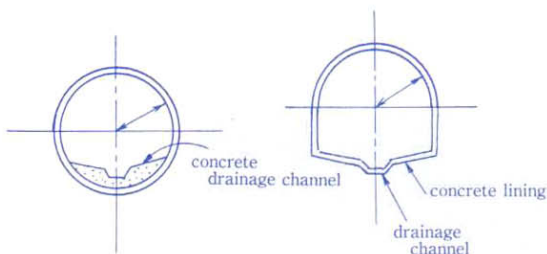
Fig. 45 Cross section of drainage tunnels

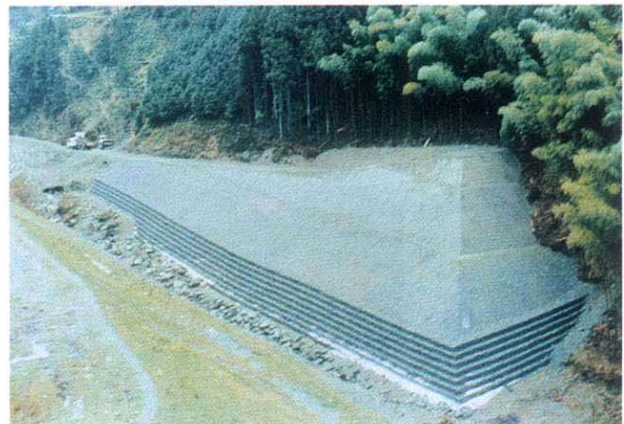
Fig. 47 Buttress fill works

The buttress fill is placed at the lower portions of the landslide in order to counterweight the landslide mass. It is most effective if the soils generated by the soil removal works are used (Fig. 47).

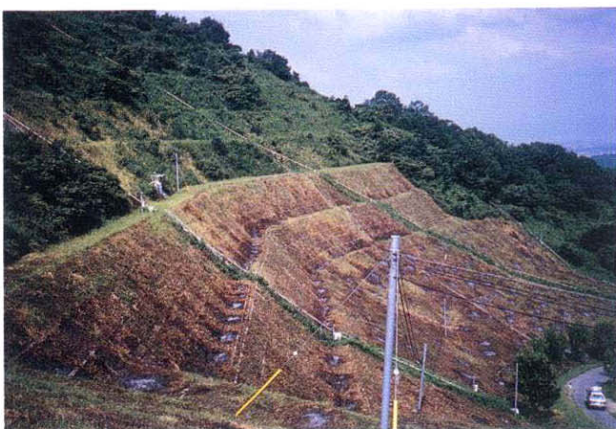
Fig. 46 Earth removal works

This is one of the methods where the most reliable results can be expected, and generally applies to small to medium sized landslides. Except for special cases, the soil removal is focused on the head portion of the slide (Fig. 46).

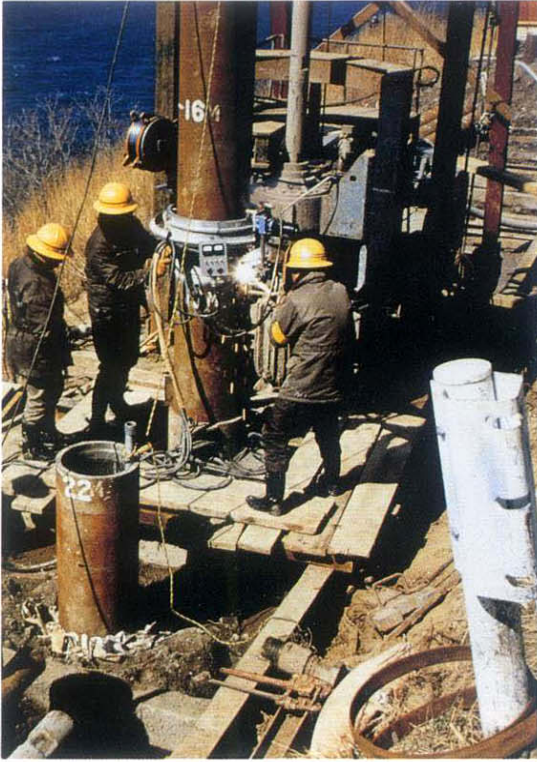
Fig. 48 Pile works

restrain the movement. Generally, a thick walled steel pipe is used as the pile, and is then filled with concrete (Fig. 48).

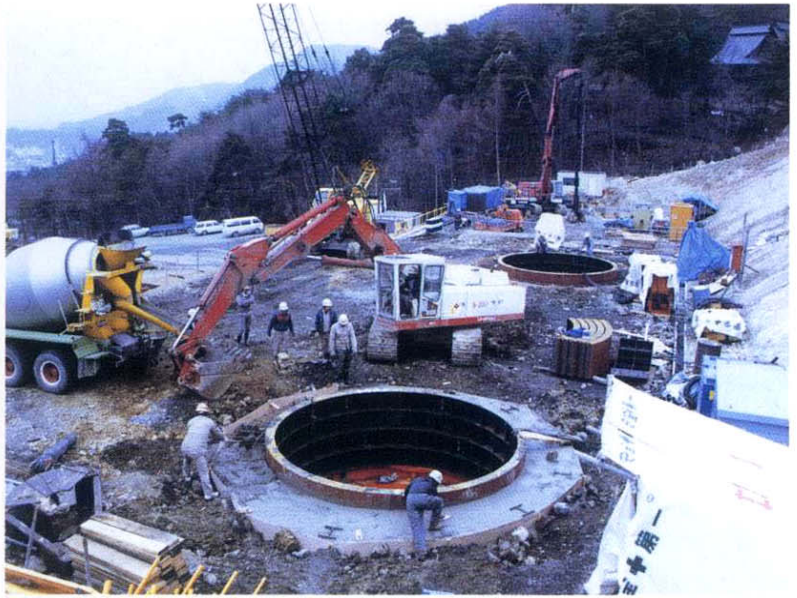
Fig. 49 Under construction of the large diameter cast-in-place pile works

The large diameter cast-in-place works function similar to those of the pile works and are designed to tie the moving landslide and the stable ground together. However it involves much larger diameters. The construction is similar to the drainage well, and generally consists of pile of 1.5 to 6.5m in diameter and filled with reinforced concrete. Compared to the piles, the large diameter cast-in-place type are much more resistant to bending stresses (Fig. 49).

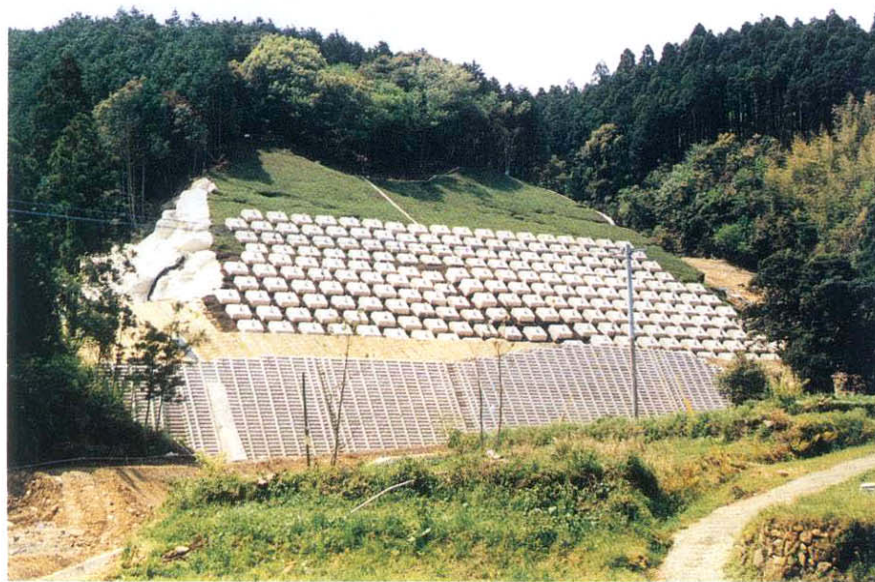
Fig. 50 Anchor works

The anchor works utilize the tensile force of anchor bodies embedded through the slide mass and into stable earth, and are connected to thrust blocks located on the ground

surface. The thrust blocks are anchored with a tendon that counteracts the driving forces of the landslide to restrain the slide movement. The advantage is that large restraint forces can be obtained from a relatively small cross sectional tendon (Fig. 50).

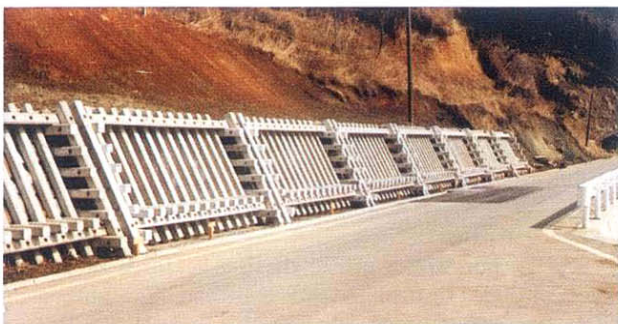
Fig. 51 An example of crib walls

Retaining walls are constructed to prevent smaller sized and secondary landslides that often occur along the toe portion of the larger landslides. Because of the large-scale earth-movement and numerous springs that are expected in landslide terrain, crib walls are common instead of conventional reinforced concrete retaining walls (Fig. 51).

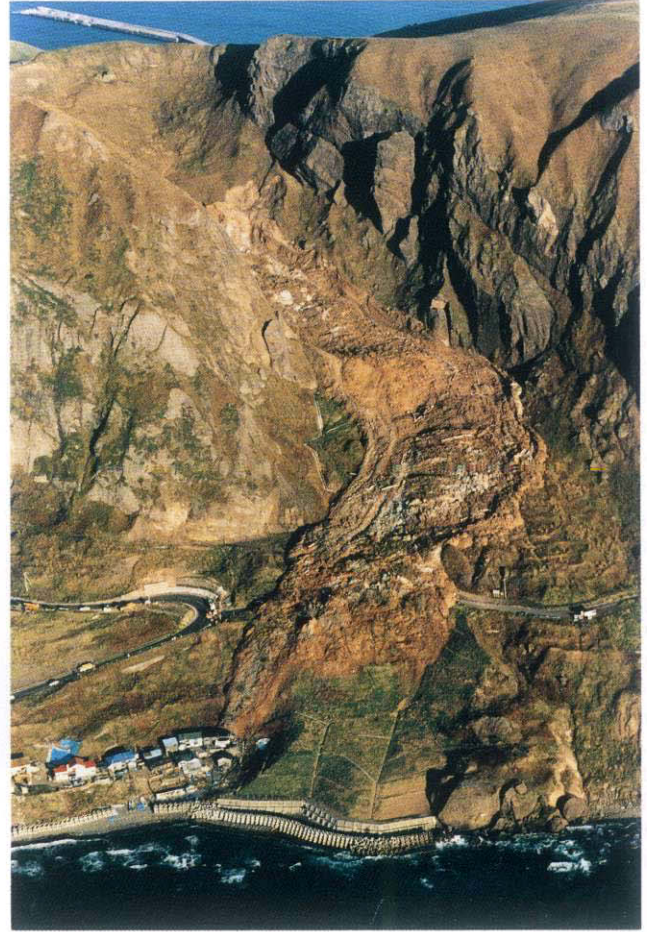
**Photo. 1** Motochi Earth Flow, conditions immediately following the sliding (Photo courtesy of the Hokkaido Press).

The Motochi earthflow originated within the South Landslide Block and consists of at least three units. The first and main flow originated along the road knocking down power poles and power lines (October 11, 2:55 AM). The failure started along the mid-portion of the South Landslide Block as a slump, then transformed into an earth flow that moved downward along a 10 to 20 degree slope. The earth flow then veered to the right at the steepest part of the slope, and terminated near the coast line. The scarp of the slump had receded and eventually reached the head portion of the South Landslide Block. Both flanks of the slump block (upper portion of the earth flow) formed lateral scarps of 5 to 10 m high, while the foot (lower portions of the earth flow) contained transverse ridges of 3 to 6 m. Previously installed corrugated metal pipes and gabion cages were pushed parallel to the side ridges (in the flow direction), while in the interior portion of the flow the pipes were pushed perpendicular to the flow direction and bent towards the direction of the flow. Small scale compression ridges were observed at the toe. It is also reported that some trees with their roots intact had been transported over 200 m.

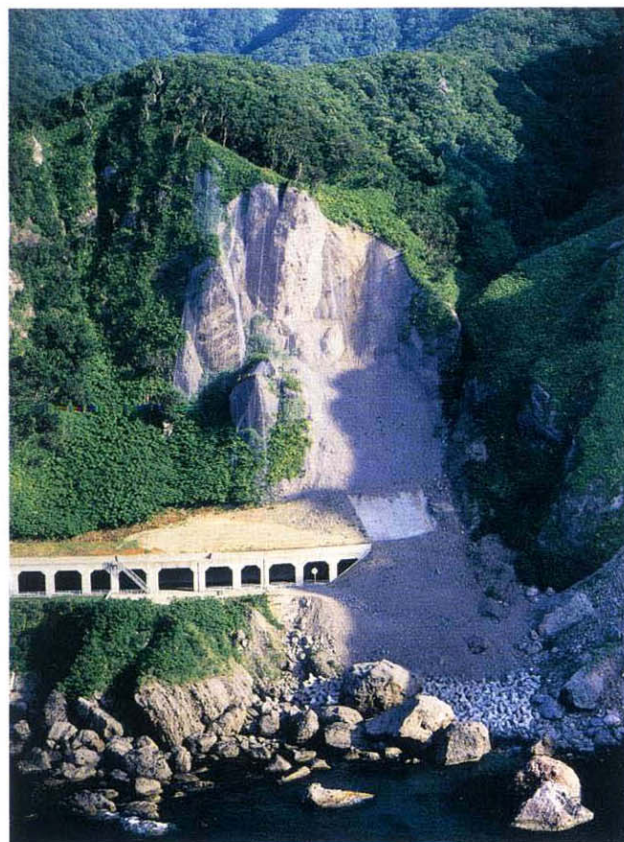
Photo. 4 Conditions following the completion of the mitigation works (Photo courtesy of Koken Engineering)

*Mitigation Measures* The mitigation measures include reinforcement of the lining below the hanging rock block with H-beams. On October 7, 1993, the hanging rock block was blasted off. Later, additional rocks were removed and wire mesh was applied over the exposed rocks.

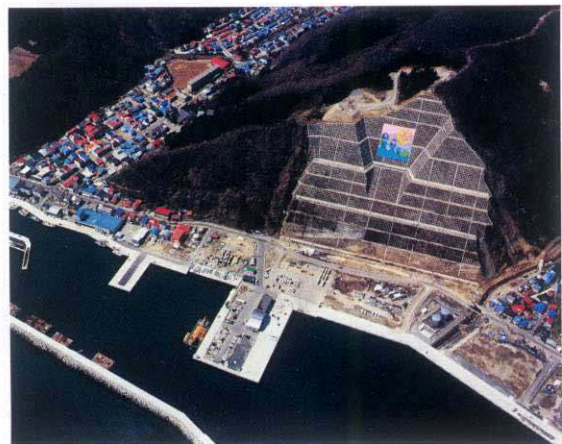
**Photo. 6** Conditions after the mitigation works (Photo courtesy of Shin Gijutsu Consultants)

*Mitigation Measures* Grading works; concrete retaining works; concrete crib retaining works; and grass planting works.

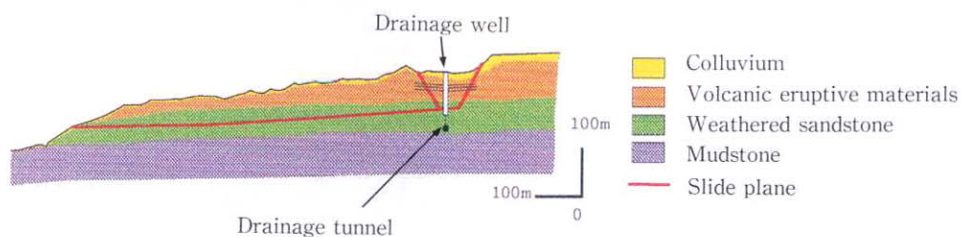
Cross section of the Sabuta Landslide

- 1) Sabuta Area: Because of the depth of the slide plane (up to 70 m), ground water removal works were considered with a combination of drainage tunnels and drainage wells.
- 2) Minamiyama Area: Due to the high groundwater table, a combination of drainage wells and drainage borings were planned, and pile works and anchor works have been implemented.
- 3) Yunotai Area: In order to protect the toe area from erosion, dams and bank protection works have been constructed. For future works, a combination of drainage wells and drainage borings and pile works have been planned.

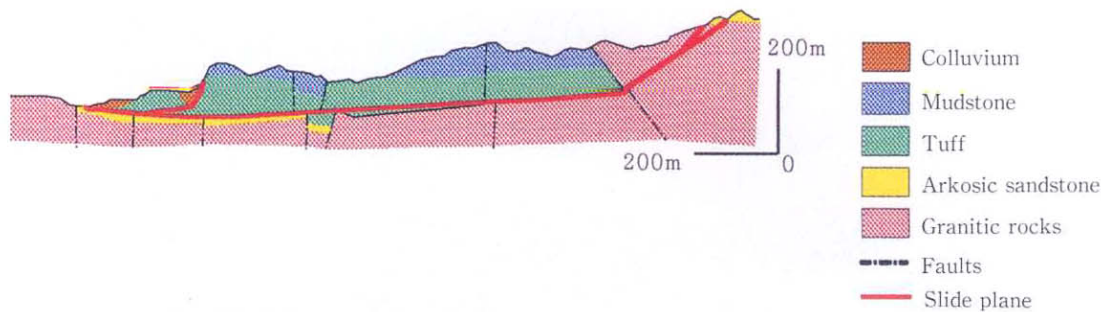
Cross section of the Takisaka Landslide

**Geology, Mechanism of Failure and Type of Movement** The Takisaka Landslide is divided into two blocks along Seki Creek: the northern block and the southern block. Geology of the site consists of pre-Tertiary granitic rocks (basement complex) and includes from bottom to top: lithified to non-lithified arkosic sandstone; green tuff; mudstone; and overlying terrace deposits consisting of sands and gravels and colluvium. The factors associated with the cause of sliding

are: 1) the green tuff weathered into a plastic clay; 2) existence of a fault fracture zone to depth. Because of these factors, this landslide is one of the largest bedrock slides in Japan where the depth to the slide plane is in excess of 100 m. Because of the increased slide movement during the snowmelt, it has been concluded that ground water inflow by snowmelt and river bank erosion from the increased Aga River flow are driving forces of the movement.

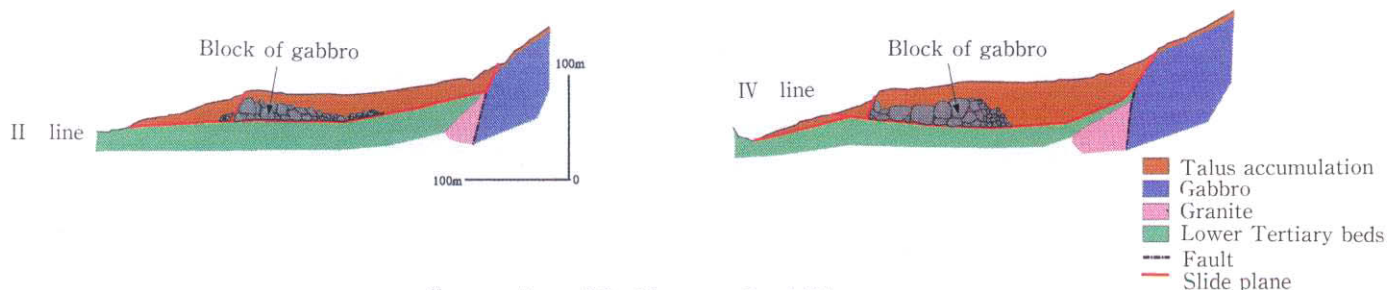
Cross sections of the Narusawa Landslide

slide mass. The causative factors of sliding include: 1) the existence of the fault at the scarp area, which acted as the plane of separation; 2) the presence of tuffaceous siltstones, which acted as the lubricant; and 3) drag folds that were formed within the Lower Tertiary beds near the fault as a result of faulting. The inclination of the tuffaceous siltstone which became the slide plane is about 20 degrees. The contributing factors of slide movement include the increased water pressure from infiltration into the open cracks along the fault separation plane, and slope instability near the toe of the slide due to erosion.

**Mitigation Measures** The landslide control works include large scale soil removal at the head area, installation of a 3-dimensional dewatering system (tunnel conduit and drainage wells) to drain the depression at the head area, and construction of dams to prevent sediment discharge at the toe area. The restraint works included installation of piers and anchors along the cut slopes and the toe area.

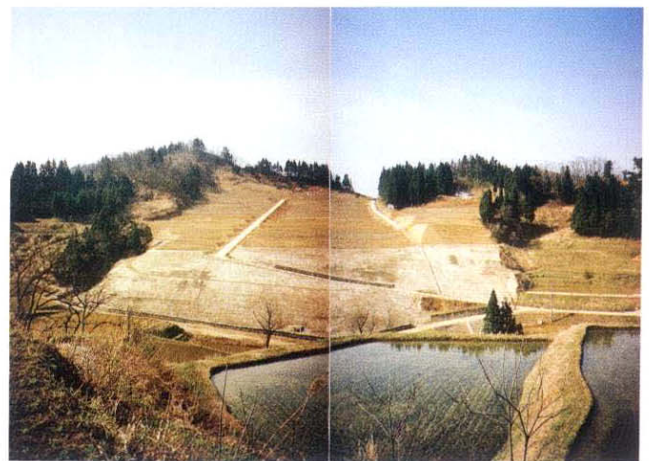
Photo. 12 Conditions following the completion of the mitigation works

**Mitigation Measures** Drainage channel works including drainage wells, drainage borings and interceptor under drains as have been constructed. Two years after the completion of

the mitigation works, some leaks have been noticed in the head portion of the slide. However, it is assessed that the drainage control works are functioning effectively as a large discharge of ground water has taken place in the drainage borings. Furthermore, the results of the movement detection instrumentation indicate that stability has been achieved.

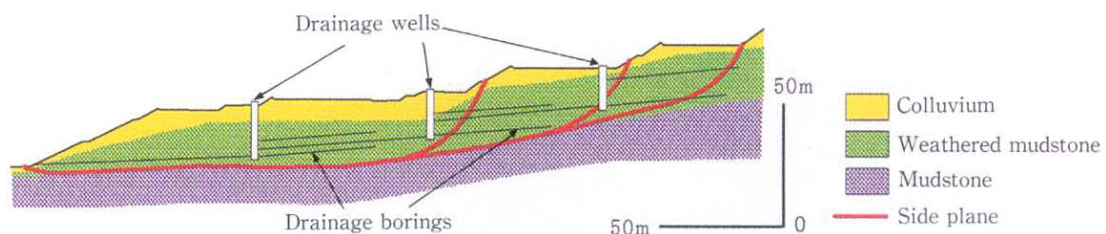
Cross section of the Jinmyono Landslide

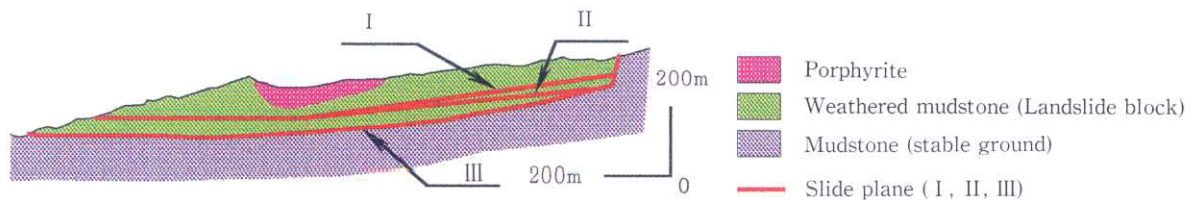
Cross section of the Dangosashi Landslide

sliding. Based on boring data, three slide planes have been identified: the slide plane I is about 70 m deep; the slide plane II is about 100 m deep; and slide plane III is about 135 m deep. Measurements taken over the past several years has revealed no movement along all three slide plane. However, the slope stability analysis indicates that slide plane I has the lowest factor safety. Therefore, the potential for slope instability still exists. Furthermore, ground water moving near slide plane I is the contributing factor for secondary sliding at the toe area. Because of the above reasons, the mitigation measures have oriented towards controlling slide plane I.

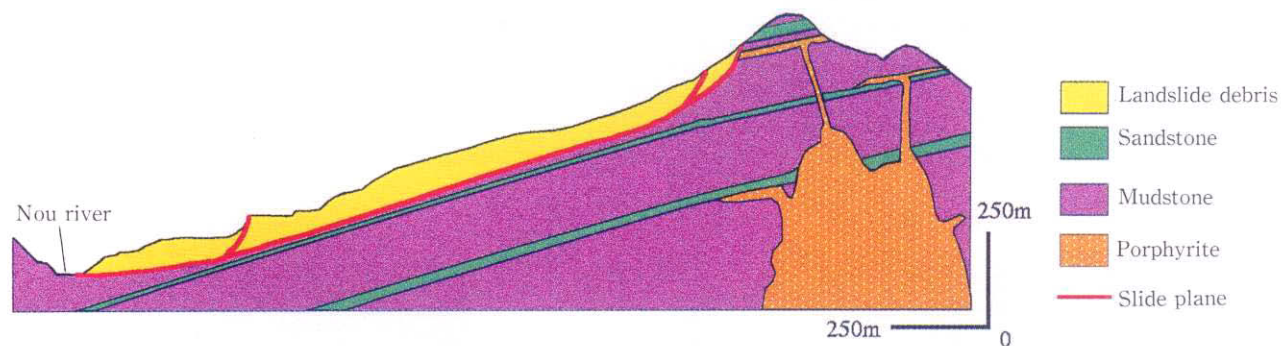
Cross section of the Tochiyama Landslide

**Geology, Mechanism of Failure and Causes of Failure** Geology consists mainly of Miocene mudstone beds with interbedded sandstone of less than 10 m thick. For the Upper Tertiary formation, it is relatively well lithified, and slump structures have developed within the formation. Bodies of porphyrite intruded along the bedding planes of the mudstone beds at the upper portion of the landslide zone. The sliding had developed joint and consists of jointed shale or fractured shale. The surficial material consists of debris flow deposits containing mostly of gravelly soil. The mudstone beds dip 10 to 30 degree approximately parallel to the topography forming a dip slope condition. Occasional presence of severely fractured beds which are interbedded within the mudstone forming a weak zone and weakening of the rock by the development of joint system from the tectonic movement is one of the primary causes of the Early Period landslides. The reason for the continuation of the current activity which was suspected to be originated during the Late Period movement is assumed the increased pore water pressure from snowmelt and snow load.

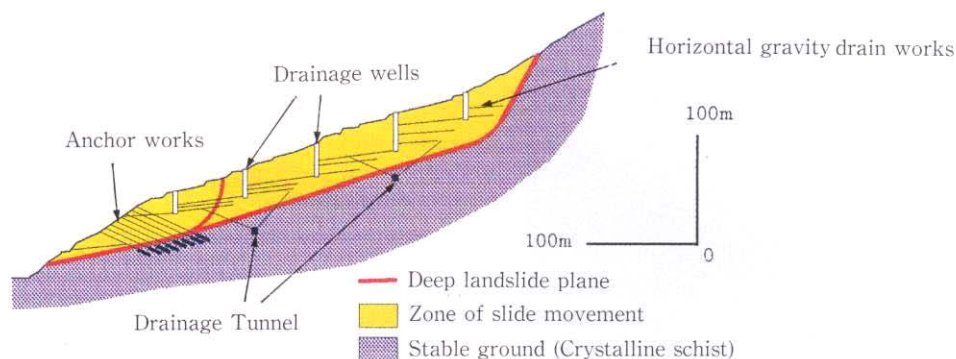
Cross section of Kayakabu downstream block.

schist. The crystalline schist exhibits a dip slope structure along the schistosity surfaces, joint surfaces and fault planes and develops cracks which promotes deep chemical weathering and over all weakening of the rocks creating the factors for the easy formation of the slide plane. Beside the rock quality, geologic structure and othe internal factors, it has been concluded that the sliding was induced by heavy rainfall (daily rainfall of 137 mm).

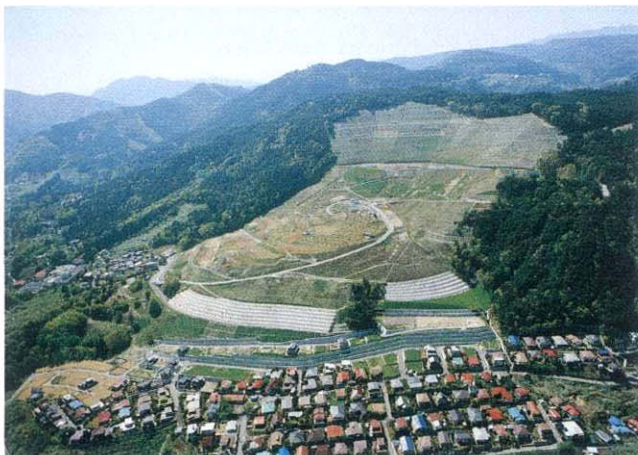
**Photo. 17** Panoramic view of the Jizukiyama Landslide following the completion of the mitigation measures.

**Mitigation Measures** Immediately following the sliding, landslide mitigation measures and restoration works have been implemented. The mitigation measures included large diameter cast-in-place pile works, anchor works, pile works as the control measures; and construction of drainage wells and drainage tunnels as restraint measures. The works were started in 1986 and completed in 1987.

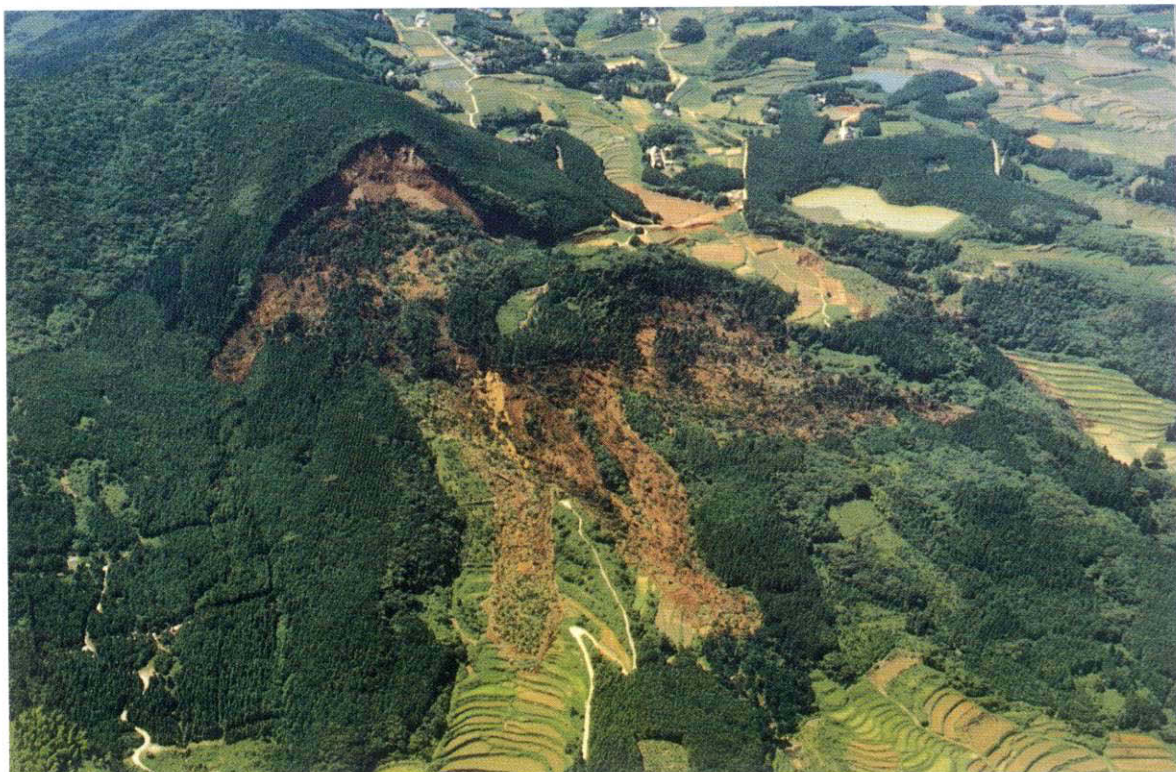
Photo. 40 Conditions immediately following the Ishikura Landslide

**Damages** Tension cracks were observed prior to the major failure of July 4, 1990. The heavy rainfall preceding the sliding (235.4 mm from July 1-2) rapidly raised the ground water level to 4 to 5 m, which in turn lubricated the slide plane along a zone of weakness and induced the failure. The damages included breach of one reservoir, toppling of one check dam, numerous damages to roadways, disturbance of 1042 m of irrigation channels, 5.8 ha of rice paddies, 1.6 ha of cultivated field, and 1.4 ha of forest.

**Geology, Mechanism of Failure and Type of Movement** The majority of the slide area is underlain by Upper Tertiary

(Early to Middle Miocene) rocks, and by Lower Tertiary rocks on the upslope areas. These Tertiary rocks are in turn overlain by basaltic volcanic rocks forming a cap rock structure. The slide plane was found to be near the bedding plane between sandstone and coal-bearing shale. The angle of the slide plane ranges between 3 and 5 degrees.

**Mitigation Measures** After the initial sliding, numerous tension cracks developed within the body of the slide mass. The open tension cracks promoted easier infiltration of rain water. Due to this increase in pore water pressure the possibility of renewed activity within the slide mass increased significantly. Consequently, a 3-dimensional dewatering system combined with drainage wells and drainage tunnels were constructed. Additionally, soil removal works were implemented at the head area, and steel pile works and anchor works were implemented at the toe area.

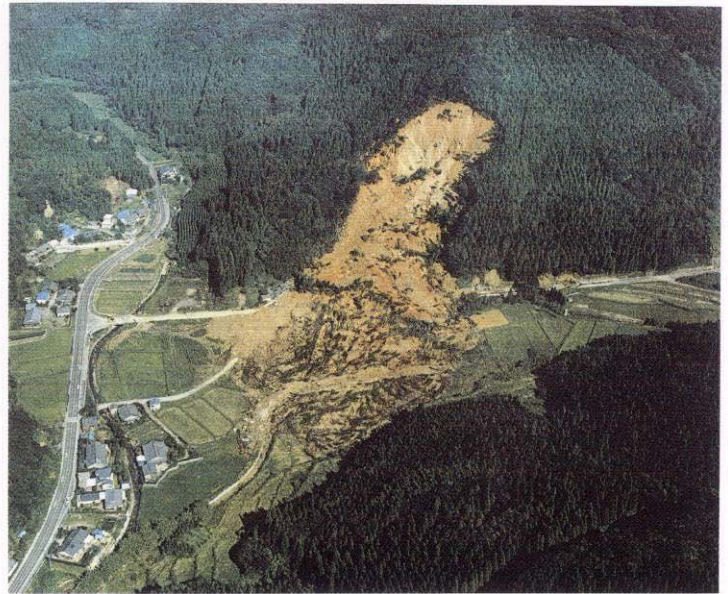
**Photo. 41** Conditions immediately following the Bishamon Landslide

**Damages** The landslide occurred on September 20, 1994, resulting in 2 deaths, 3 injuries, destruction of 2 residential structures, and affecting 436 m of roadway and 2.3 ha of cultivated field.

**Geology, Mechanism of Failure and Type of Movement** The slide area is underlain by sedimentary rocks of the Mesozoic Period (Cretaceous Epoch) with granitic intrusions located along the western slopes of Yahazudake. The upper portions of the slope are underlain by sedimentary rocks and the lower portions are underlain by granite where the landslides occur. The granitic rock is deeply weathered to argillite at about 40 m deep, and has a particularly welldeveloped clay seam that exists parallel to the granitic intrusion. Deeply and completely weathered granitic rocks contain abundant clay of form an impervious zone. It is possible that pore water pressure within the slope underlain by granitic rocks could remain stable for a long period of time after the ground water level is raised by rainfall. It has been concluded that the primary cause of the sliding was a reduction in shear strength within the argillaceous granitic rocks by increased residual pore water pressure. The failure occurred along the weak beds (such as clay seams) where alteration is highest.

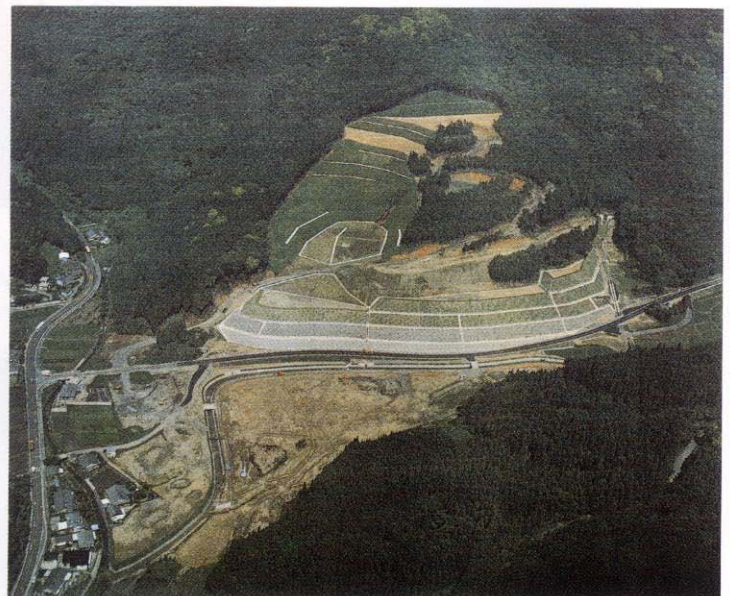
**Photo. 42** Conditions following the completion of the mitigation measures

**Mitigation Measures** Due to the large scale of the sliding mass, the mitigation measures were oriented towards increasing the stability factor mainly by control works combined with the selected constraint works where positive results can be expected. Specifically, mitigation measures included soil removal works at the head portion of the landslide and buttress fill along the toe portion of the slide. Attempts were also made to control the sliding force by ground water removal by installing drainage wells, and horizontal gravity drains. Finally, restraint by piles were implemented to complete the mitigation efforts.
