LANDSLIDES IN JAPAN

(The Sixth Revision)

Japan Landslide Society
National Conference of Landslide Control

2002

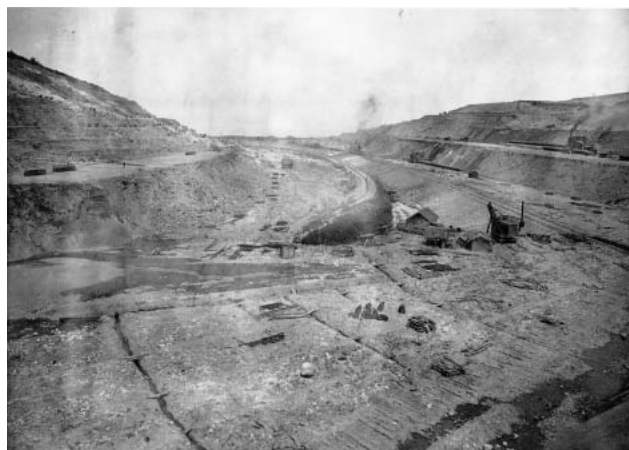
Photo 2-1 Ohkouzu diversion channel (landslide occurred on the right hand side of the photo) (courtesy of Ministry of Land Infrastructure and Transport)

Several large landslides were induced along the right shore of an open excavation of the Ohkouzu Diversion Channel during its construction in 1916 and 1919 (Photo 2-1). The work was commissioned to reduce and prevent flooding along the lower reaches of the Shinano River. Furthermore, after the completion of the diversion channel, a post-construction landslide in 1924 delayed the completion date from 1920 to 1927. The predominant control measure for these landslides was the removal of the active landslide masses totaling about $2.88 \times 10^7 \text{ m}^3$. In order to remove such a large volume of earth, a locomotive was utilized, an evolutionary approach in those days.

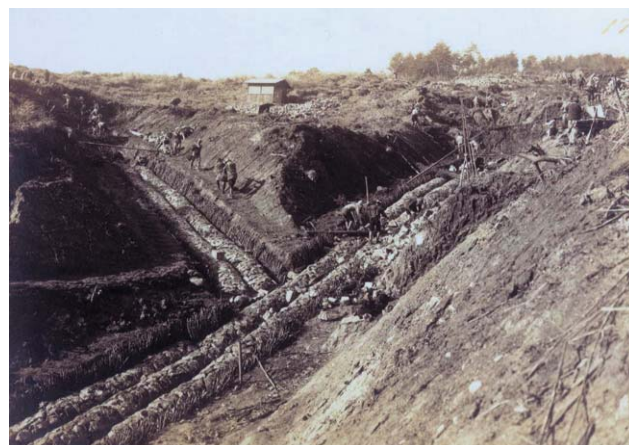
Photo 2-2 Installation of interceptor underdrain at Chausuyama landslide (courtesy of Nagano Prefecture)

According to Taniguchi³⁾ along with massive grading works, surface drainage and interceptor underdrains were installed at the Gamou landslide in Tottori Prefecture and the Chausuyama landslide (Photo 2-2) in Nagano Prefecture during that period.

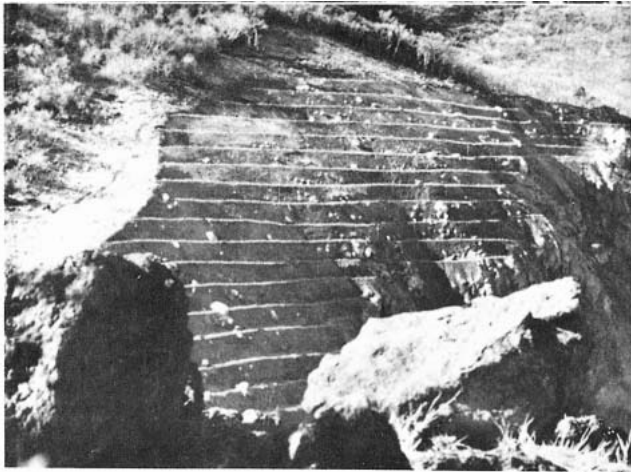
Photo 2-5 Grading work (Earth removal) at Sohunzan landslide (courtesy of Kanagawa Prefecture)

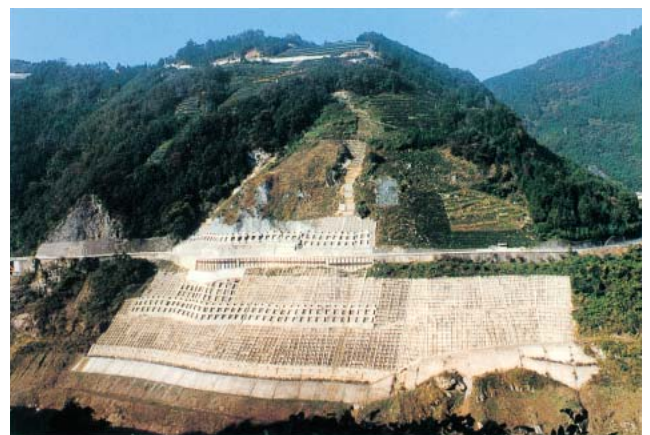
Photo 2-8 landslide at Ohdo reservoir following the completion of anchor installation (courtesy of Ministry of L. I. and T.)

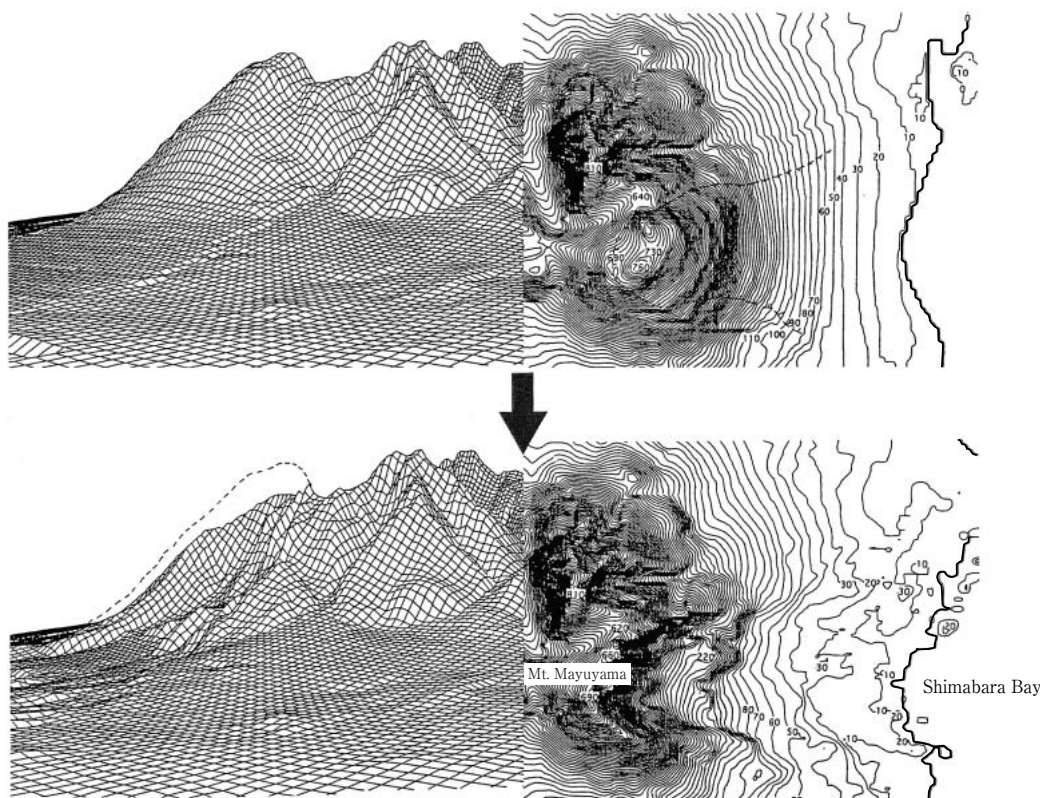
Fig. 3-8 Bird's eye views and the contour maps of Mayuyama before and after the rockslide avalanche in 1792 (Inoue¹⁰⁾)

(1) **Rockslide Avalanche / Debris Avalanche**: This type of failure occurs only at composite volcanoes and lava domes of high relief. As new volcanic activities centered within the deeper portion of the volcano that contain upward-migrating magma, earthquakes and fluctuating groundwater levels could induce a catastrophic failure of the volcano and develop into rockslide avalanche/debris avalanche. This type of failure deposits large, scattered unbroken blocks along foothills and the lower reaches of drainages. The volume of this type of failure is on the order of 10^8 to 10^{10} m³. Most of the cases involve andesitic volcanoes, but there are cases that involve basaltic volcanoes. Fig. 3-8 shows bird's eye views and topographic maps of hummocky avalanche deposits formed by a rock-

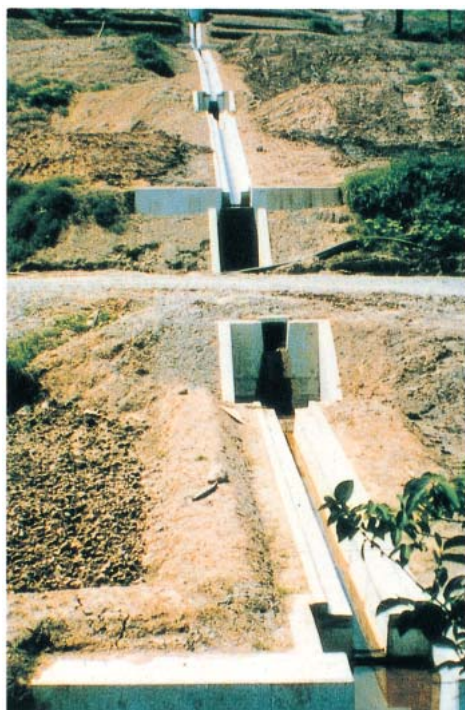
Photo 5-1 Surface drainage ditches

clude two major categories : drainage collection and drainage channel works. The drainage collection is designed to collect surface flow by installing corrugated half pipes or lined V-ditches along the slopes, and then connecting them to the drainage channels. The drainage channels are designed to remove the collected water from the landslide zone as quickly as possible, and are constructed from the same materials as the drainage collection works. The surface drainage control measures are often combined with the subsurface control measures (Fig. 5-2, 5-3, Photo 5-1).

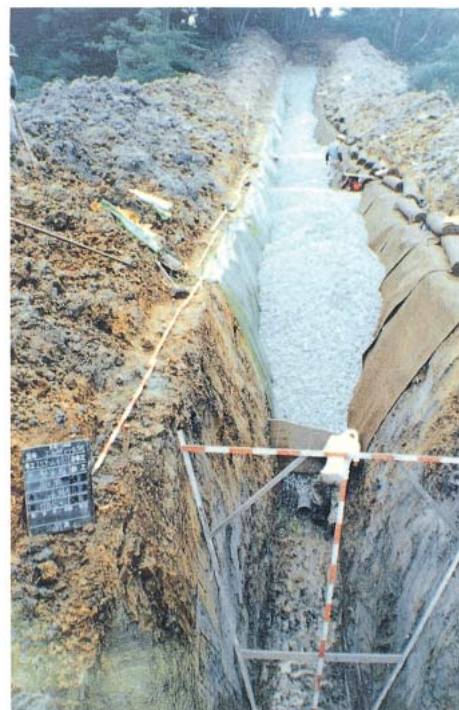
Photo 5-2 Interceptor trench drains

derdrains contain impervious sheets at the bottom of the trench, and gravels are wrapped with filter fabric and the drains are connected at ground sills or catch basins (Photo 5-2).

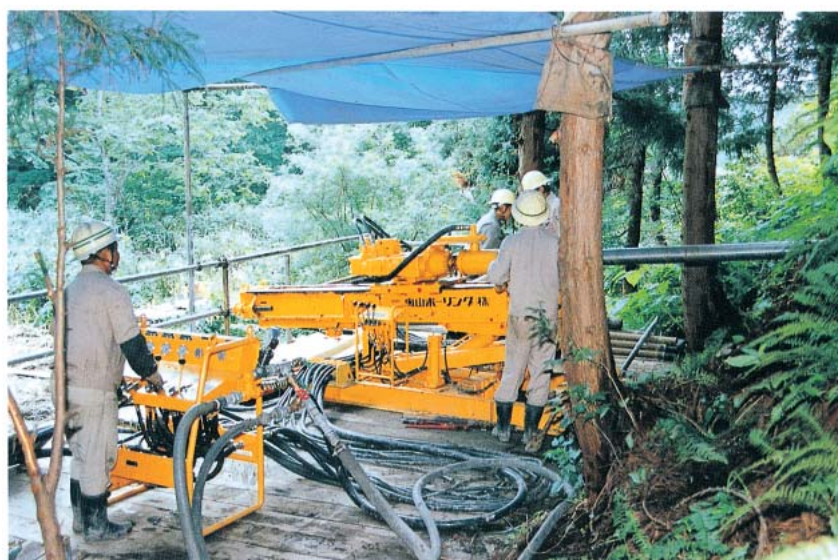
Photo 5-3 Horizontal gravity drains installation

In order to remove groundwater, 30 to 50 m-long horizontal gravity drains are installed. The pipes could be either perforated P.V. C. (polyvinyl chloride) or steel construction, and are typically drilled at an angle of 5 to 10° from the horizontal line (Photo 5-3, 5-4).

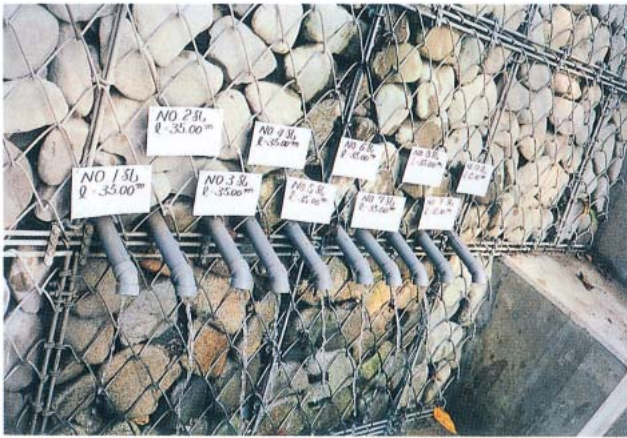
Photo 5-4 Outlet of horizontal gravity drain pipes

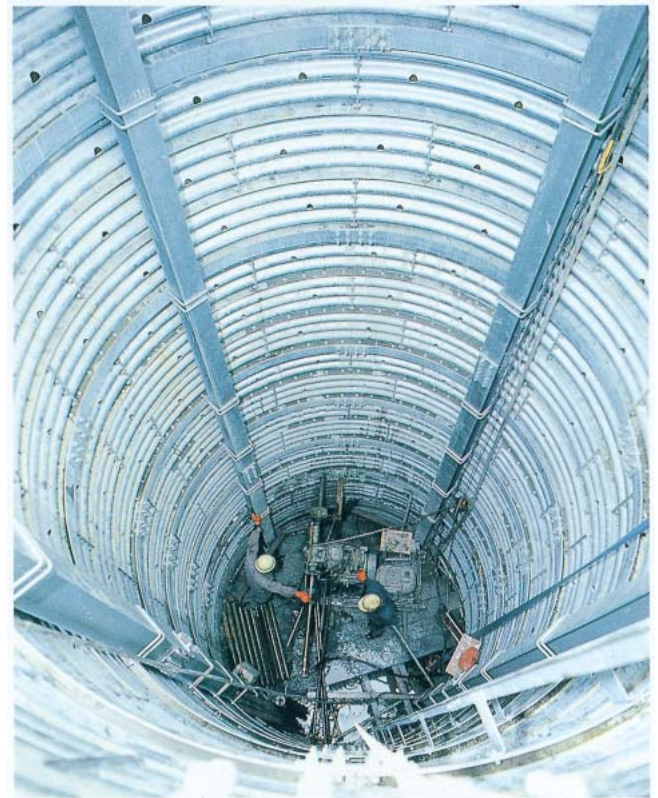
Photo 5-5 Drainage well using steel segments

structed of either steel or reinforced concrete segments, and concrete is used at the well bottoms and the upper portion of the well (Fig. 5-4, Photo 5-5, 5-6).

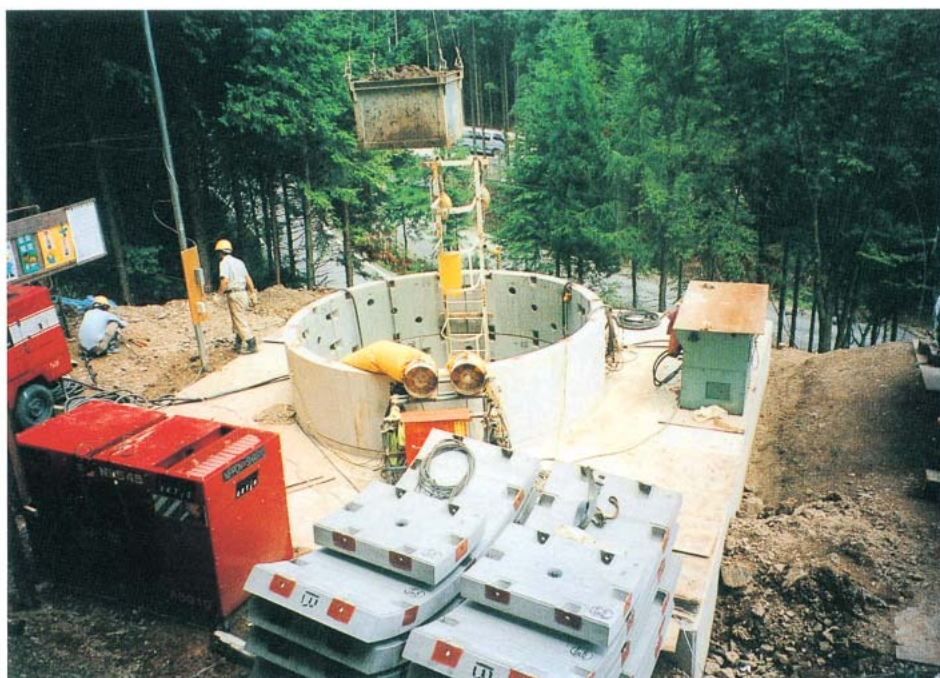
Photo 5-6 Drainage well using reinforced concrete segments

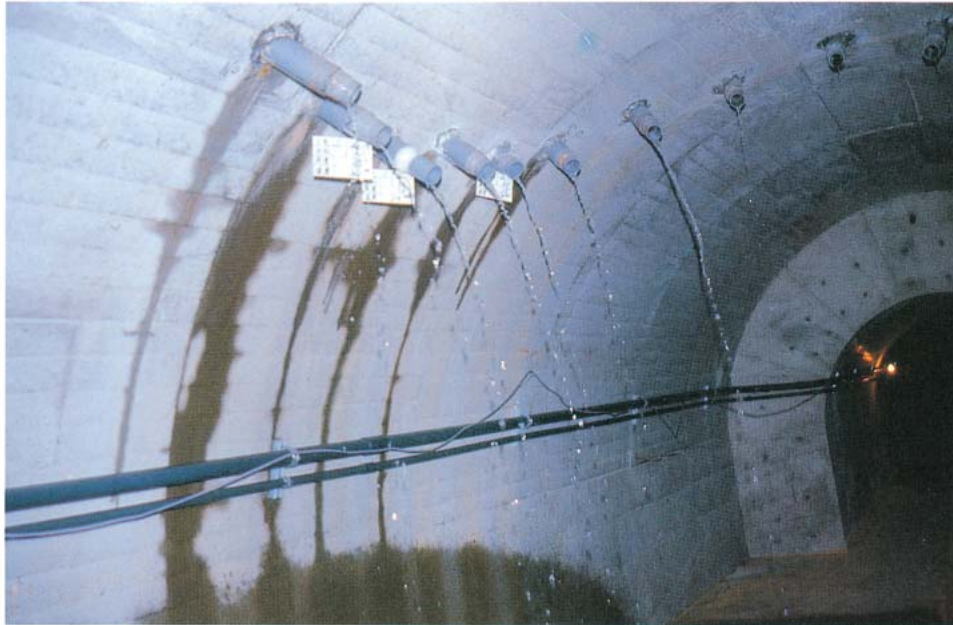
Photo 5-7 Inside of a drainage tunnel

Generally, the diameter of the tunnel is between 1.8 and 2.5 m, and the drainage channel is constructed along the invert (Fig. 5-5, Photo 5-7).

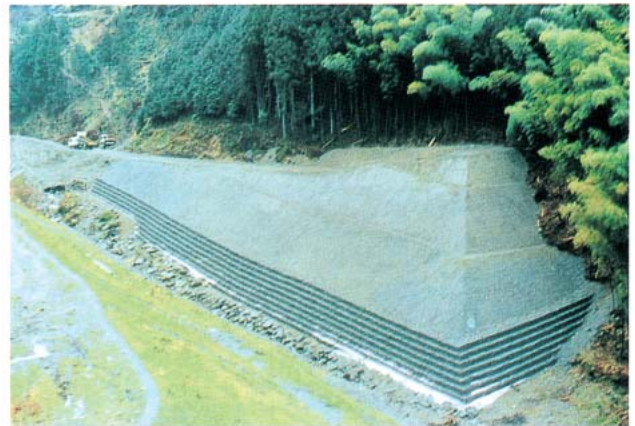
Photo 5-9 Buttress fill

employed as an emergency measure. It is most effective if the soils generated by the soil removal works are used (Photo 5-9).

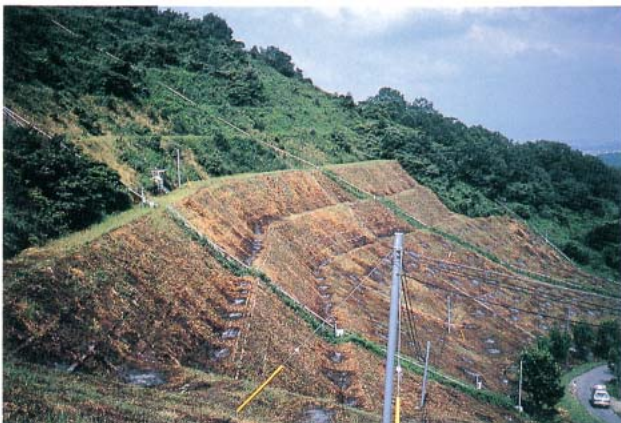
Photo 5-8 Earth removal

This is one of the methods where the most reliable results can be expected, and generally applies to small to medium sized landslides. Except for special cases, the earth removal is focused on the head portion of the slide (Photo 5-8).

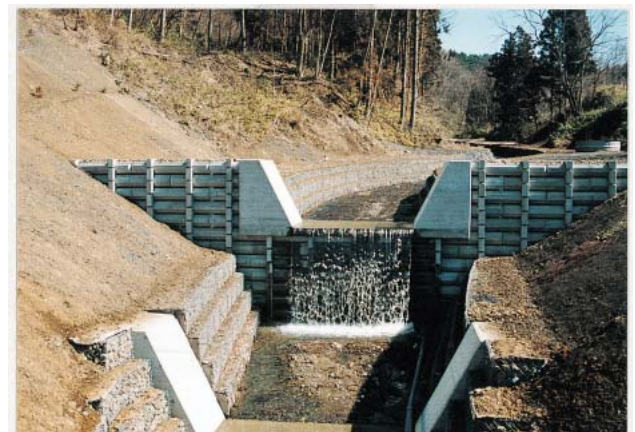
Photo 5-10 Sabo dam (check dam)

Degradation and channel bank erosion reduces earth stability and often tends to induce slide activity. In such cases, sabo dams, ground sils, revetments and other river structures can be constructed to prevent further erosion (Photo 5-10).

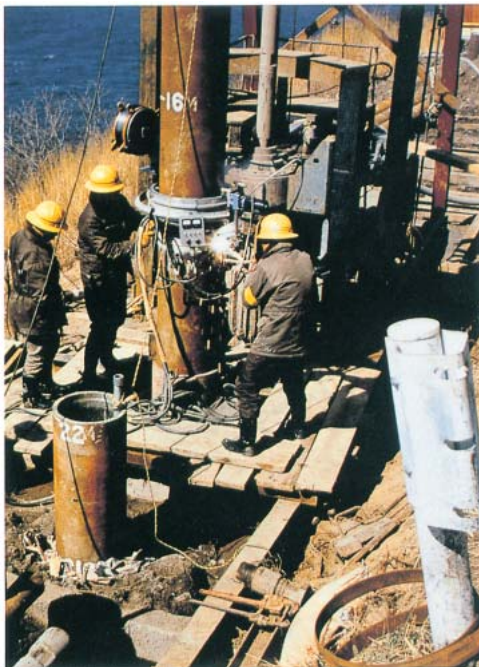
Photo 5-11 Pile driving

Piles are driven into the pre-drilled shafts in order to tie the moving landslide blocks and the stable ground together. The piles are designed to resist shearing and bending stress, and generally consist of thick walled steel construction. The interior of the piles are filled with concrete (Photo 5-11).

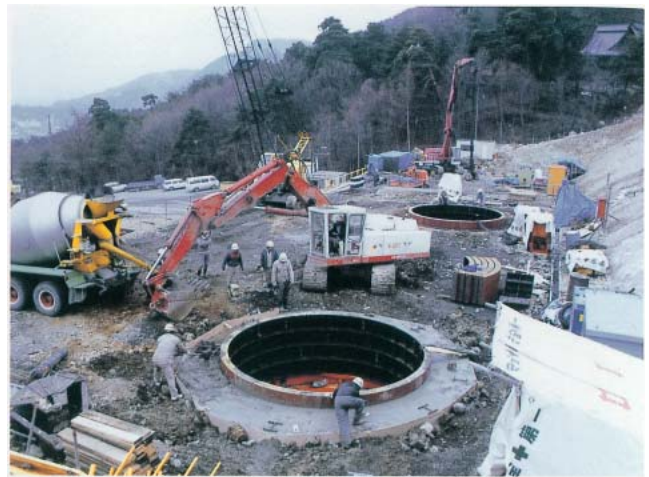
Photo 5-12 Installation of large diameter cast-in-place shafts

The large diameter, cast-in-place shafts function similar to those of the piles and are also designed to tie the moving landslide and the stable ground together. However, this measure involves much larger diameters. Construction is similar to that of drainage wells, and generally consists of shafts with diameters of 1.5 to 6.5 m, and are then filled with reinforced concrete. Compared to the piles, the large diameter cast-in-place type are much more resistant to bending stresses (Photo 5-12).

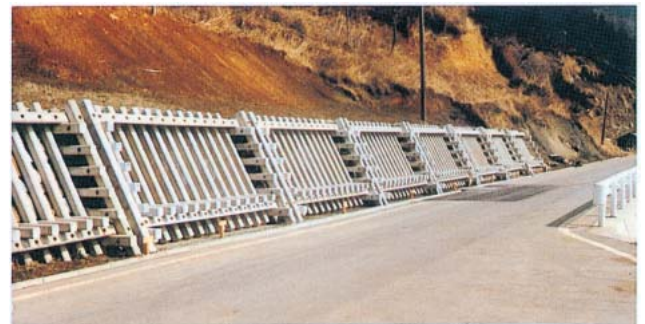
Photo 5-14 Crib walls

Retaining walls are constructed to prevent smaller sized and secondary landslides that often occur along the toe portion of the larger landslides. Because of the large-scale earth movement and numerous springs that are expected in landslide terrain, more flexible crib walls are common instead of conventional reinforced concrete retaining walls (Photo 5-14).

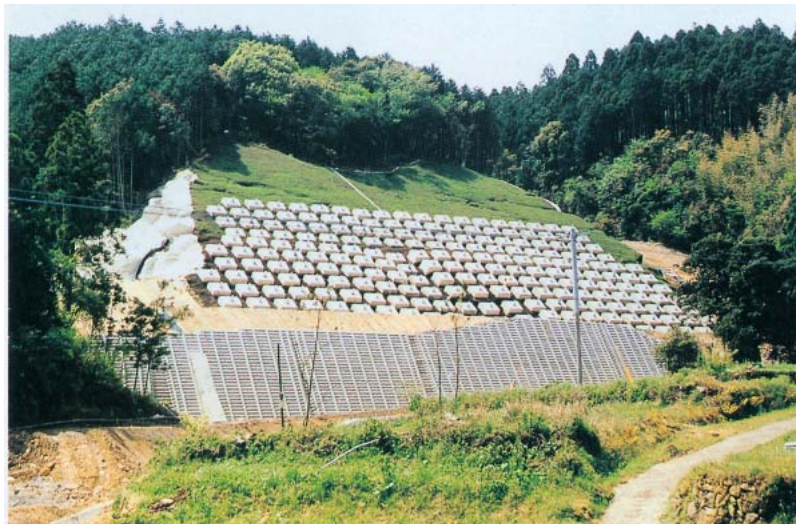
Photo 5-13 Completed anchor installation

through the slide mass and into stable bedrock, and are connected to thrust blocks located on the ground surface. The thrust blocks are anchored with a tendon that counteracts the driving forces of the landslide to restrain the slide movement. The advantage is that large restraint forces can be obtained from a relatively small cross sectional tendon (Photo 5-13).

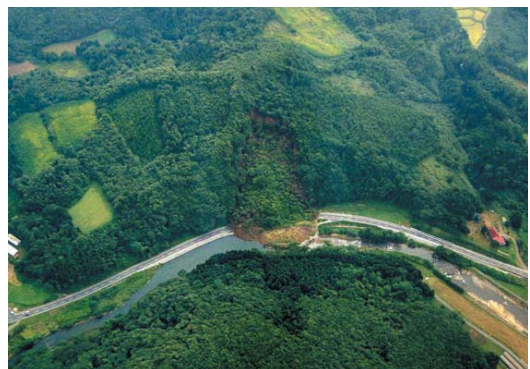
Photo 6-6 Yamadate landslide following the first landslide (Sep. 13, 1998) (courtesy of Iwate Prefecture)

(3) **History and Damages** : There are no historical records for this landslide. The first landslide occurred suddenly on September 13, 1998, the second slide occurred on September 28, 1998, and the third landslide occurred on January 7, 1999. The first landslide buried and closed the main Prefectural Highway for a distance of 120 m and buried about two-third of the Ide River. The second landslide involved the head-ward enlargement of the first for 25m. The third landslide continued to enlarge head-ward for an additional 60m and completely blocked the Ide River. In all of the other landslides, the movement finished within several minutes.

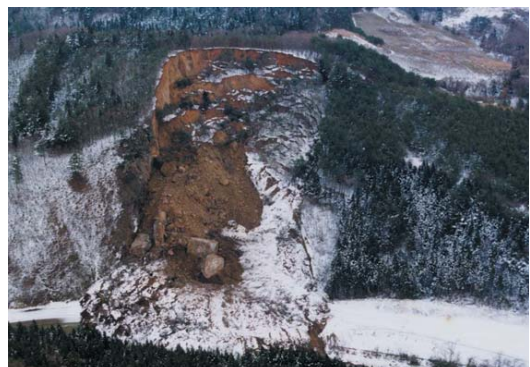
Photo 6-7 Yamadate landslide following the second landslide (Jan. 7, 1999) (courtesy of Iwate Prefecture)

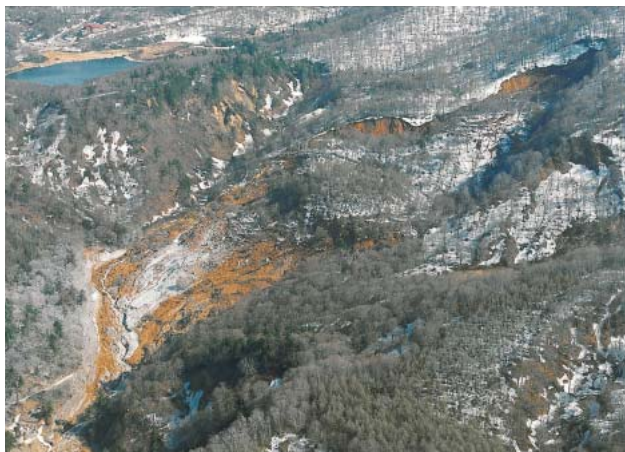
Photo 6-8 Sumikawa landslide (courtesy of F. Agency)

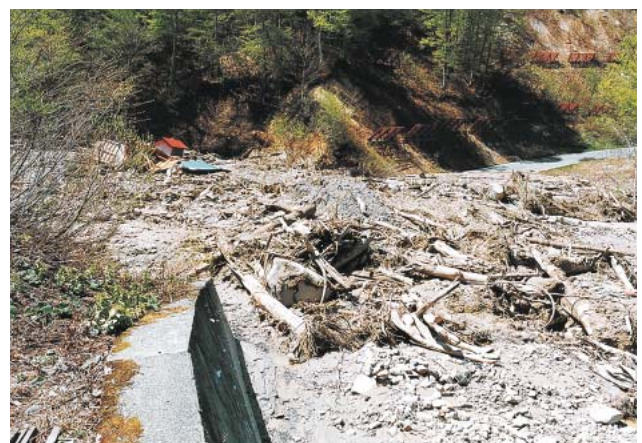
Photo 6-9 Deposition of debris and sediments by debris flow caused by Sumikawa landslide (courtesy of F. Agency)

(3) **History and Damages** : Signs of landslide movement such as cloudy drinking water supplies and cracks on the road, appeared during the snowmelt period, around May 4, 1997. Following rainfall in excess of 100mm between May 7 and 9, major landslide movement occurred on May 10 around the 2 : 30 hour, destroying a bath house at a Sumikawa hot spring resort which is located within the slide blocks. On the following day, May 11, around 8 : 00 further movement completely destroyed nine residence halls. By then the landslide debris had turned into a debris flow and completely destroyed seven structures at another hot spring resort (Akagawa hot spring resort) located 1.2km down stream. The debris flow continued and buried a bridge of the National Highway. Fortunately, the 51 guests and employees of the resort were warned in advance and evacuated prior to the arrival of the debris flow.

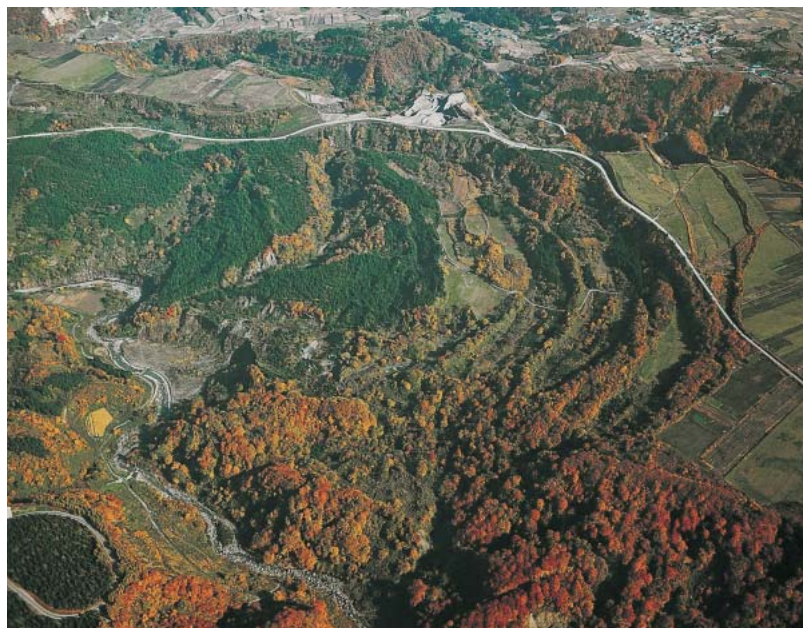
Photo 6-11 Dozangawa landslide (courtesy of F. Agency)

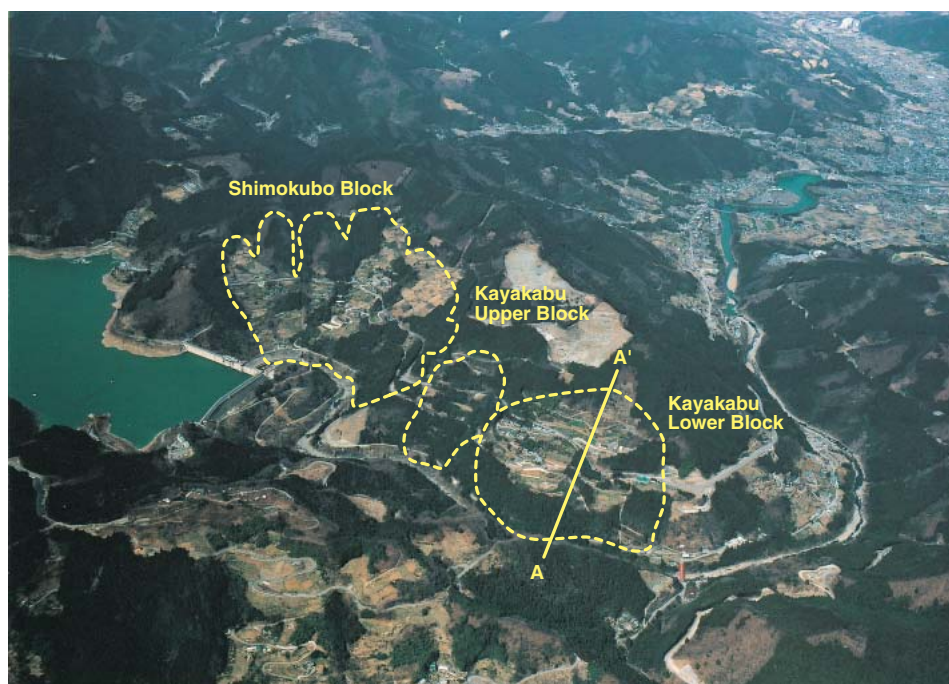
Photo 6-12 Yuzurihara landslide (courtesy of Ministry of L. I. and T.)

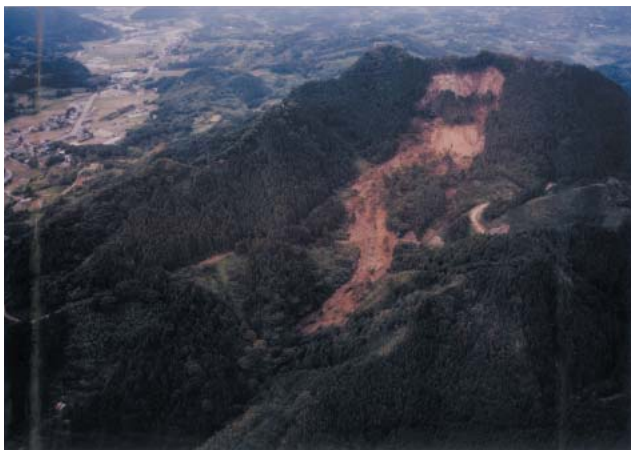
Photo 6-13 Iyogatake landslide
(courtesy of Chiba Prefecture)

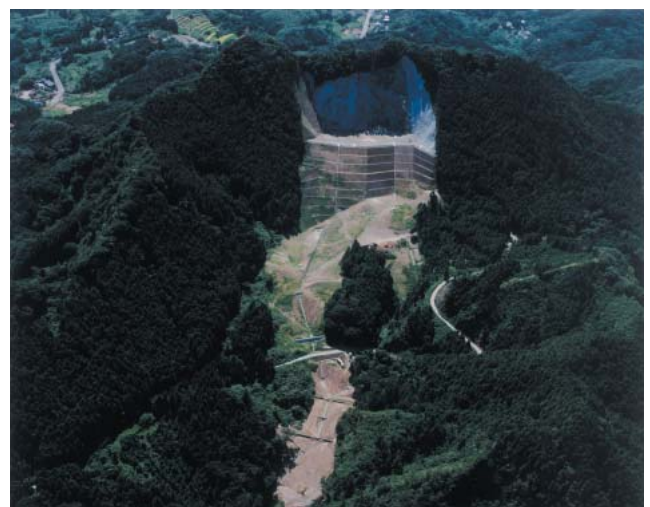
Photo 6-14 Iyogatake landslide following the completion of mitigation measures
(courtesy of Chiba Prefecture)

The improvement of the safety factor was attempted by earth removal from the head portion of the Upper Block and supplemented by dewatering. For the Middle Block, an increase in the safety factor was accomplished by installing four drainage wells supplemented by three rows of steel piles. Mitigation measures in the Lower Block included earth retaining structures, sabo dams, and ground sills to prevent further movement of earth materials.

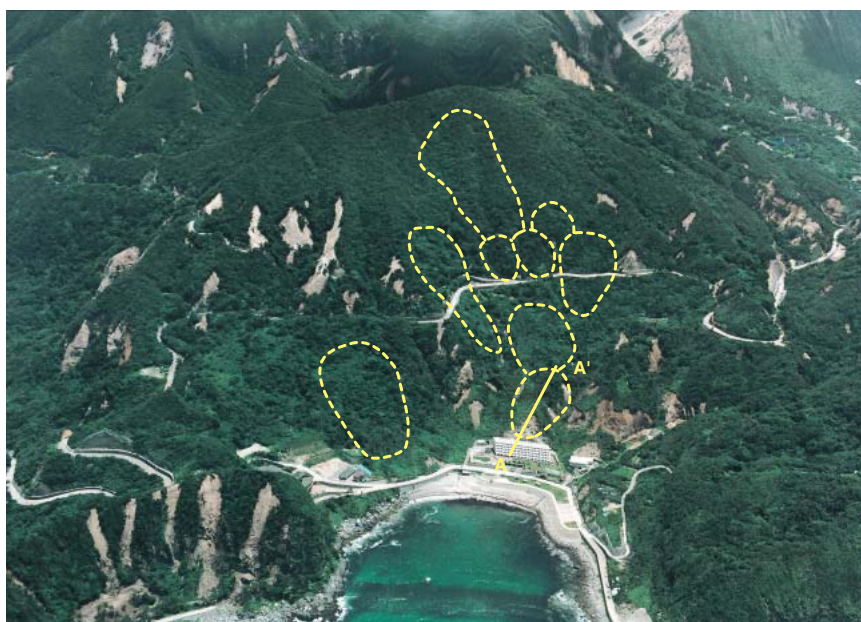
Photo 6-15 Ohrisawa landslide (courtesy of Tokyo Metropolitan Government)

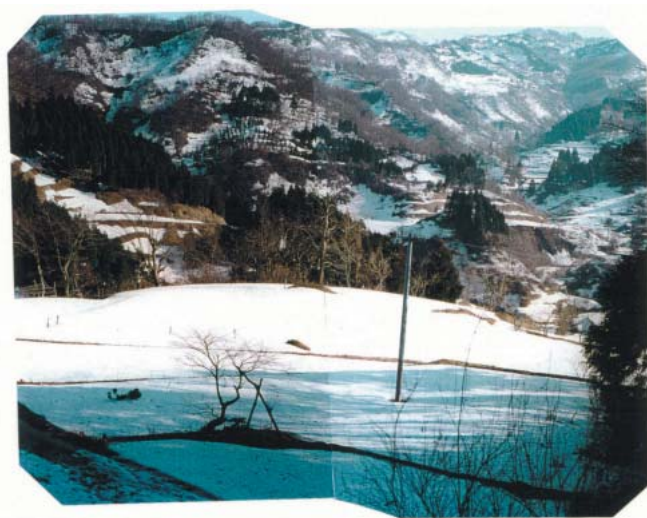
Photo 6-16 Sorakumashinden landslide prior to the sliding (Mar. 13, 1997) (courtesy of Niigata Prefecture)

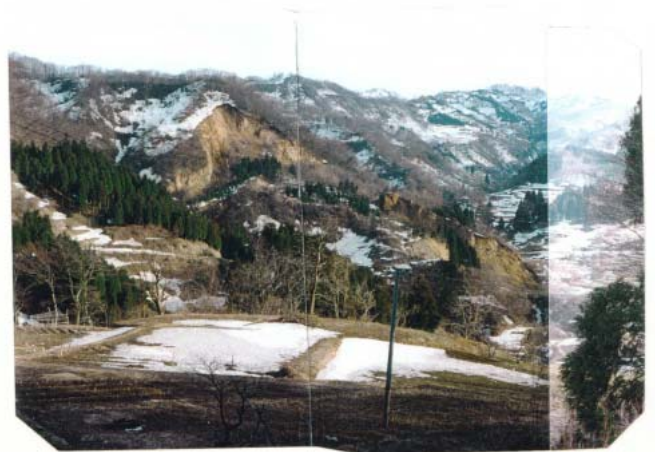
Photo 6-17 Sorakumashinden landslide following the sliding (Mar. 17, 1997) (courtesy of Niigata Prefecture)

(3) **History and Damages :** The landslide occurred on March 17, 1997. Damages include 430m of roadway, 430m of water main, 0.3 ha of farm land, and 680m of channels.

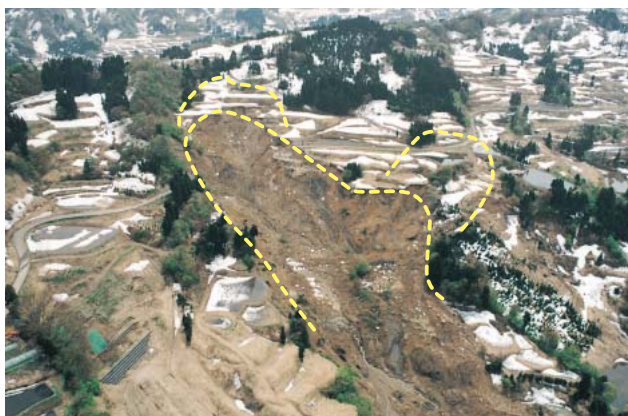
Photo 6-18 Kinyuba landslide (May 6, 1996) (courtesy of Niigata Prefecture)

(3) **History and Damages :** The May 6, 1996 landslide damaged a 150m section of the roadway. The landslide mass had very high water content and was very fluid. The fluid landslide mass traveled down 900m along the Funakura River, filling the river with debris, and buried three sabo dams and destroyed one bridge. The August 12, 1996 landslide moved 80m in response to the instability created by the May 6 landslide. An additional 200m section of the roadway was also destroyed.

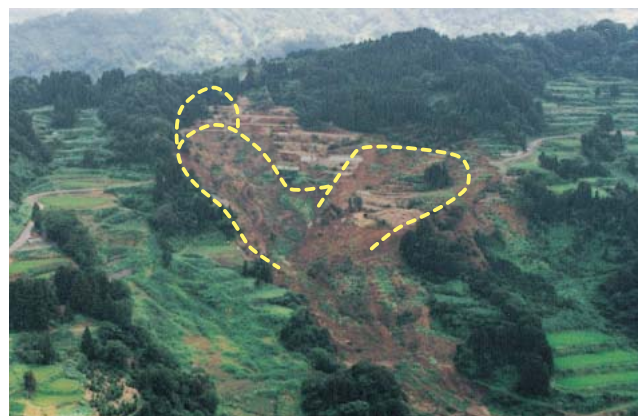
Photo 6-19 Kinyuba landslide following the second landslide (Aug. 12, 1996) (courtesy of Niigata Prefecture)

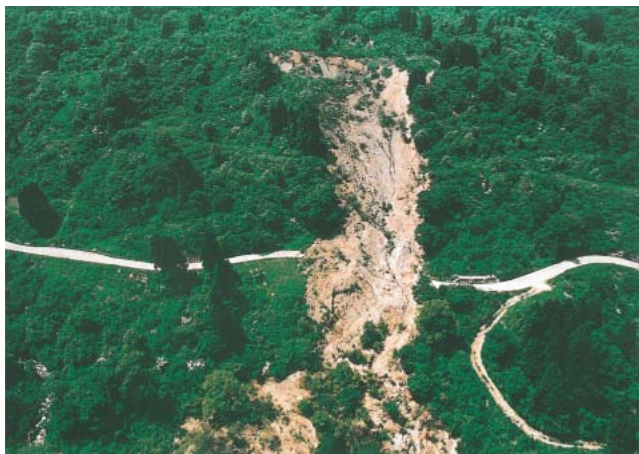
Photo 6-20 Kuwanokidaira landslide (courtesy of F. Agency)

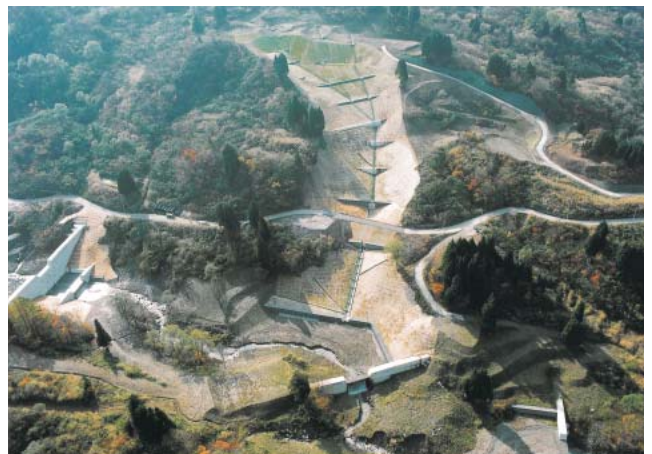
Photo 6-21 Kuwanokidaira landslide following the completion of mitigation measures (courtesy of F. Agency)

(5) **Mitigation Measures :** The mitigation measures for the Upper Block include : two drainage wells ; 60 piles ; and horizontal gravity drains at six locations. The mitigation measures for the Lower Block include : revetments, check dams, seven earth retaining structures, earth removal, interceptor underdrains, and channel improvements. The exposed slopes are protected and stabilized by log grating cribs and terracing with logs and re-vegetated with the aid of straw mats.

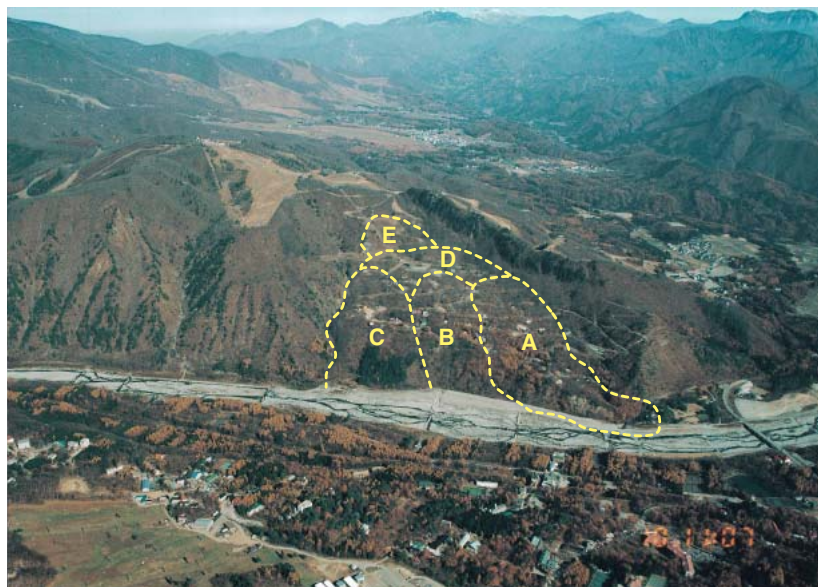
Photo 6-22 Kurashita landslide (courtesy of Nagano Prefecture)

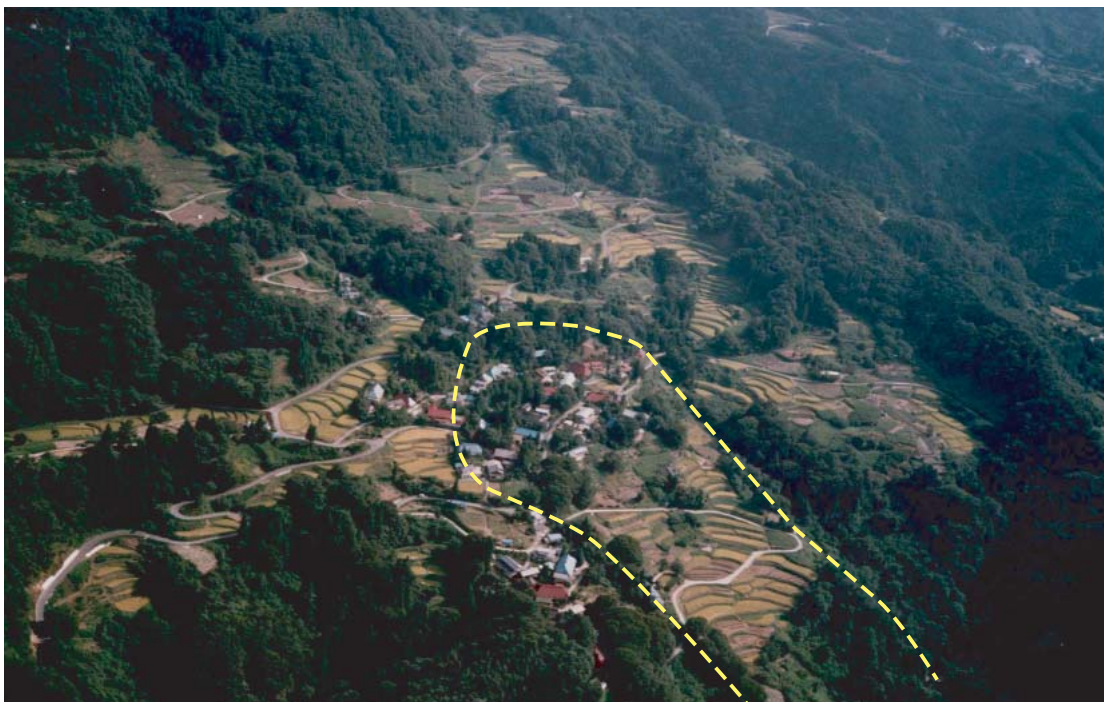
Photo 6-23 Shiomoto landslide (courtesy of Ministry of A. F. and F.)

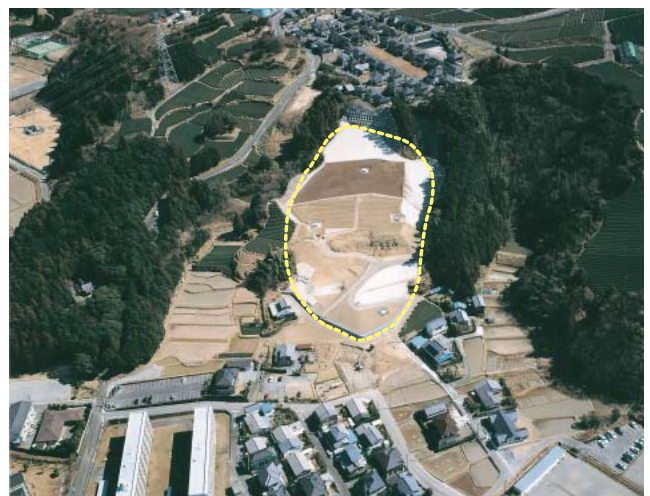
Photo 6-28 Hansai landslide following the completion of mitigation measures (courtesy of Shizuoka Prefecture)

(5) **Mitigation Measures** : Comprehensive mitigation measures were necessary for this landslide because : (1) it was induced by heavy rains ; (2) it is relatively large ; and (3) it was a potential danger to residential structures and river. The selected landslide control measures to increase the safety factor include : earth removal at the head area ; buttress fill at the toe area ; drainage wells ; and horizontal gravity drains. Further, in order to maintain the design safety factor, steel piles were driven at selected locations. At the scarp area, the inclination of the slopes were reduced by cutting, followed by hydromulching for erosion control, and the graded faces were supported by anchors.

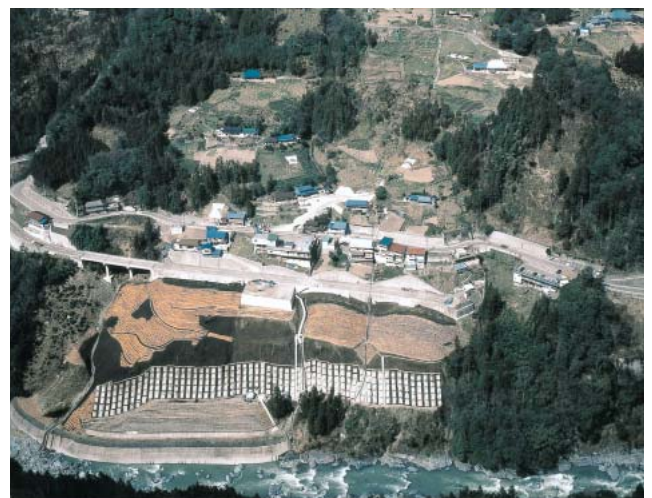
Photo 6-33 Zentoku landslides, Z1 Block following the completion of mitigation measures (courtesy of Ministry of L. I. and T.)

(5) **Mitigation Measures :** It is speculated that the Ansei Earthquake of 1854 may have triggered the Zentoku landslide, since active movement continued. The landslide was named as a Designated Landslide Threatened Area in 1959. Since 1952, the Tokushima Prefectural Government has implemented mitigation measures such as horizontal gravity drains, drainage wells, and surface drainage improvements. However, in 1982 the Ministry of Construction took it over as a direct project. Comprehensive mitigation measures started in 1992, including groundwater control measures and installations of large diameter cast-in-place shafts and anchors for Z1 Block. Recently, mitigation measures have been implemented for Z6 Block and Imakubo Block.

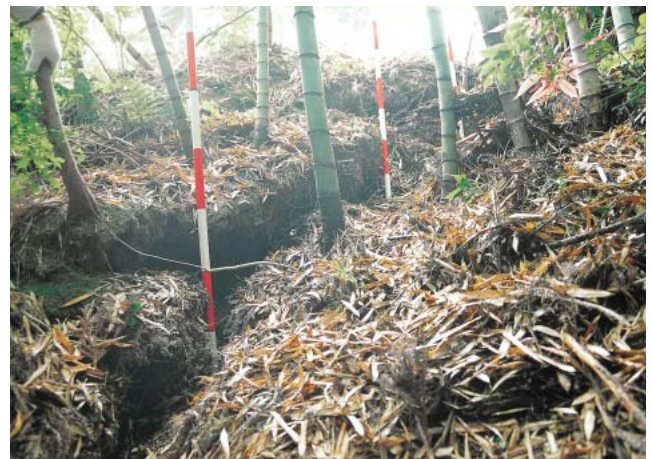
Photo 6-35 Surface deformation of Kashio landslide (courtesy of F. Agency)

(3) **History and Damages :** There is no historical record of the landslide ; however, the slide is thought to have originated in pre-historic time. The movement is almost imperceptible and chronic, about 5cm/year, showing some deformation on residential structures and settlement in roadways. In 1993 and 1994, increased movement of up to 30cm/year caused partial destruction of a house, roadway settlements, pushed out revetments, and pressure cracking on embankments.

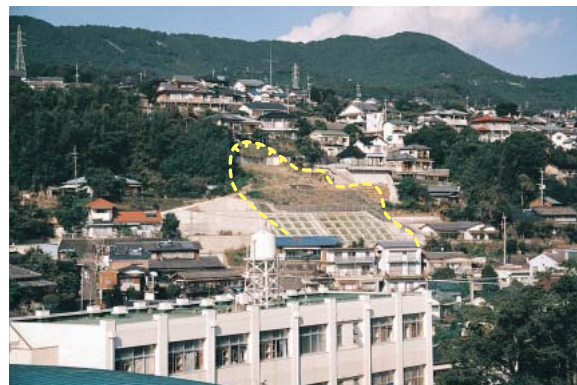
Photo 6-39 Harabun landslide following the completion of mitigation measures (courtesy of Nagasaki Prefecture)

Permanent Measures : As landslide control measures, horizontal gravity drains and surface drainage improvements were implemented. As landslide restraint measures, piles and anchors were also installed.
